NUCLEAR-CRITICAL ACCIDENT AT THE LOS ALAMOS SCIENTIFIC LABORATORY ON DECEMBER 30, 1958

LAMS-2293 HEALTH AND SAFETY (TID-4500, 14th ed.)

H. C. Paxton R. D. Baker W. J. Maraman Roy Reider

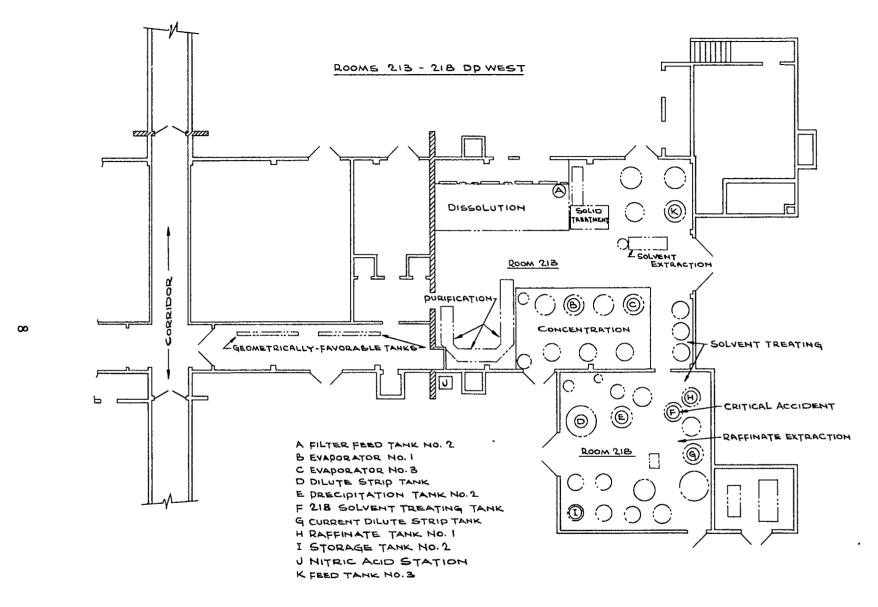
Fig. 3 Layout of equipment in area where accident occurred.

Material transfers leading up to the accident were as follows (refer to Fig. 3 for container locations).

Location of Chemical Operators*	Dosage, rem
Against 218 Solvent Treating Tank	12,000 ± 50%
Behind Feed Tank No. 3 (43 ft)	134
In purification area (35 ft)	53
In other areas (>75 ft from supercritical burst)	<4

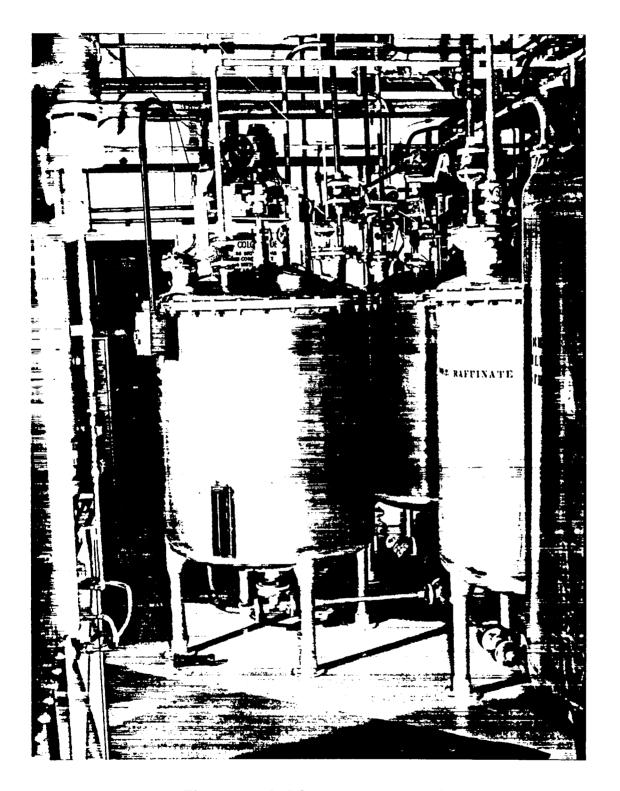
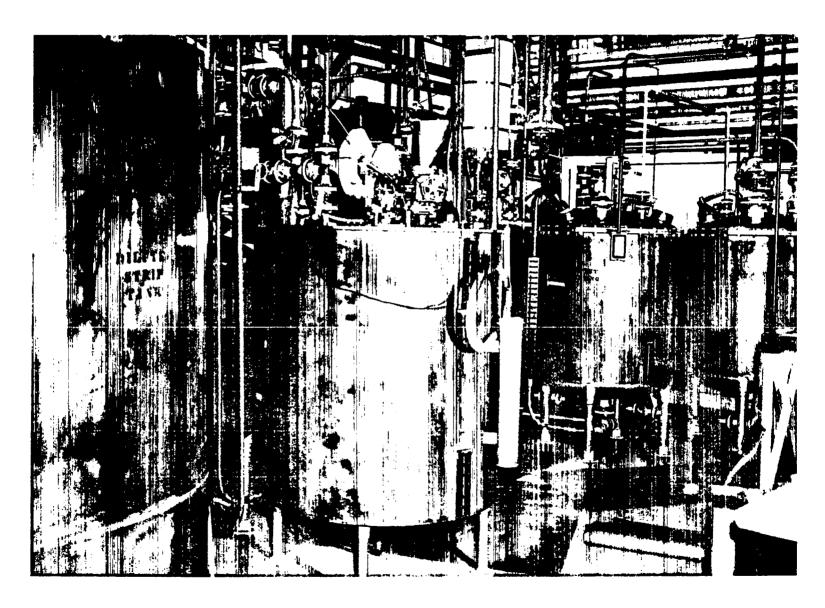
Fig. 10 218 Solvent Treating Tank.

solvent layer on top of the solution. Subsequent transfer of this plutonium-rich solvent and the nitric acid slurry of residual solids in the bottom of the tank into the 218 Solvent Treating Tank (Figs. 10, 11, and 12) acidified the emulsion, freeing additional solvent for further extraction of any remaining hydrolysis products into the combined organic phase. As in the case of the Current Dilute Strip Tank, mixing and extraction resulted from the air-sparging of this material through the bottom inlet of this tank. Upon cessation of the air-sparging the solvent phase separated into an 8-in. layer on top of the aqueous which was subcritical at this time. This thickness was determined by evaluation of the solutions in the tank after the accident. Phase separation took about 2-1/2 minutes.

A chemical operator started the motor driving the mechanical agitator in the solvent-treating tank. There was a "blue flash" and a muffled report. The operator, who was looking into a sight glass at the top of the tank (Figs. 10 and 12), was knocked off the two-step ladder on which he stood. Though the shock displaced the tank about 3/8 inch at its supports, the tank was not ruptured and no plutonium escaped. The operator apparently turned the stirrer motor off, then on again (this time noticing a rumbling sound), ran out a nearby exterior door, and called that he was "burning up." A second operator, some 40 feet away in an adjoining room, saw a reflection of the light on the walls ("like a photo-flash"), heard the report, went to help, and was joined by a third operator. Returning to lead the first man to a shower (on request, apparently as the result of suspecting an acid burn), they passed the tank, and the second operator turned off the stirrer motor.

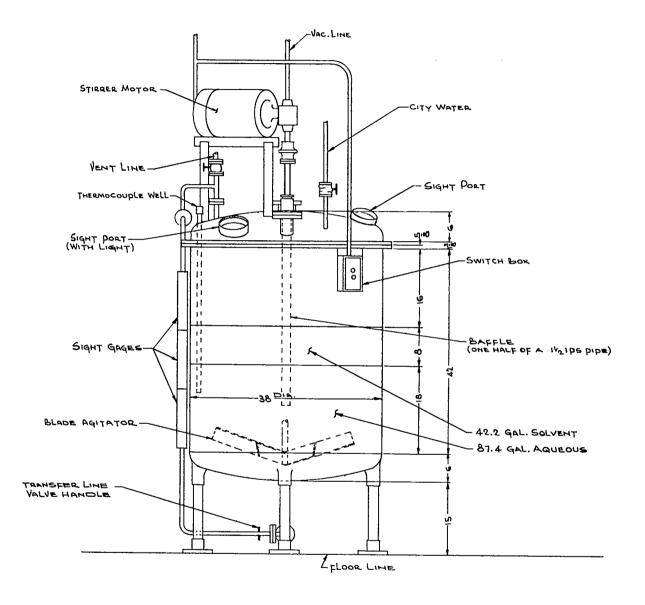
Fig. 12 Diagram of solvent-treating tank, showing levels of aqueous and organic phases before stirrer was activated.

The situation in the 225-gallon, 38-in.-diameter, solvent-treating tank immediately before the accident is believed to be as illustrated in Fig. 12: 87.4 gallons of aqueous solution contained 40 g of Pu, and on top, a 42.2-gallon layer of solvent contained 3.27 kg of Pu. Solids (containing 60 g of Pu) were suspended in both the aqueous and organic phases and at the interface. Few solids settled to the bottom of the tank. Estimates based on Fig. 13, taking into account the tank diameter and effects of neutron "poisons," indicate that the 8-in.-thick solvent layer was barely subcritical at the plutonium concentration of 20 g/liter (the estimated critical thickness is 8-1/4 inches, and the actual configuration was roughly 5 dollars subcritical).

The initial action of the stirrer in the solvent-treating tank forced aqueous solution up along the wall, displacing the outer portion of the solvent layer and thickening the central portion. An average increase in solvent-layer thickness of about 0.4 inch, corresponding to an average radius decrease of 1/2 inch, could account for the obviously supercritical configuration. The burst was certainly terminated by the violent disturbance that it generated, and continuation of the stirring diluted the plutonium beyond the point at which a critical reaction could recur.

Additional evidence that the plutonium was concentrated in the solvent layer when the burst occurred is given by the long-lived gamma activity of the stainless steel baffle (type-347) that was located about 6 inches within the wall of the solvent-treating tank (Fig. 12). Scanning indicated a peak in activity about 1 inch below the mid-plane of the solvent layer.

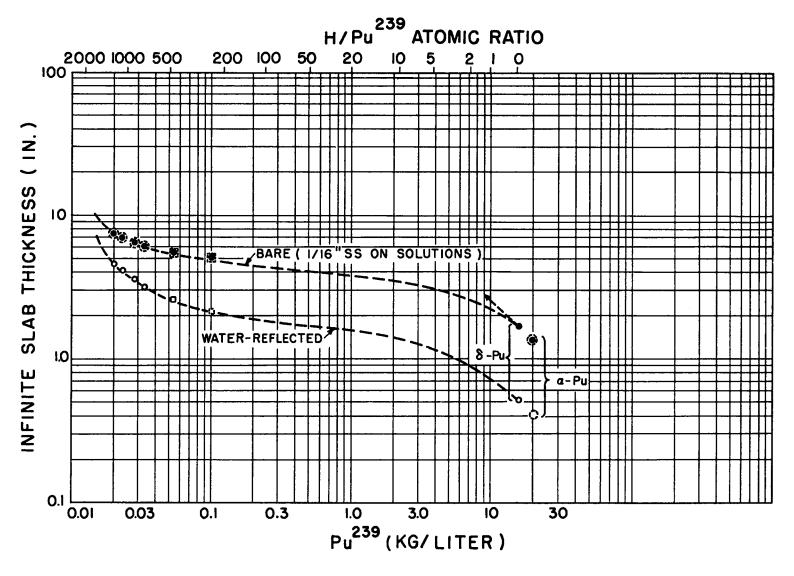
Fig. 13 Estimated critical thicknesses of infinite slabs of homogeneous water-moderated Pu<sup>239</sup> in the absence of NO<sub>3</sub> and Pu<sup>240</sup>. Based on data from F. E. Kruesi, J. O. Erkman, and D. D. Lanning, Hanford Report HW-24514, May 1952 (classified).

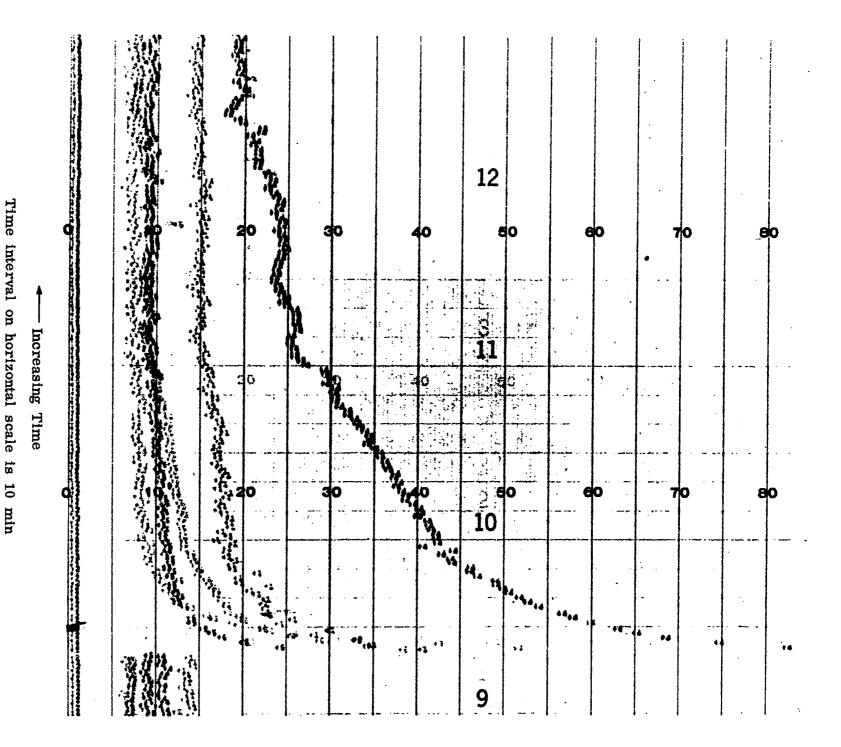
Fig. 14 Trace of slow-acting recorder (Point No. 4) located 160 ft from tank.

None of the gamma-sensitive recording detectors within range of the accident showed an ideal trace. They suggest, however, that there was but a single burst -- see, for example, the record reproduced in Fig. 14.

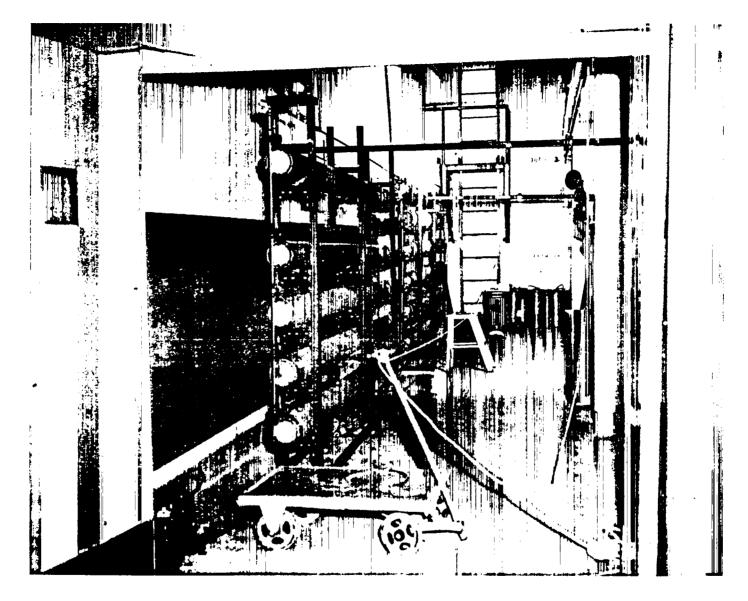
Fig. 15 Geometrically-favorable tanks used to receive the solution.

Immediately after the incident, a bank of ten 6- and 5-in.-diameter cylinders was fabricated and set up about 100 feet from the point of the accident (see Figs. 3, 15, and 16). This storage array was connected to a transfer line that leads from the bottom outlet of the solvent-treating tank. As the disposition of plutonium in the tank was then unknown, opening of the bottom outlet valve was a suspect operation and was therefore accomplished from behind a temporary shield by means of a 10-foot extension handle. The solution was vacuum-transferred into the bank of cylinders without complication on January 1, 1959. The solution level within the cylinders was followed by gamma-sensing instruments. Maximum reading at contact was about 1 r/hr, and indications along the wall of the solvent-treating tank immediately after emptying were less than 50 mr/hr.
