September 28, 1943

By A. U. Seybolt

Imploded steel tube sample, identified by the Ordnance Group as no. 28, was received for metallographic examination. This sample was in three pieces with deep cracks running in a radial direction. Some cracks went from the center to the outside while others went within a fraction of an inch of the outside. The general shape was somewhat suggestive of a clover leaf, Fig. 1.

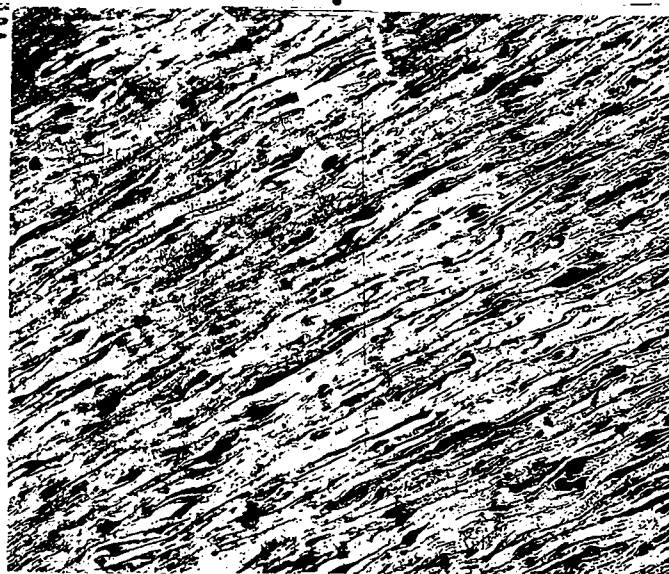
Microscopic examination of the dark and the light areas showed as in the earlier sample that the dark areas were characterized by what appeared to be profuse Neumann bands, while the light etching areas were comparatively free of banding. The Neumann bands observed on this sample were more chaotic and less distinguishable as individuals than on the previous imploded sample 21. There is possibly a slight doubt that they are Neumann bands, but intermediate etching zones seem to show Neumann bands, and hence it is inferred that the dark etching areas are areas of exceedingly profuse bands which can not be distinguished as individuals. Figs. 2-5 show the structure of various sections cut from the slab. The elongated grains shown in Fig. 2 are characteristic of transverse areas near the center of the section. Fig. 3 shows almost an equi-axed grain structure near the side of the section. Examination of this sample showed that the grains became progressively elongated toward the center or banded region. The longitudinal sections, characterized by Figs. 4 and 5 for the banded, interior areas, show a fairly equi-axed grain structure.

Fig. 2 Area of Profuse Neumann Bands
Transverse Section X 100
Etching reagent: 1% nital
Photo no. 2009

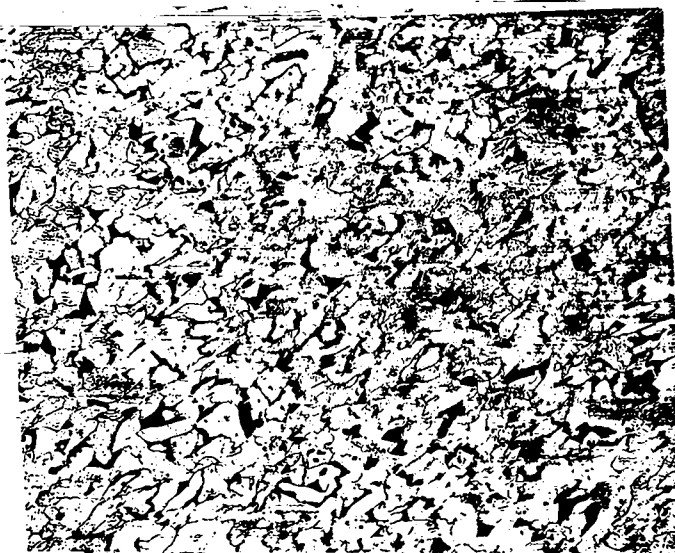
Fig. 3 Area of Normal Structure
(few or no Neumann Bands)
Transverse Section X 100
Etching reagent: 1% nital
Photo no. 2010

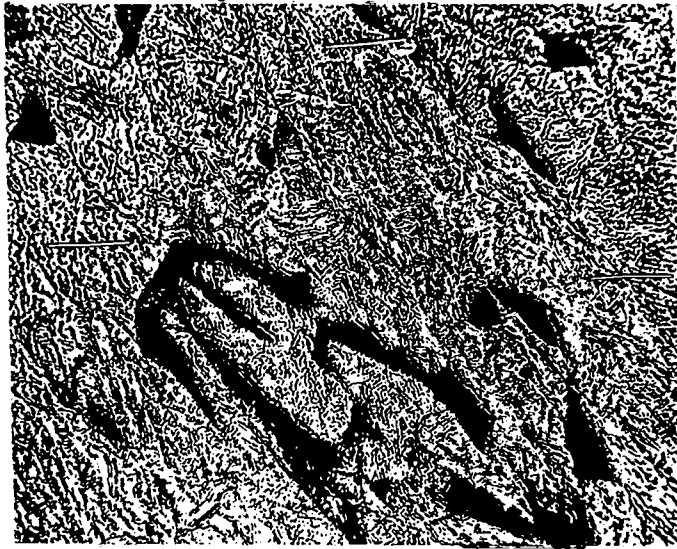
Fig. 4 Area of Profuse Neumann Bands
Longitudinal Section X 500
Etching Reagent: 1% nital
Photo no. 2011-1

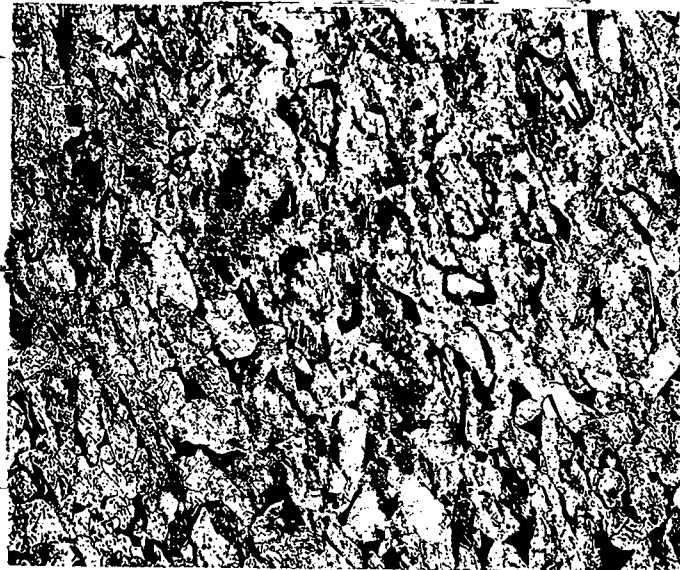
Fig. 5 Area of Profuse Neumann Bands
Longitudinal Section X 100
Etching Reagent: 1% nital
Photo no. 2011-2
