LA-10446-MS

Issued: September 1985

Radiation Monitor for Surveillance of Moving Vehicles

RADIATION MONITOR FOR SURVEILLANCE
OF MOVING VEHICLES

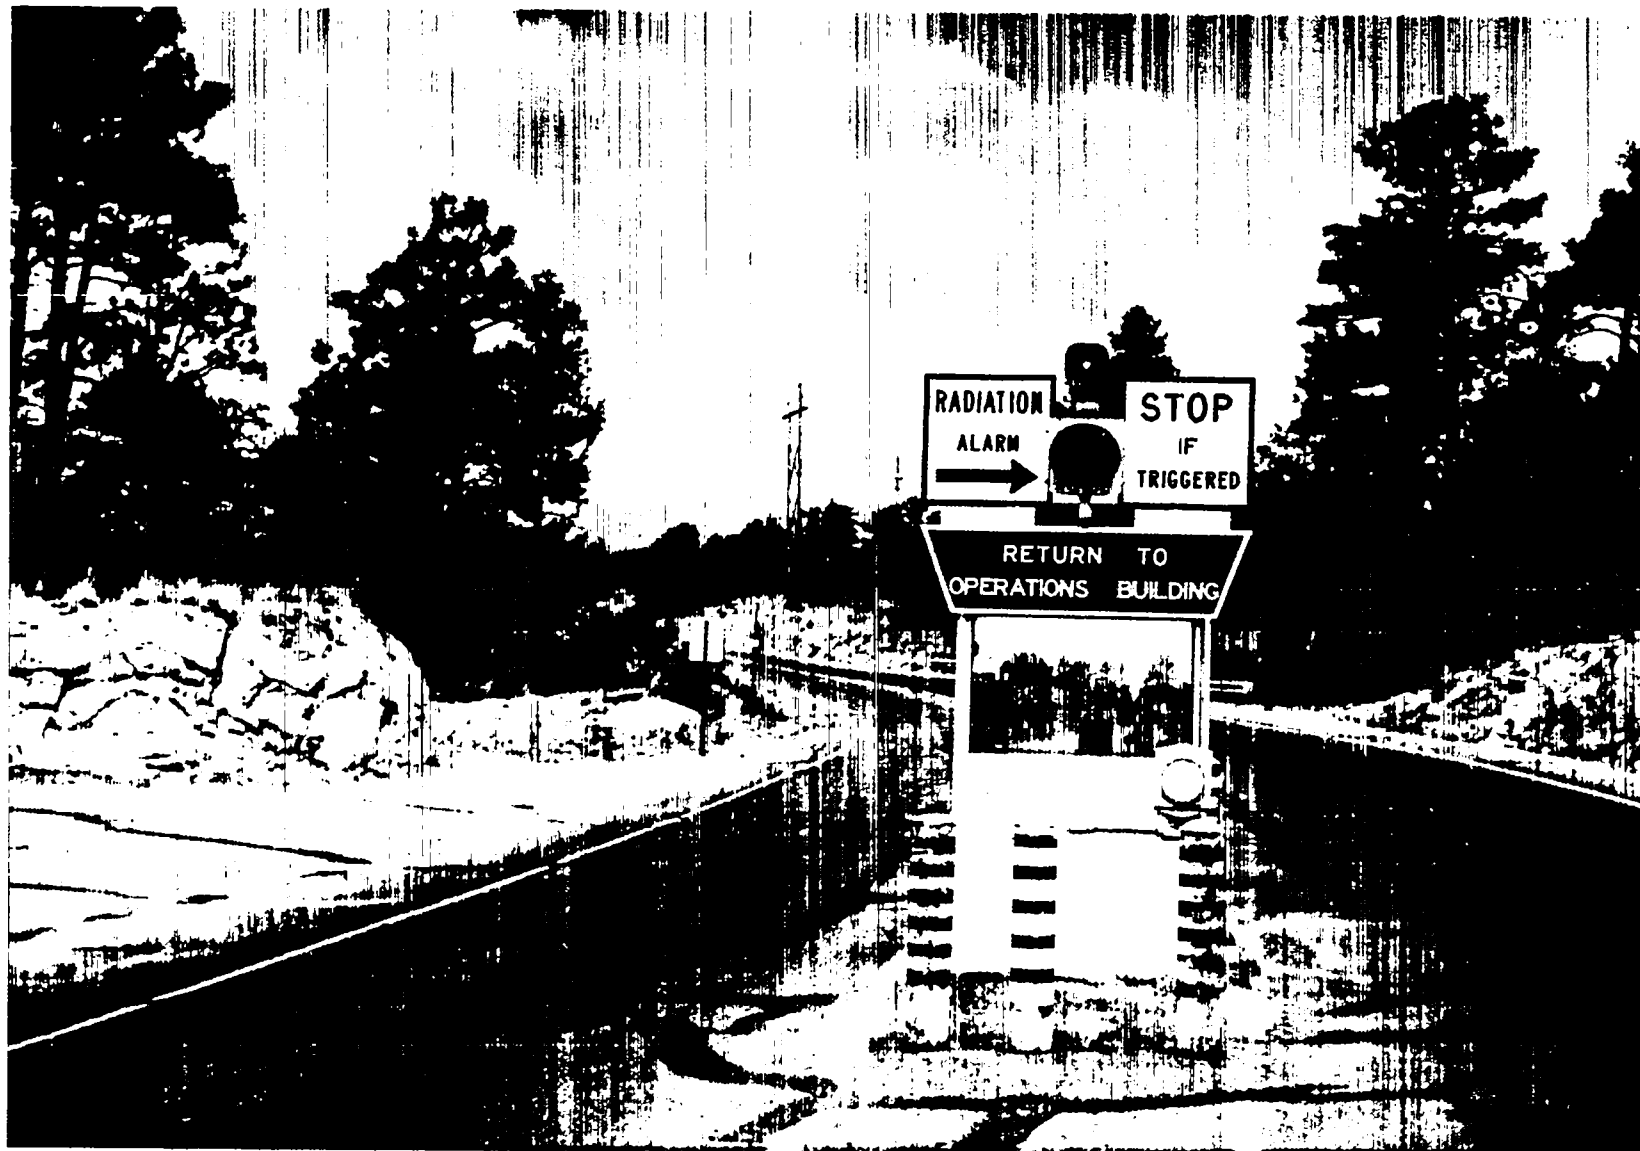
Figure 1. The guard station with alarm light and Klaxon. The system electronics are mounted inside the station.

station in the exit lane. The electronics package was mounted in the guard station with connection to the detector by buried conduit. An alarm light and a Klaxon horn were mounted on the roof along with instructions to stop at the guard station on alarm. Fig. 1 shows the guard station with attendant signs, light, and Klaxon horn.

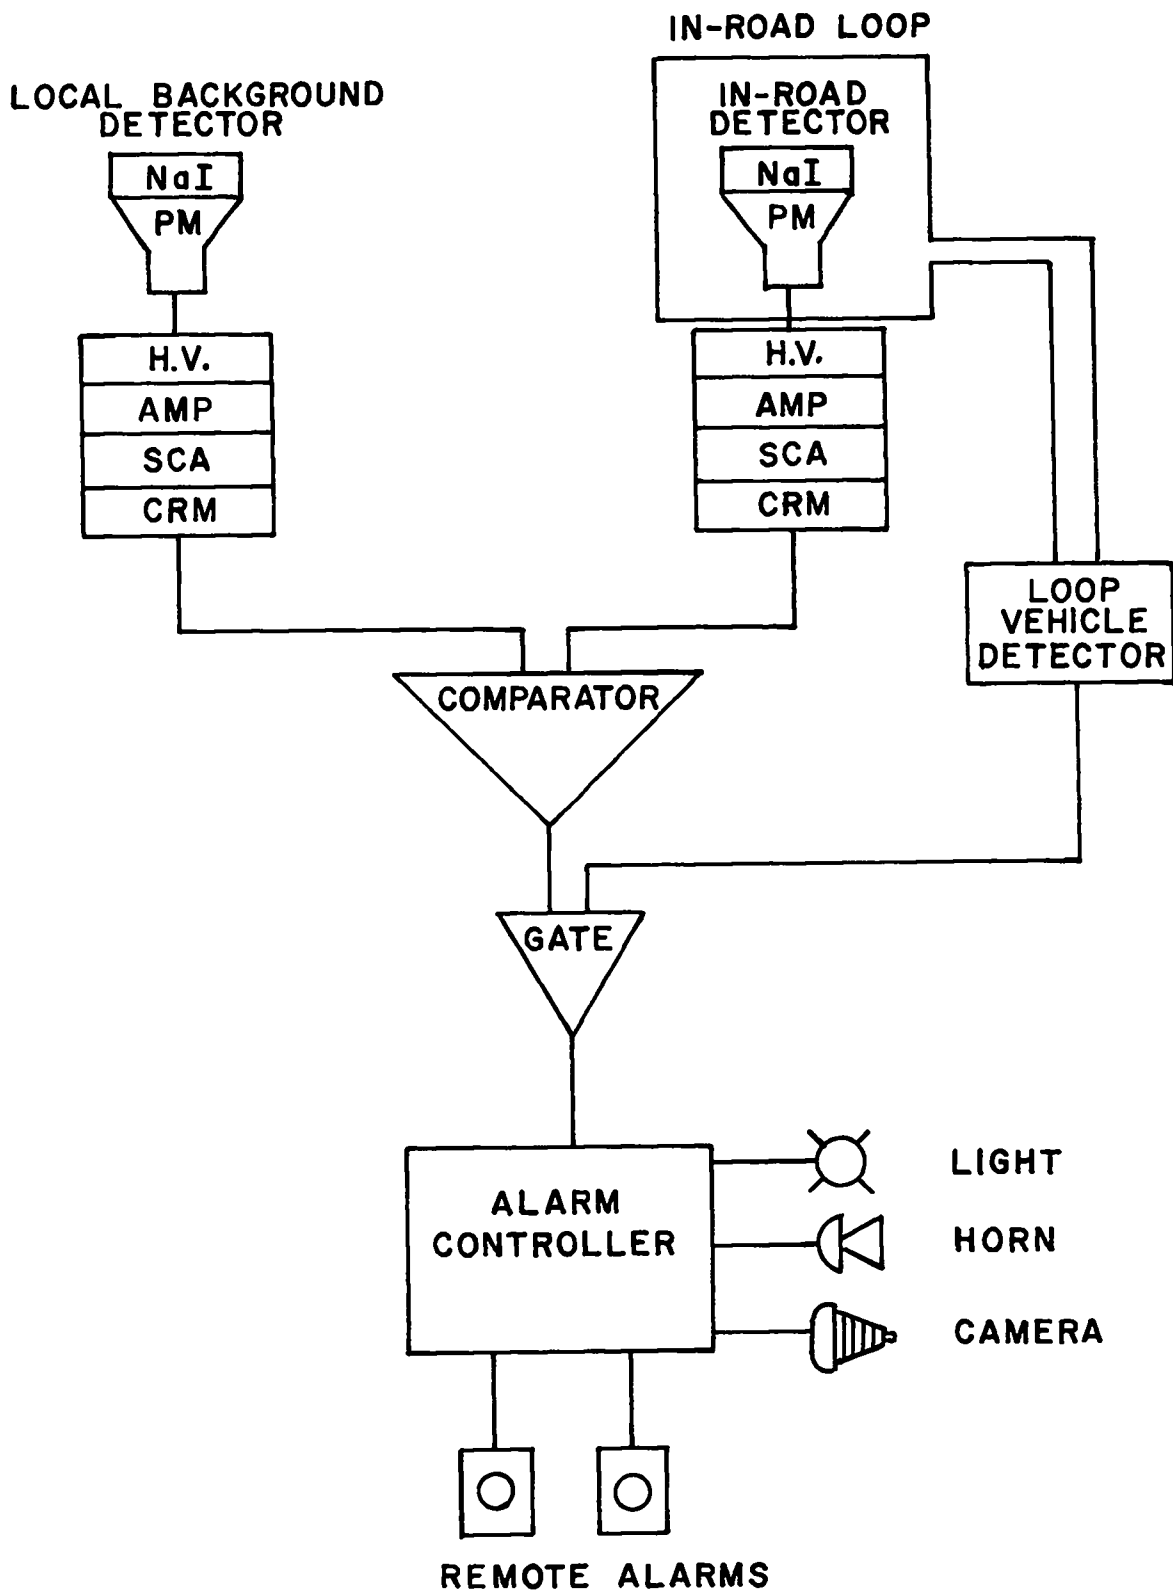
Figure 5. Schematic of monitoring system.

With the exception of the alarm modules, the electronic components are conventional. A schematic is shown in Fig. 5. To minimize noise problems, the PM tube is operated at relatively high voltage and, correspondingly, the pulse amplifier is set at a relatively low gain. The single-channel analyzer module is used with a window between 75 keV and 1.5 MeV. These settings are not necessarily optimum, but clearly an upper level cutoff is necessary to reduce the interference from lightning-generated noise.

The outputs of the two count-rate meters are scaled to equal voltage levels, and an adjustable increment is added to the background signal to allow for statistical fluctuations. A monitor signal in excess of the conditioned background signal initiates

an alarm. If a vehicle is present, as indicated by the loop vehicle detector, the alarm controller is activated, causing the warning light to be turned on, the Klaxon horn to be sounded, and a photo to be taken. Alarm is also sounded in the Health Physics offices from which point appropriate action is initiated. Fig. 6 shows one of the remote alarm boxes. Alarm reset and a partial system disable can be accomplished from the remote office locations.
