LA-8715-PR

Space Nuclear Safety and Fuels Program

October 1980

I. GENERAL-PURPOSE HEAT SOURCE (GPHS)

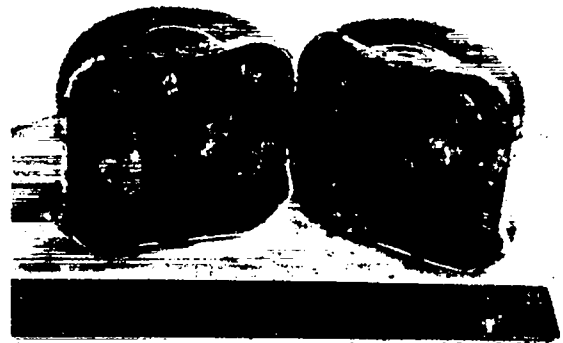
Fig. 7.
After the iridium capsules were cut open, the degree of fuel fracture was evident. a) IRG-87; b) IRG-89, and c) IRG-90.

After recovery, the capsules from DVT-1, DVT-3, and DVT-4 (IRG-87, -89, and -90) were opened so that the fuel could be recovered for particle-size analyses. The fuel from IRG-88 (DVT-2) was not removed in the same manner, because of the failure of the clad. The split capsules with the fuel inside are shown in Fig. 7. The major fuel shear planes that controlled the local deformation offset in IRG-87 are readily apparent in Fig. 7a. Similar shear planes are visible in IRG-89 (Fig. 7b), but the full support provided by the aeroshell and impact shell in the end-on orientation prevented the differential movement necessary to cause the capsule offset. The fuel fragmentation in IRG-90, shown in Fig. 7c, was greater than that observed in either of the other orientations.
