**TITLE: DEMOLITION OF BUILDING 12, AN OLD PLUTONIUM FILTER FACILITY**

**AUTHOR(S): E. L. Christensen, R. Garde, and A. M. Valentine**

**SUBMITTED TO: 2nd AEC ENVIRONMENTAL PROTECTION CONFERENCE,  
ALBUQUERQUE, NEW MEXICO, APRIL 16-19, 1974**

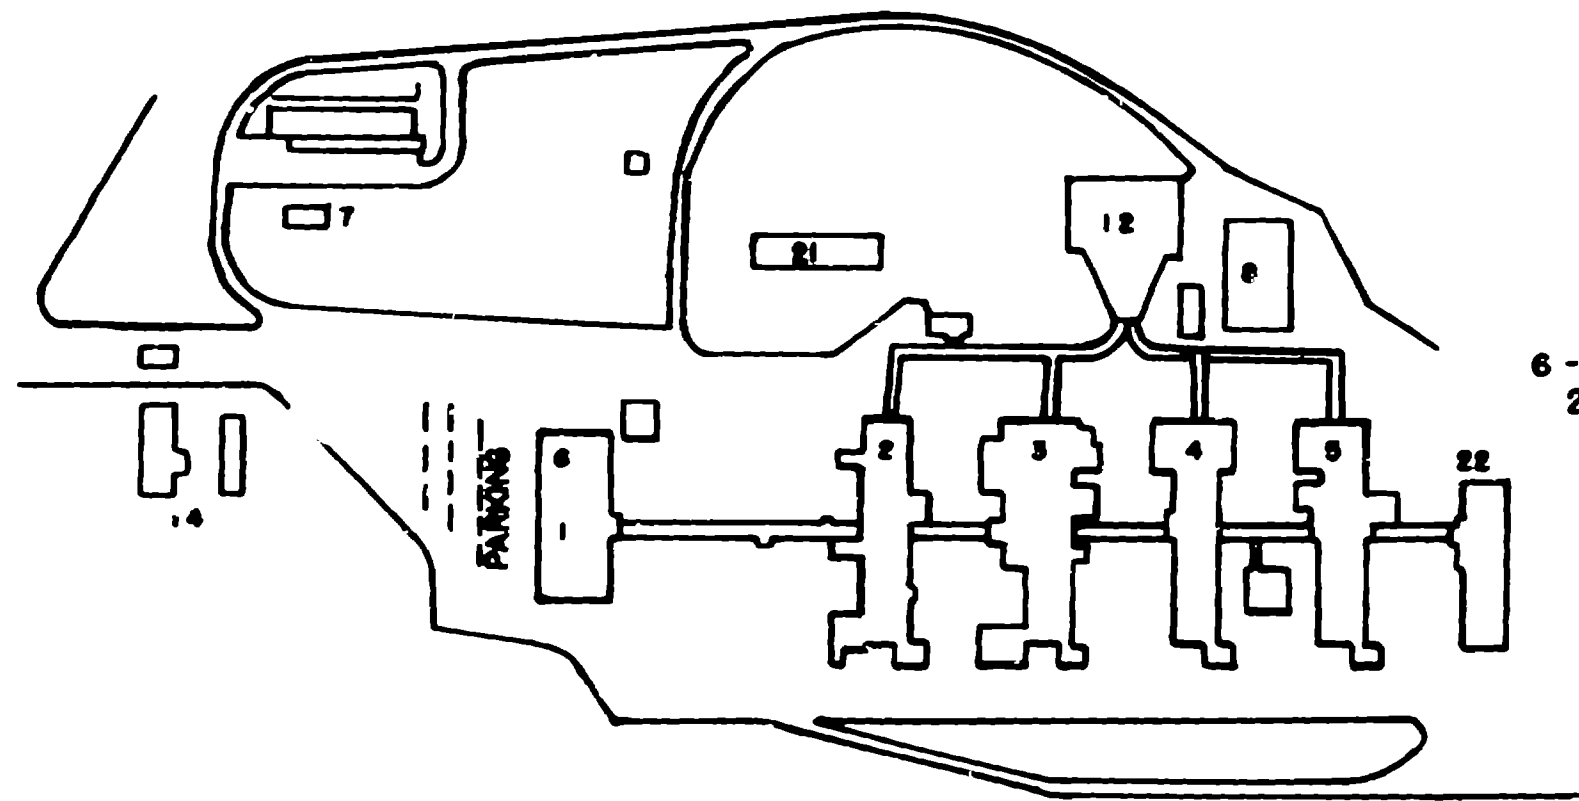
Fig. 1. GENERAL LAYOUT OF DP SITE WEST

**The site plan in Fig. 1 shows the relationship of the process buildings to the filter building. The air from the rooms was exhausted at floor level, up vertical ducts through the roof, then in ducts mounted parallel to the roof, to the collector duct built on the peak of the roof. The finished site is shown in Fig. 2. The filter building, designated as Building 12, can be seen on the left. The ductwork was constructed of galvanized steel. Corrosion began immediately in the ductwork for those rooms where chemical fumes were generated, and small holes were created within a few years. Corrosion products along with dirt drawn through the holes in the ductwork were all deposited in the plenum of Building 12.**

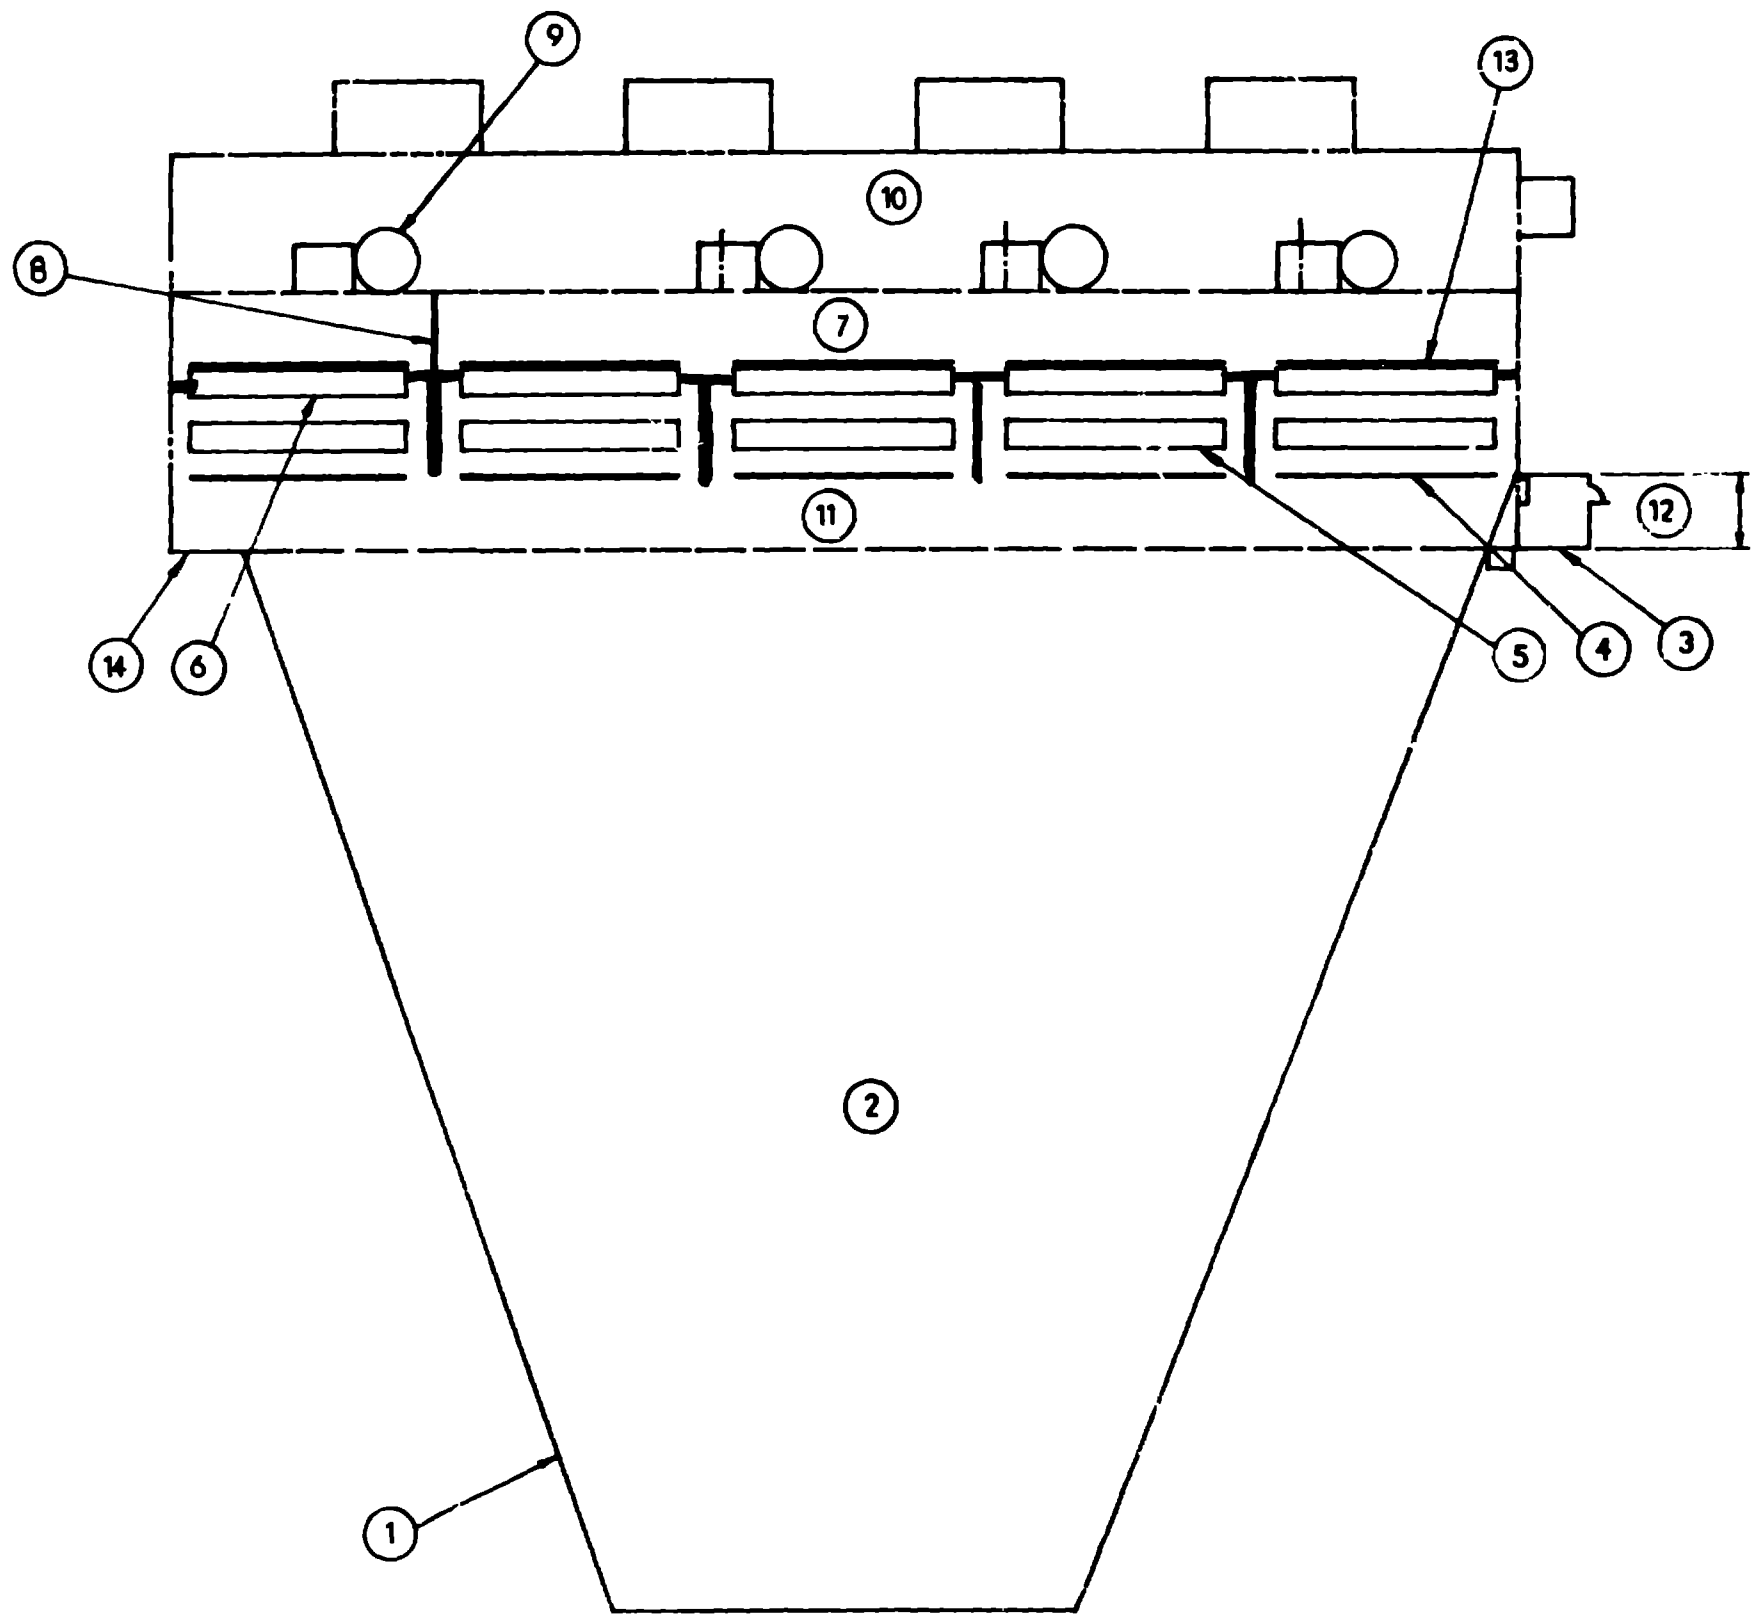
Fig. 3. PLAN- BUILDING DP-12

**The floor plan of Building 12 is shown in Fig. 3 with the legend being listed in Table 1. The floor area was 30.8 metres by 19.5 metres for that portion housing the filters and precipitron units. The intake**

- 1. Transition Plenum Opening**
- 2. Transition Plenum Area**
- 3. Temporary Change Room**
- 4. South Filter Isolation Doors**
- 5. Electrostatic Precipitron Framing**
- 6. Filters and Filter Framing**
- 7. Exhaust Blower Plenum Area**
- 8. New Temporary Wall**
- 9. Operative Exhaust Fan and Stack**
- 10. Blower Room Area**
- 11. Area of Plastered Ceiling**
- 12. Penthouse Area above Structure**
- 13. Plenum Isolation Doors**
- 14. Existing Brick Walls**

plenum was a trapezoidal area measuring 23.5 metres wide at its longest base, 7.6 metres wide where the air entered the building and 18.9 metres from that point to the rectangular portion of the building.

The precipitron units and filter banks were built in 5 sections with a wall between each section. Each section had two large doors that could be lowered to isolate a section while filters were being changed or while work was being done on the precipitron unit in that section. Access to the isolated section was by way of ladders from the second story section of the building. This second story also housed the doors when they were in the raised position.

**The first step in the demolition was the removal of the ductwork leading to Building 12. This work was started in 1972 and was completed in February, 1973. As ductwork was removed and air supply reduced, blowers in Building 12 were shut down. When the third blower was shut down a partition was built in the blower plenum so that blower number 4 and filter bank number 5 would provide ventilation for the building during demolition. The position of the partition is shown in Fig. 3 at point number 8.**

**In preparation for the cleaning and demolition, a change room was constructed on the east side of the building adjacent to the air lock and access door shown in Fig. 3. The workers were suited up, including a fitting and testing of full face masks, in this change room.**

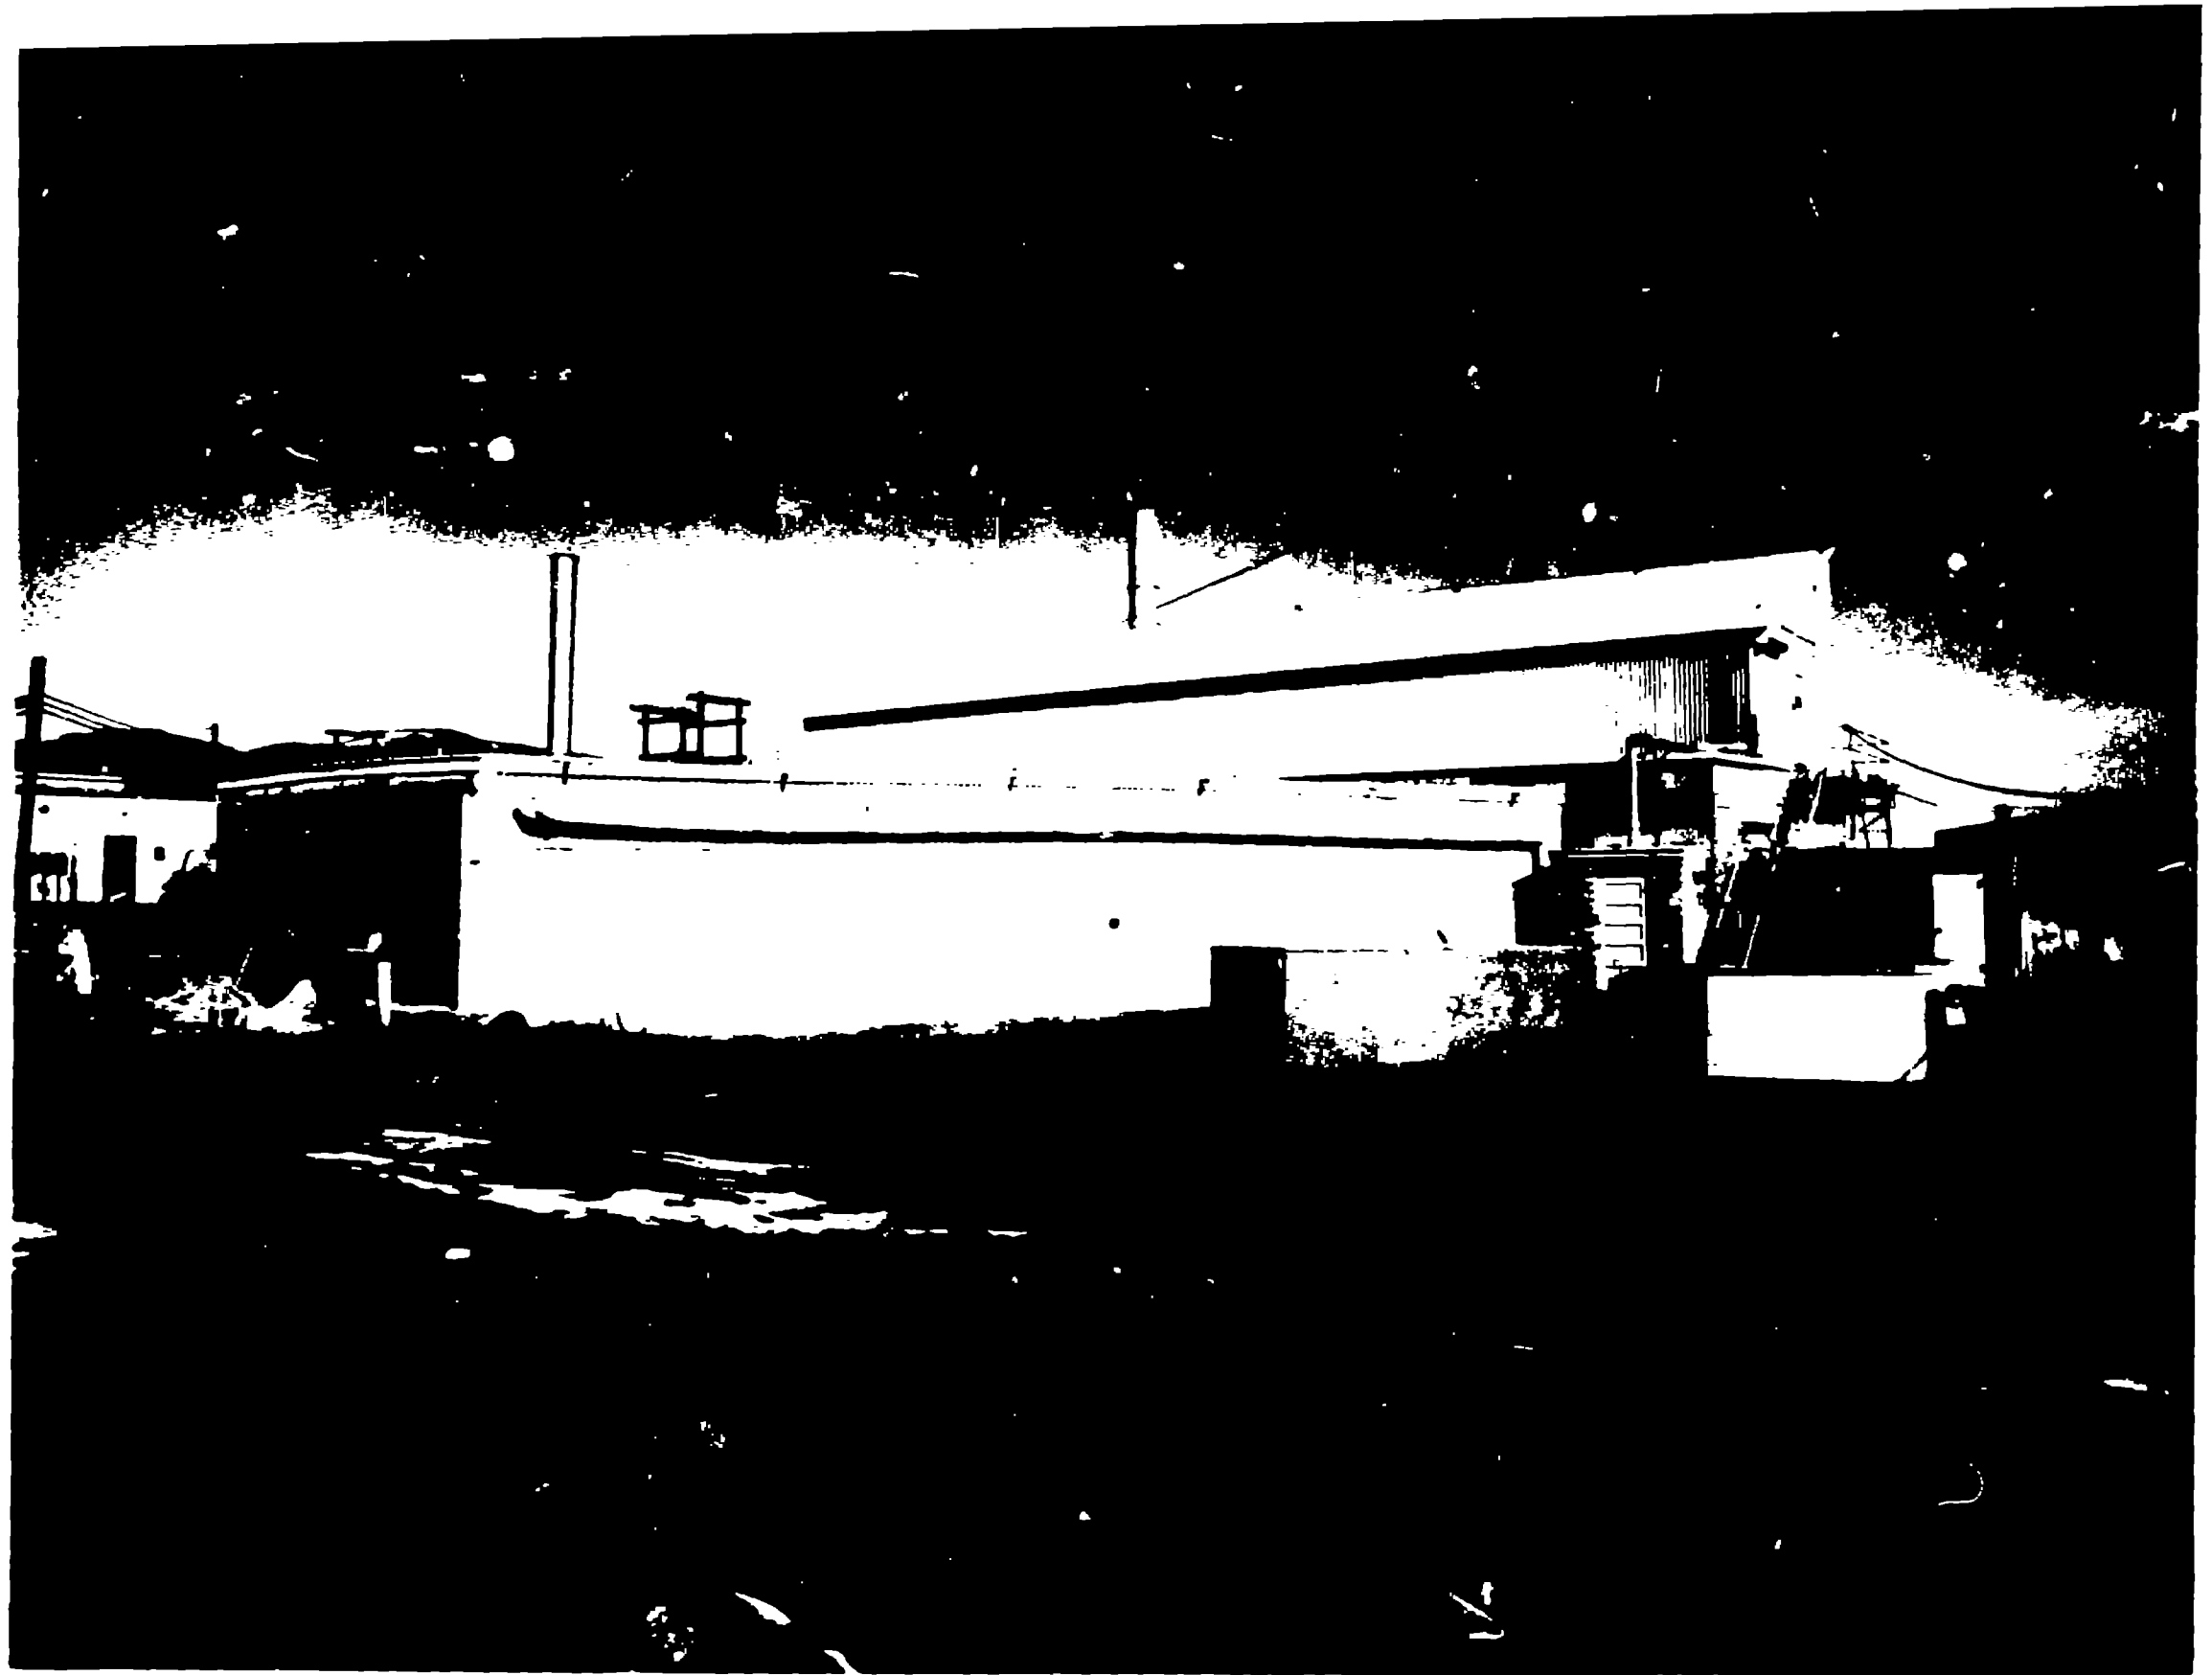
Fig. 4. SIDE VIEW OF BUILDING 12

A side view of the building is shown in Fig. 4 and a side view of the filter and blower area, Fig. 5, shows the position of the electrostatic precipitron units, the PL-24 filter bank, the common blower plenum, the exhaust blowers, and the doors used to isolate each of the filter sections. A front view of the building is shown in Fig. 6.

1. Intake Plenum Isolation Door
2. Blower Plenum Isolation Door
3. Intake Plenum
4. Electrostatic Precipitrons
5. PL-24 Filters
6. Blower Plenum
7. Blowers

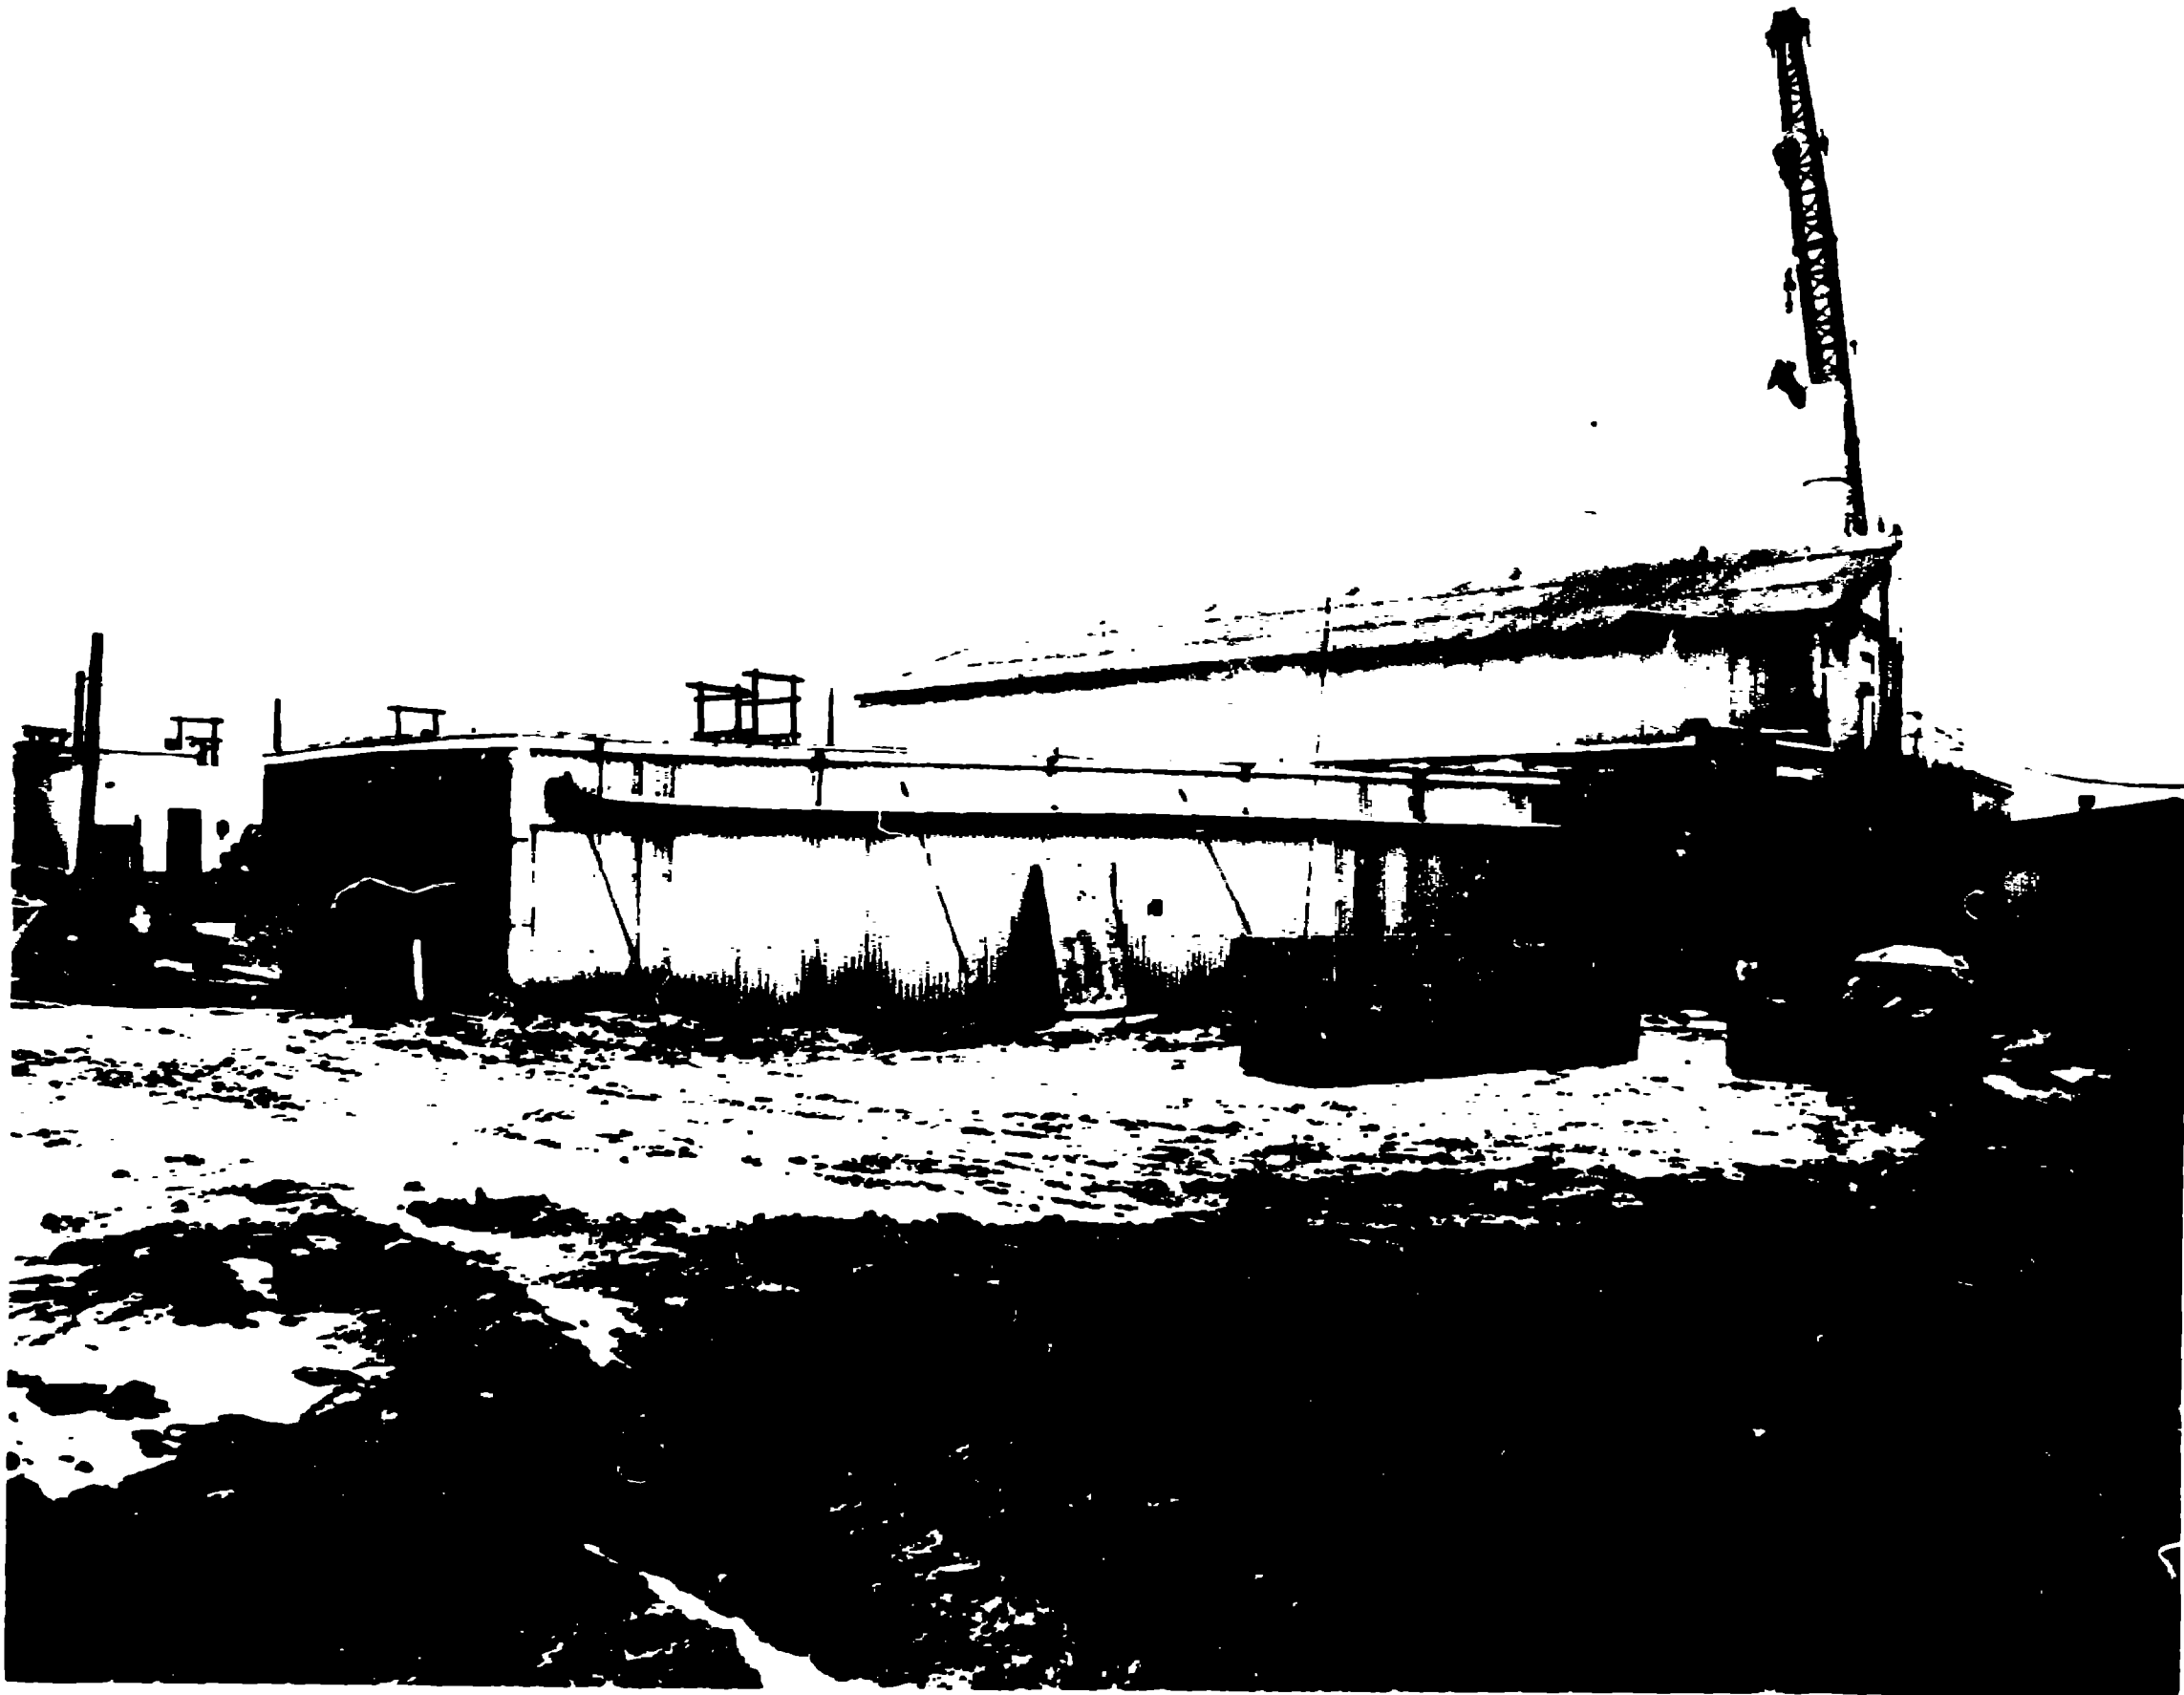
Fig. 7. PREPARING TO REMOVE STACK NUMBER ONE

After the blower room roof had been removed, except for a section over blower number 4 and another section over the electrical panels, work was started on removal of the stacks. Fig. 7 shows a rigger being lifted to the top of the first 50 foot stack to attach a lifting collar to the stack. The stacks had a square base which was slipped over a slightly smaller male fitting on the blower to provide the air seal. This joint was taped and painted to make it air tight. The stack was removed by cutting the tape, cutting some external supports (which were not contaminated) and lifting the stack off the blower with a crane. The bottom of the stack and the opening of the blower were immediately covered with pre-assembled sheets of plywood. The stack was then placed on a low-boy and the ends sealed with metal plates and wrapped in plastic for hauling to the burial

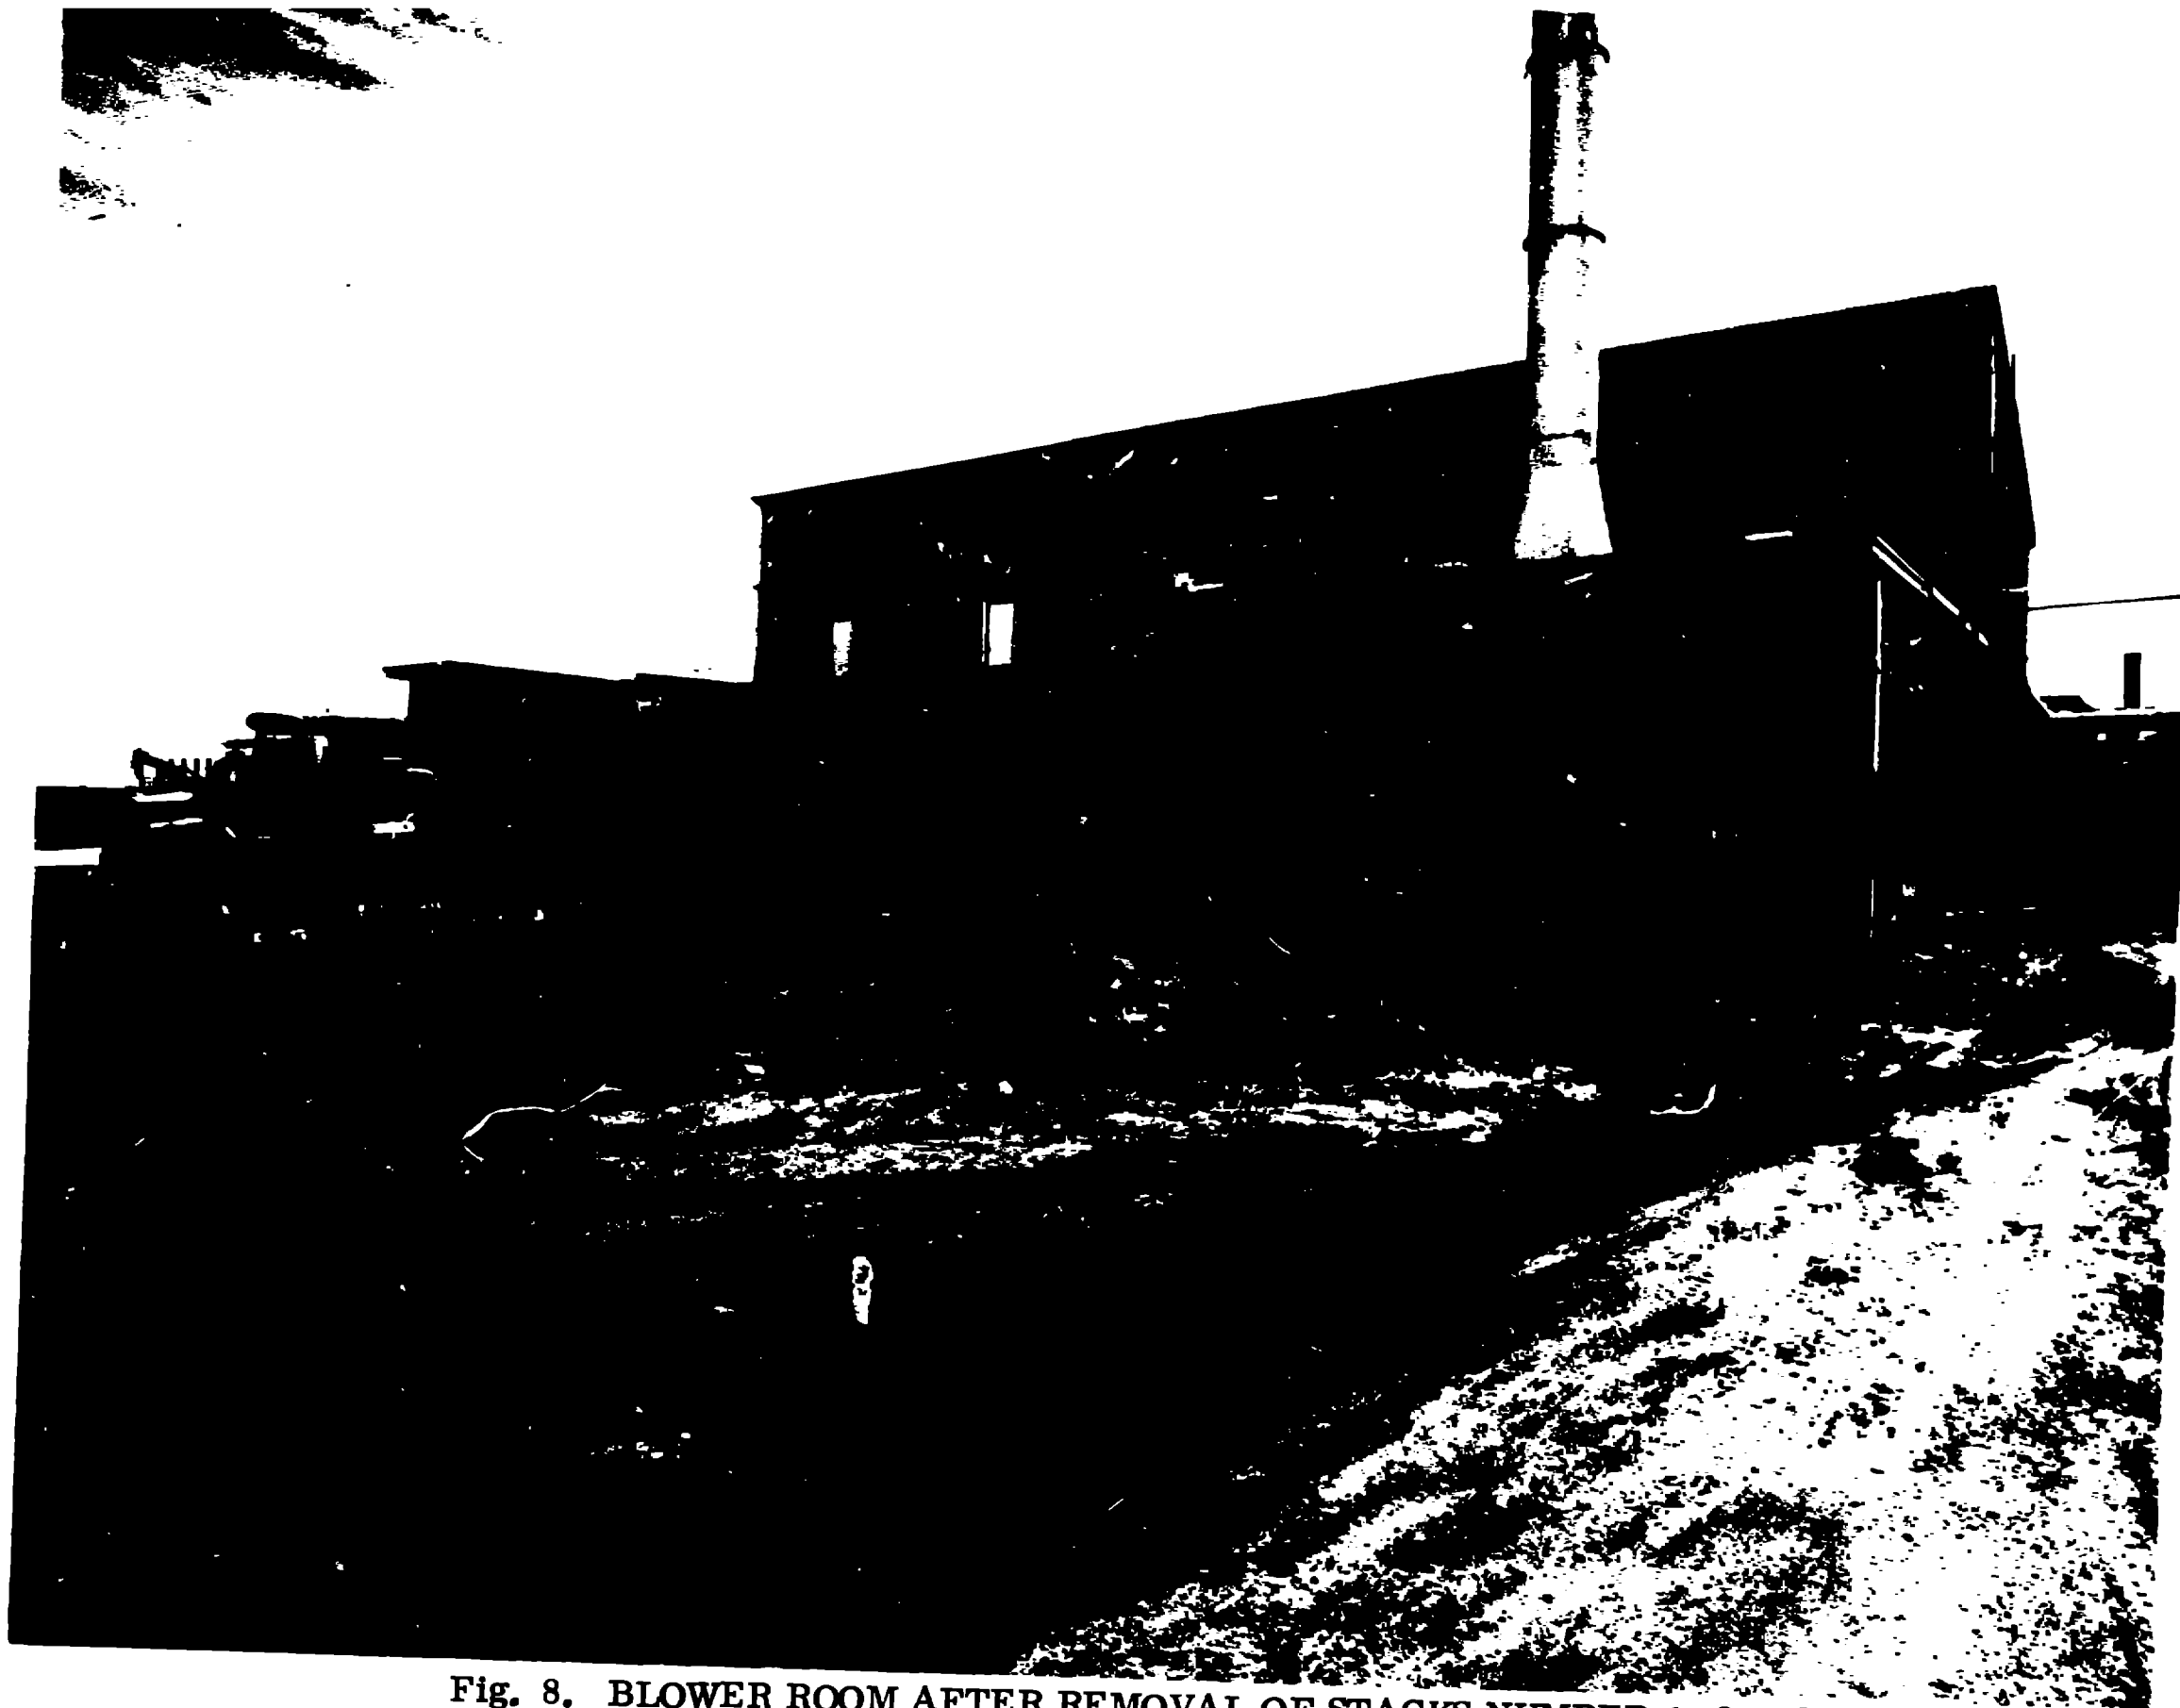
Fig. 8. BLOWER ROOM AFTER REMOVAL OF STACKS NUMBER 1, 2 and 3

site. Fig. 8 shows the blower room after the first 3 stacks had been removed.

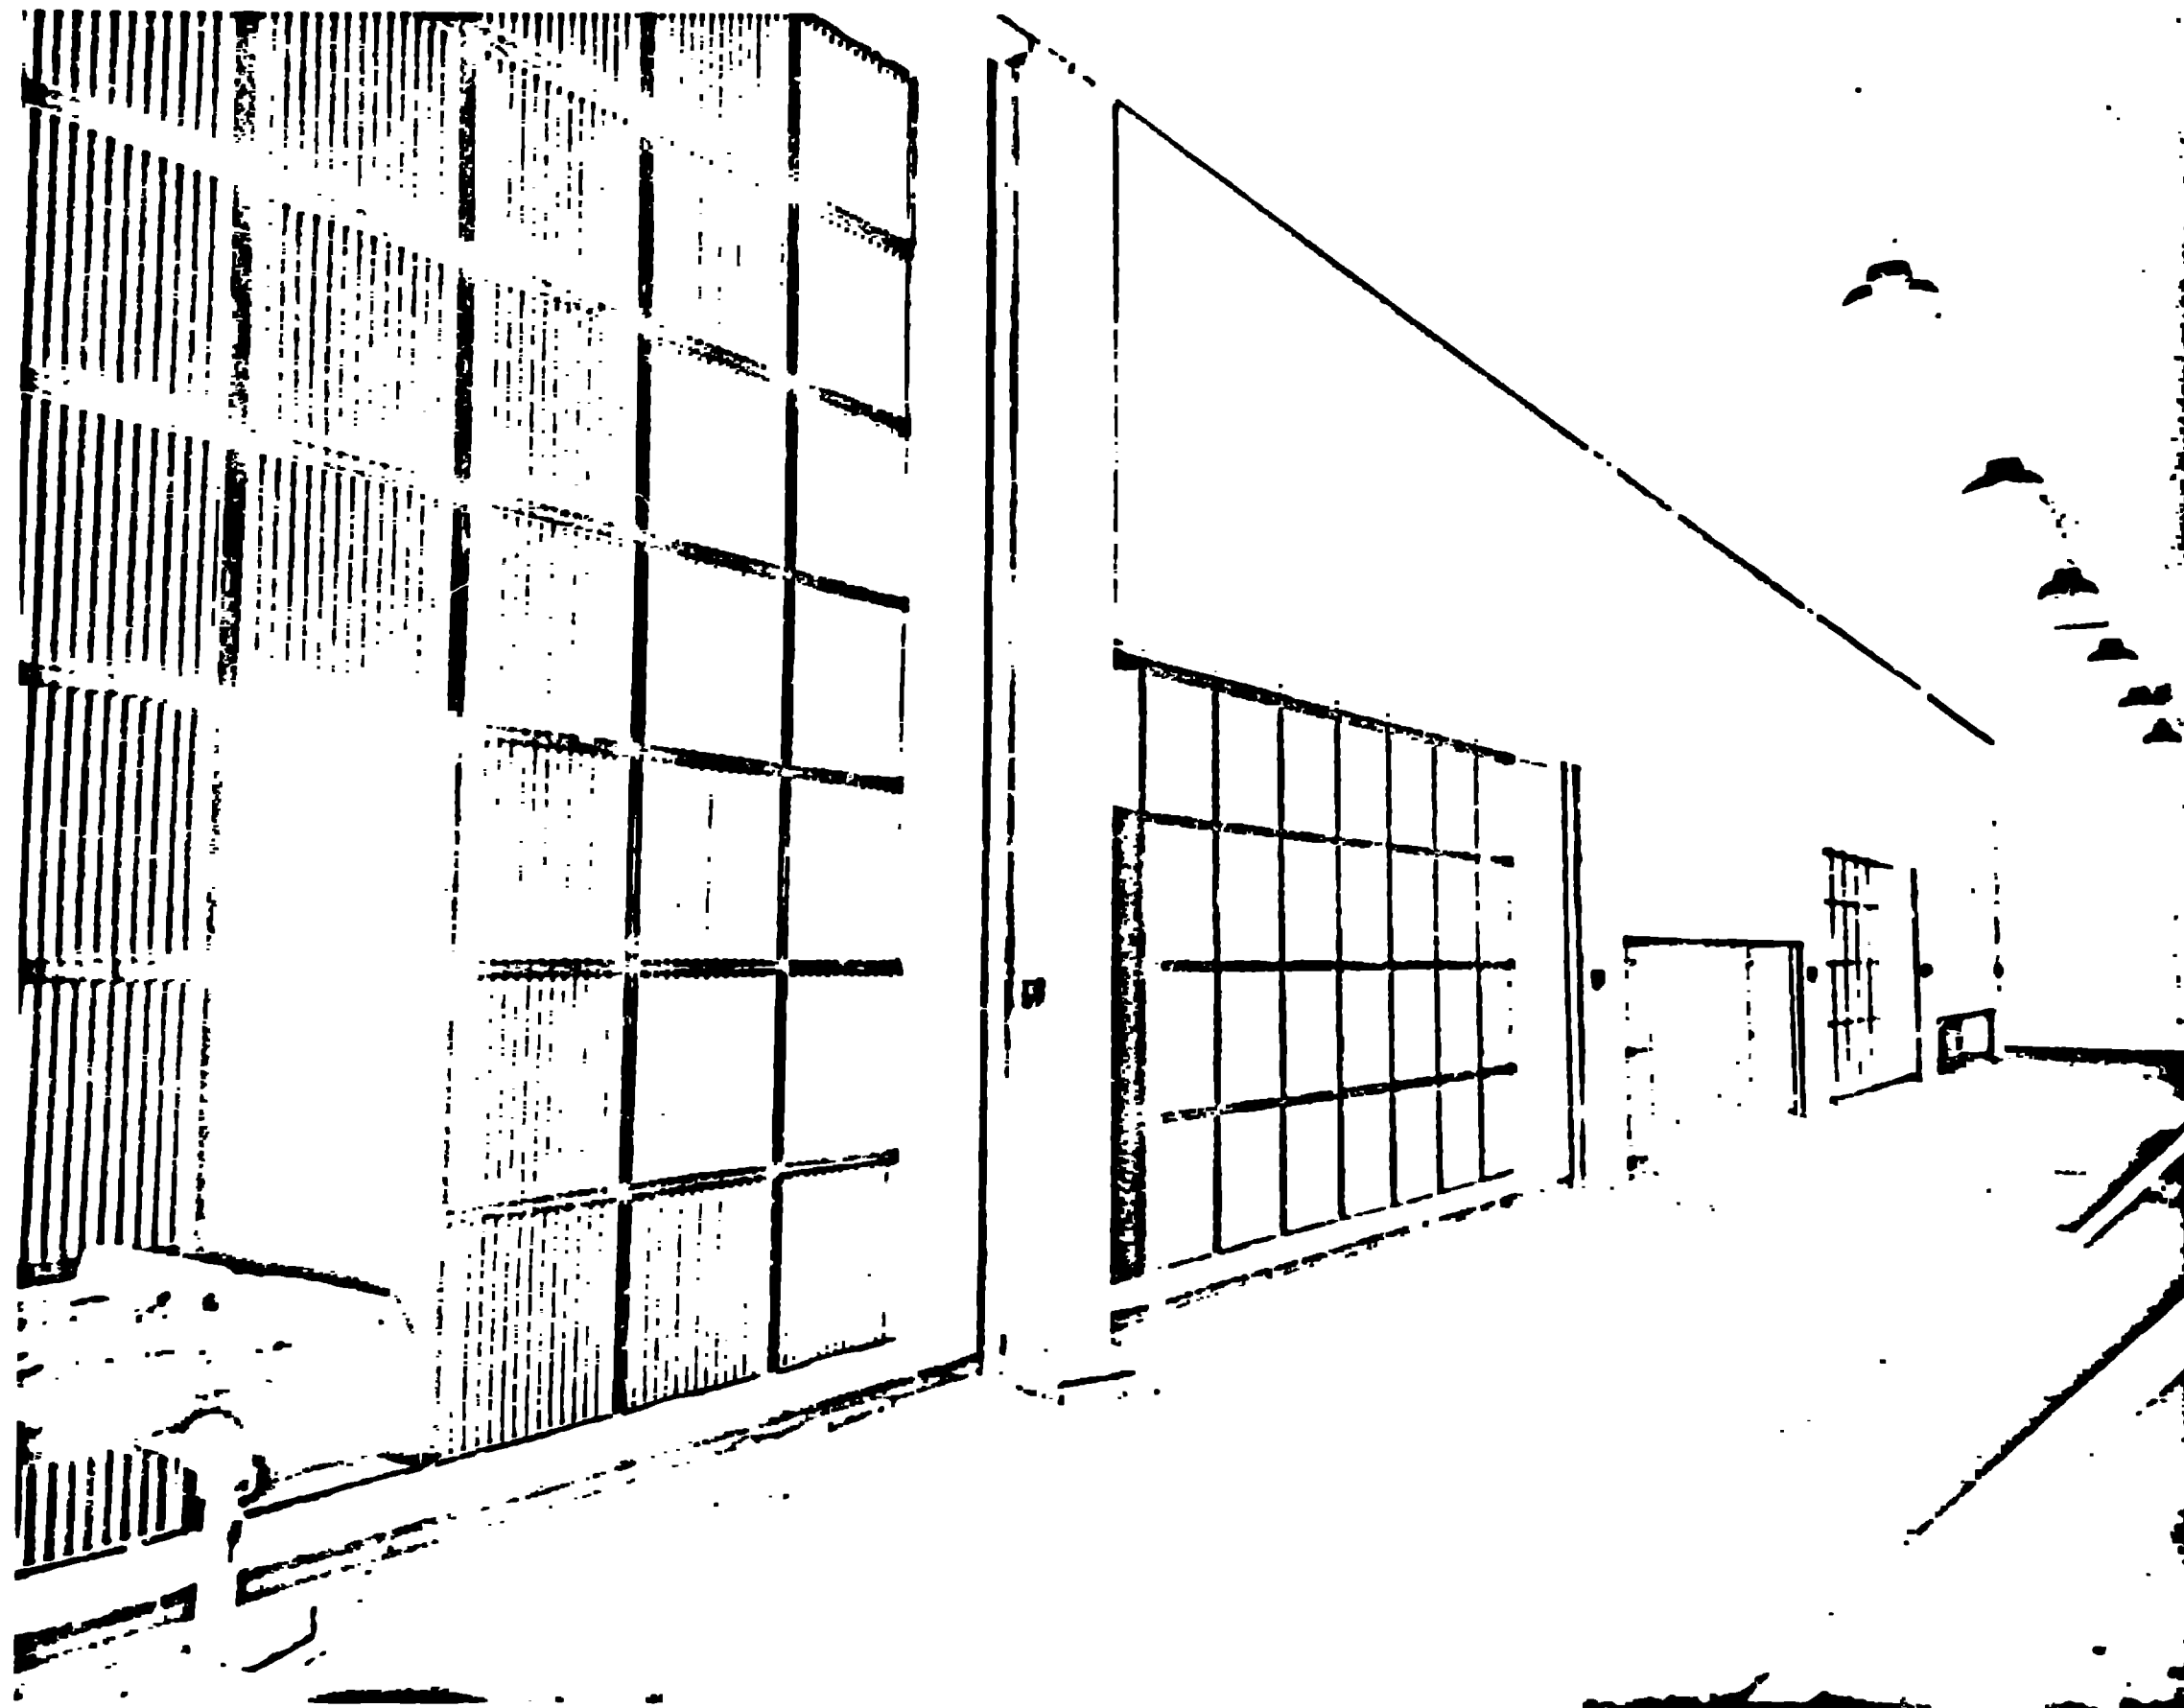
Fig. 9. VIEW OF FILTER BANKS IN 1945

The next step was to remove all of the filters in banks 1 through 4. As can be seen in Fig. 9, each bank contained 63 filters, each being 0.67 m x 0.67 m x 0.22 m (2' x 2' x 8"). The filters were lifted out of the frame and put into plastic bags, carried to the access door of the change room and slipped into another bag being held by 2 laborers. This outer bag was checked for external contamination so that the package could either be re-bagged or it could be safely carried through the change room to the plywood boxes to be crated for burial.
