**TITLE: DEMOLITION OF BUILDING 12, AN OLD PLUTONIUM FILTER FACILITY**

**AUTHOR(S): E. L. Christensen, R. Garde, and A. M. Valentine**

**SUBMITTED TO: 2nd AEC ENVIRONMENTAL PROTECTION CONFERENCE,  
ALBUQUERQUE, NEW MEXICO, APRIL 16-19, 1974**

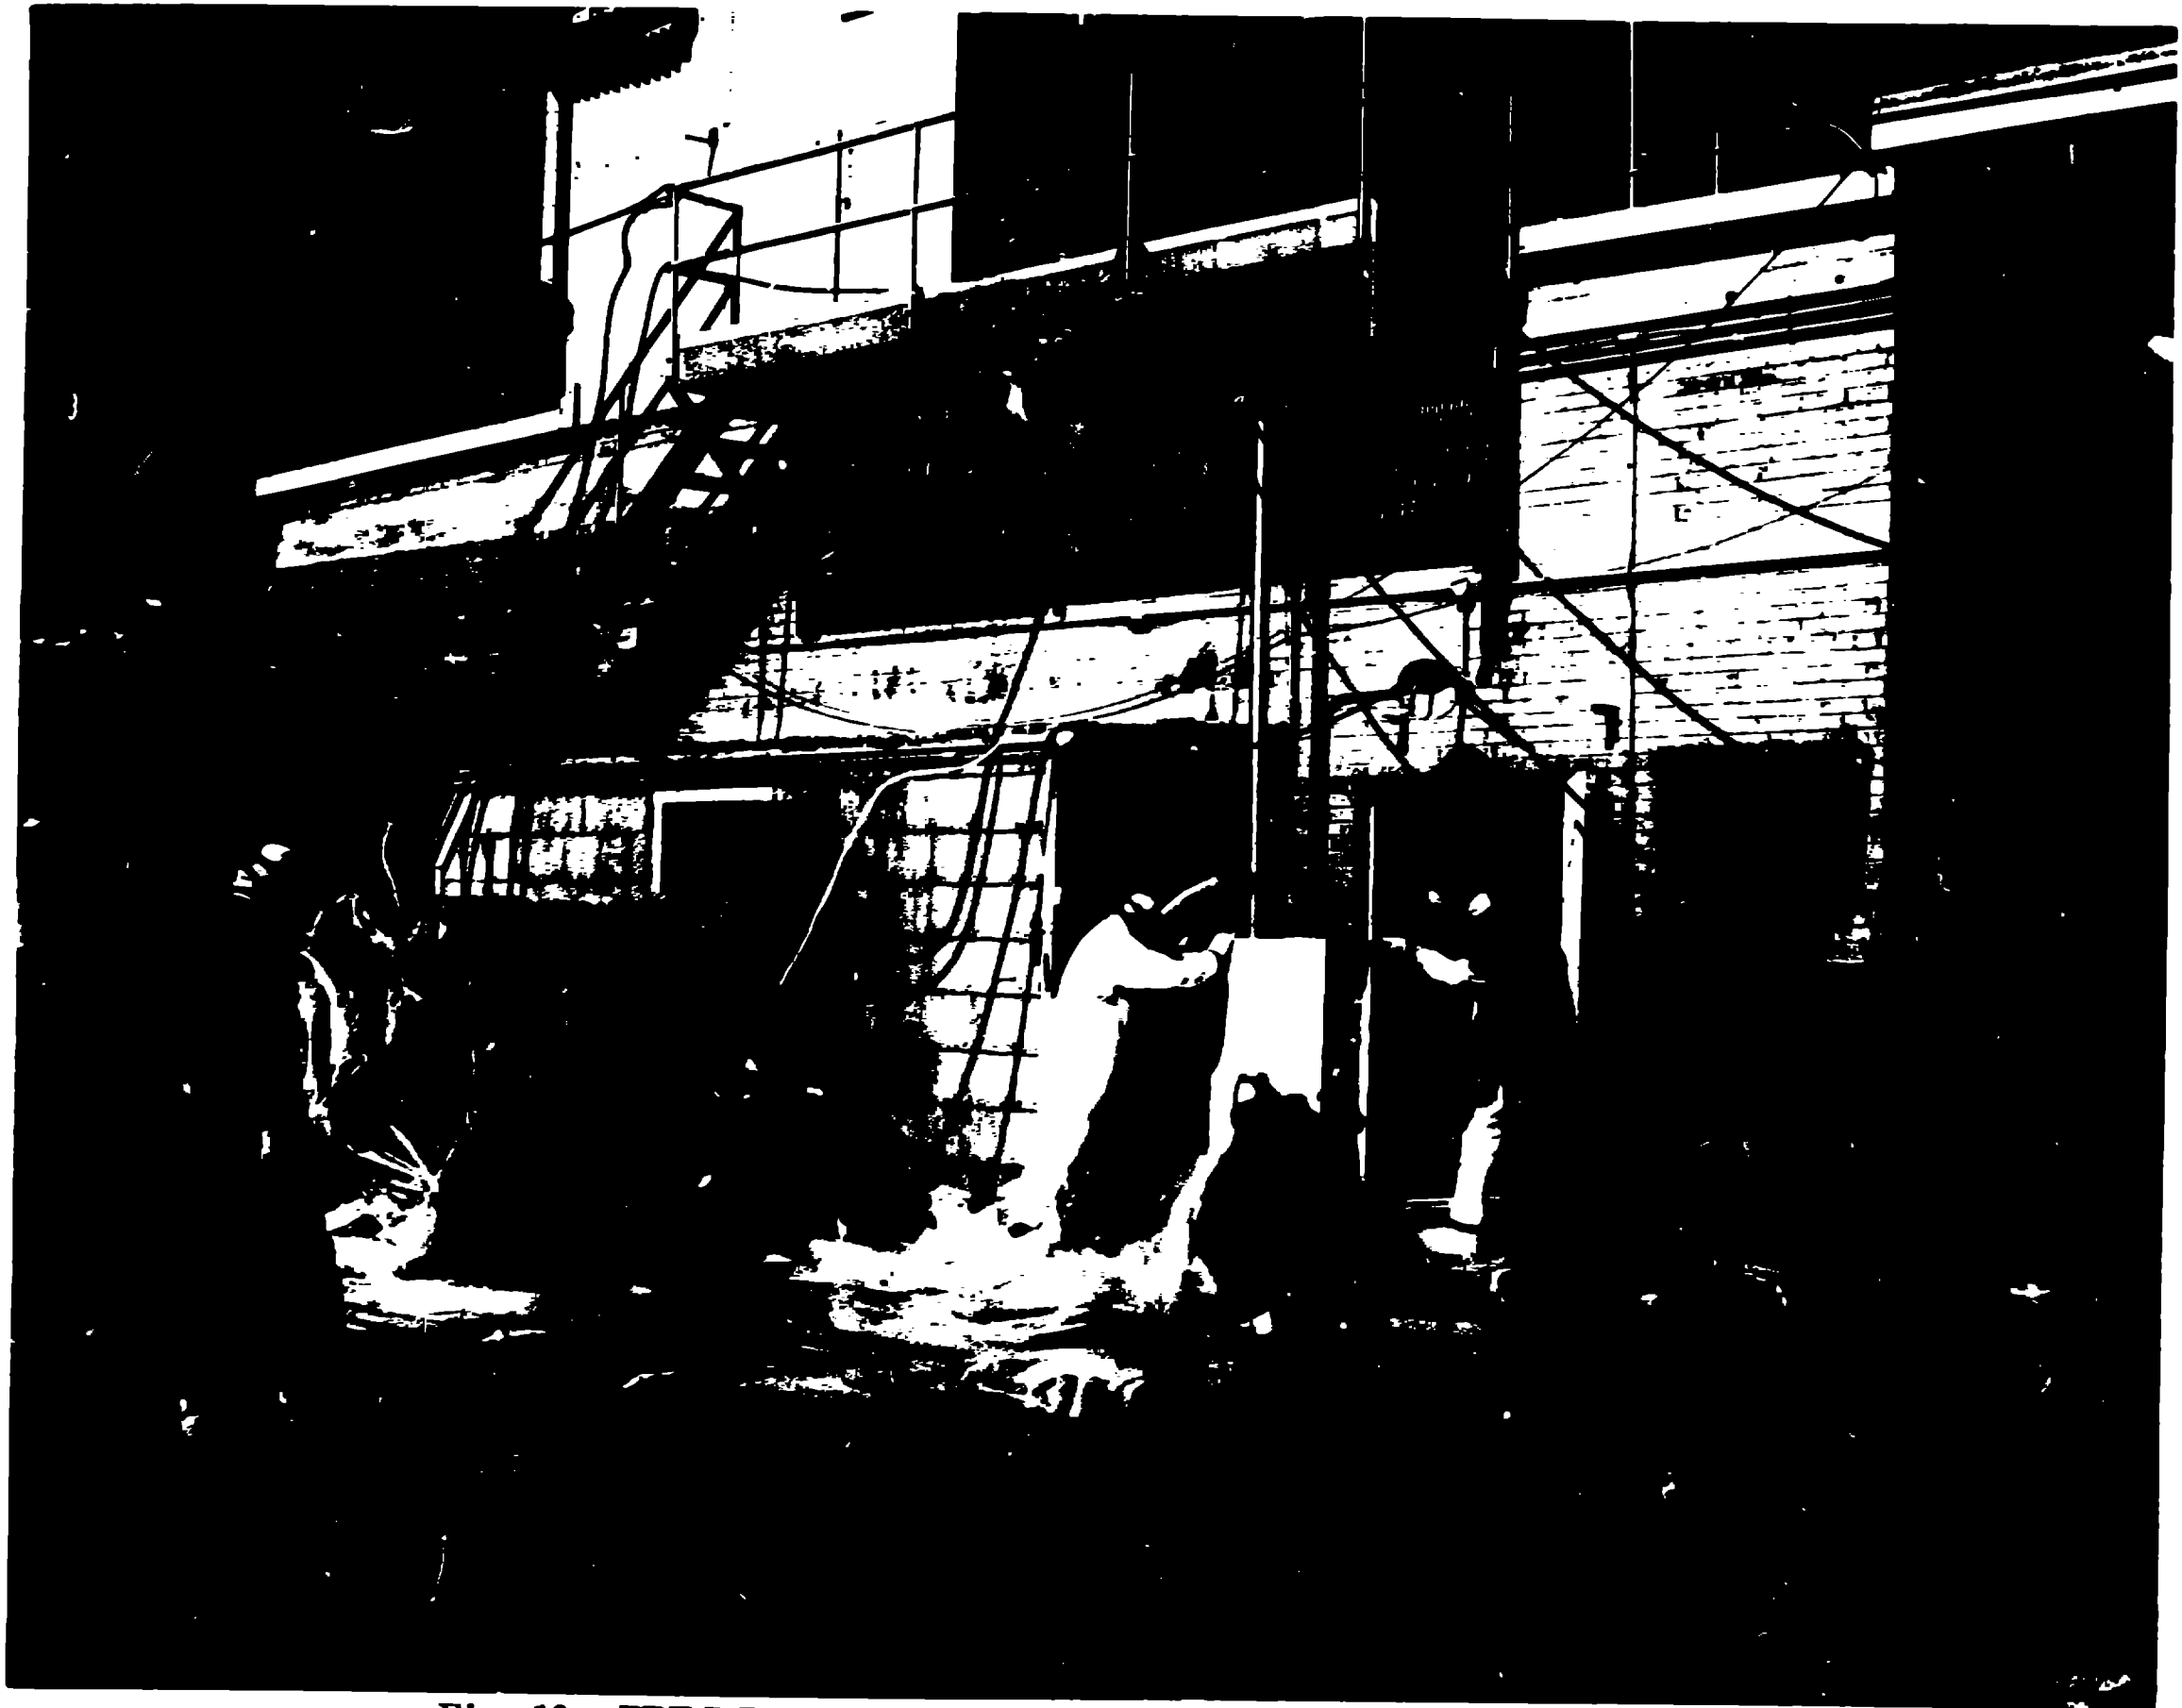
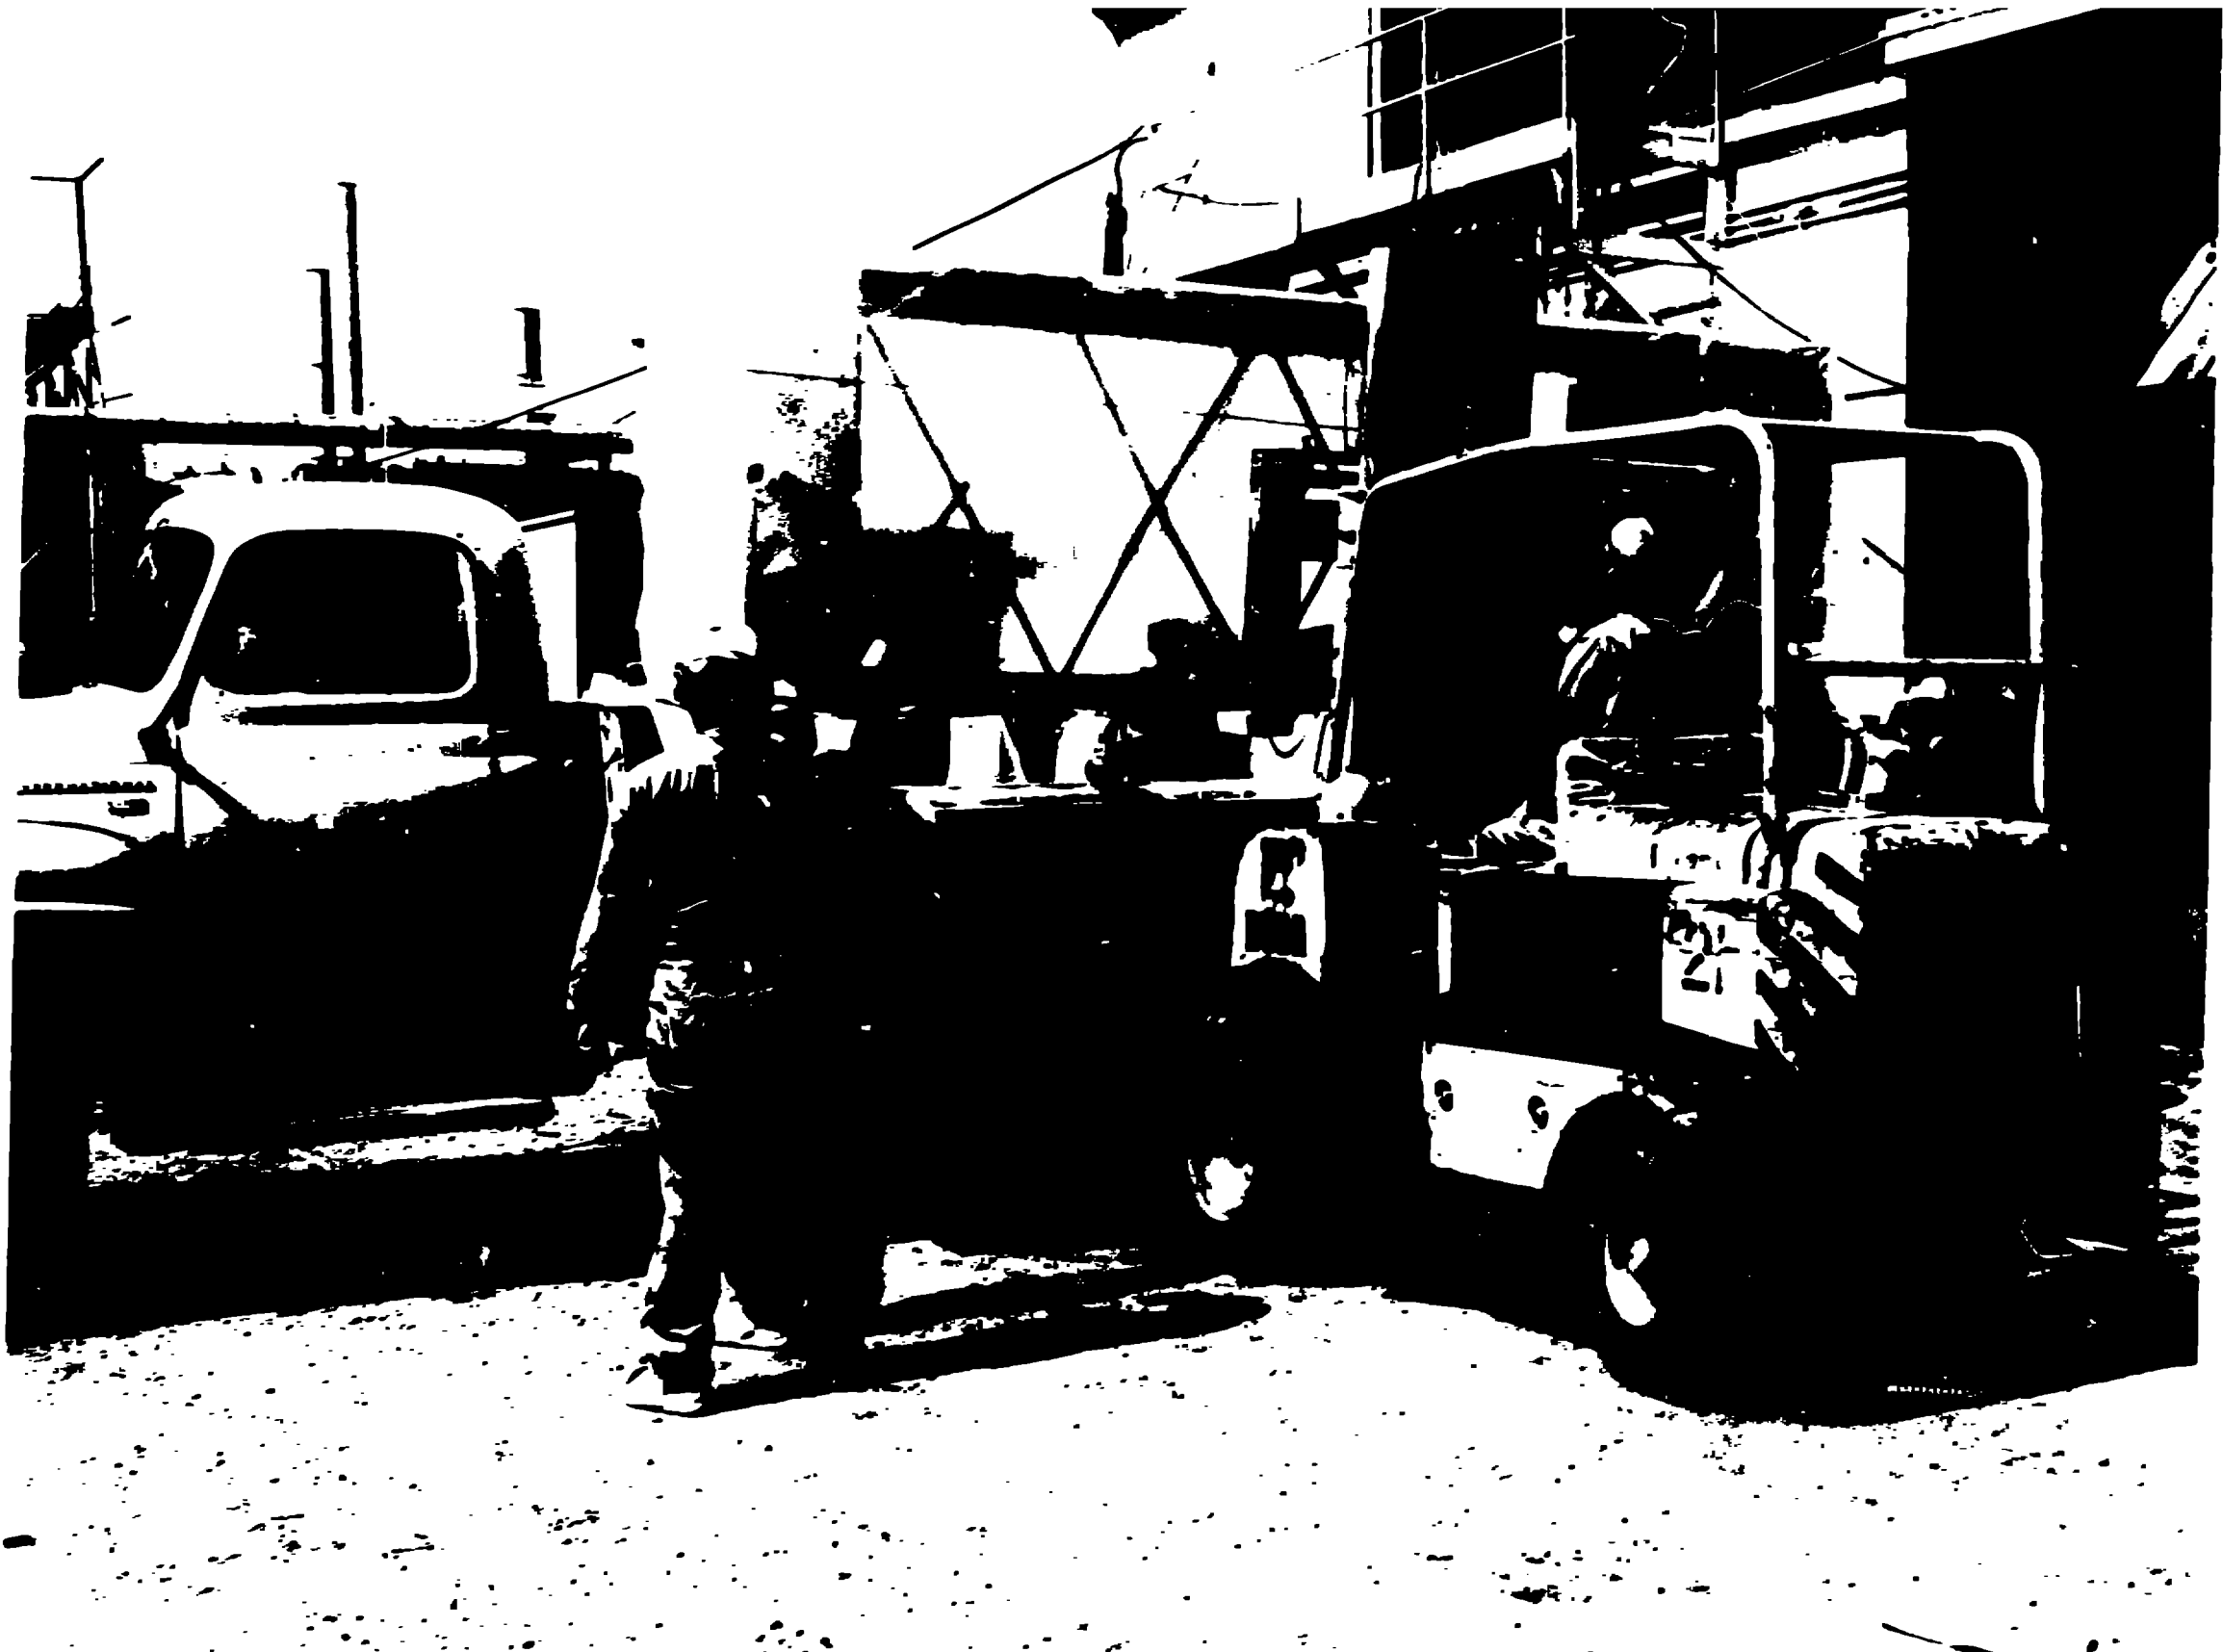
rollers so they could be moved to an access door of the exhaust blower plenum area (See Fig. 3). There a final coat of paint was applied before the frame was rolled through the door onto large plastic sheeting. The frame was wrapped in plastic, loaded on a truck and hauled to the burial site. Figures 10, 11 and 12 give views of various stages of this operation.

Fig. 10. PRECIPITRON FRAME BEING ROLLED ONTO PLASTIC SHEETING

**Fig. 11. PRECIPITRON FRAME BEING WRAPPED IN PLASTIC  
READY FOR LOADING**

**Fig. 12. PRECIPITRON FRAME READY FOR HAULING TO DISPOSAL SITE**

The laborers then started disassembly of the precipitron frames. These frames were 1.22 metres wide, 0.61 metres deep and 4.27 metres high with a gross weight of 275 kg. As they were unbolted they were lowered to the floor with a chain hoist. They were cleaned, painted and placed on

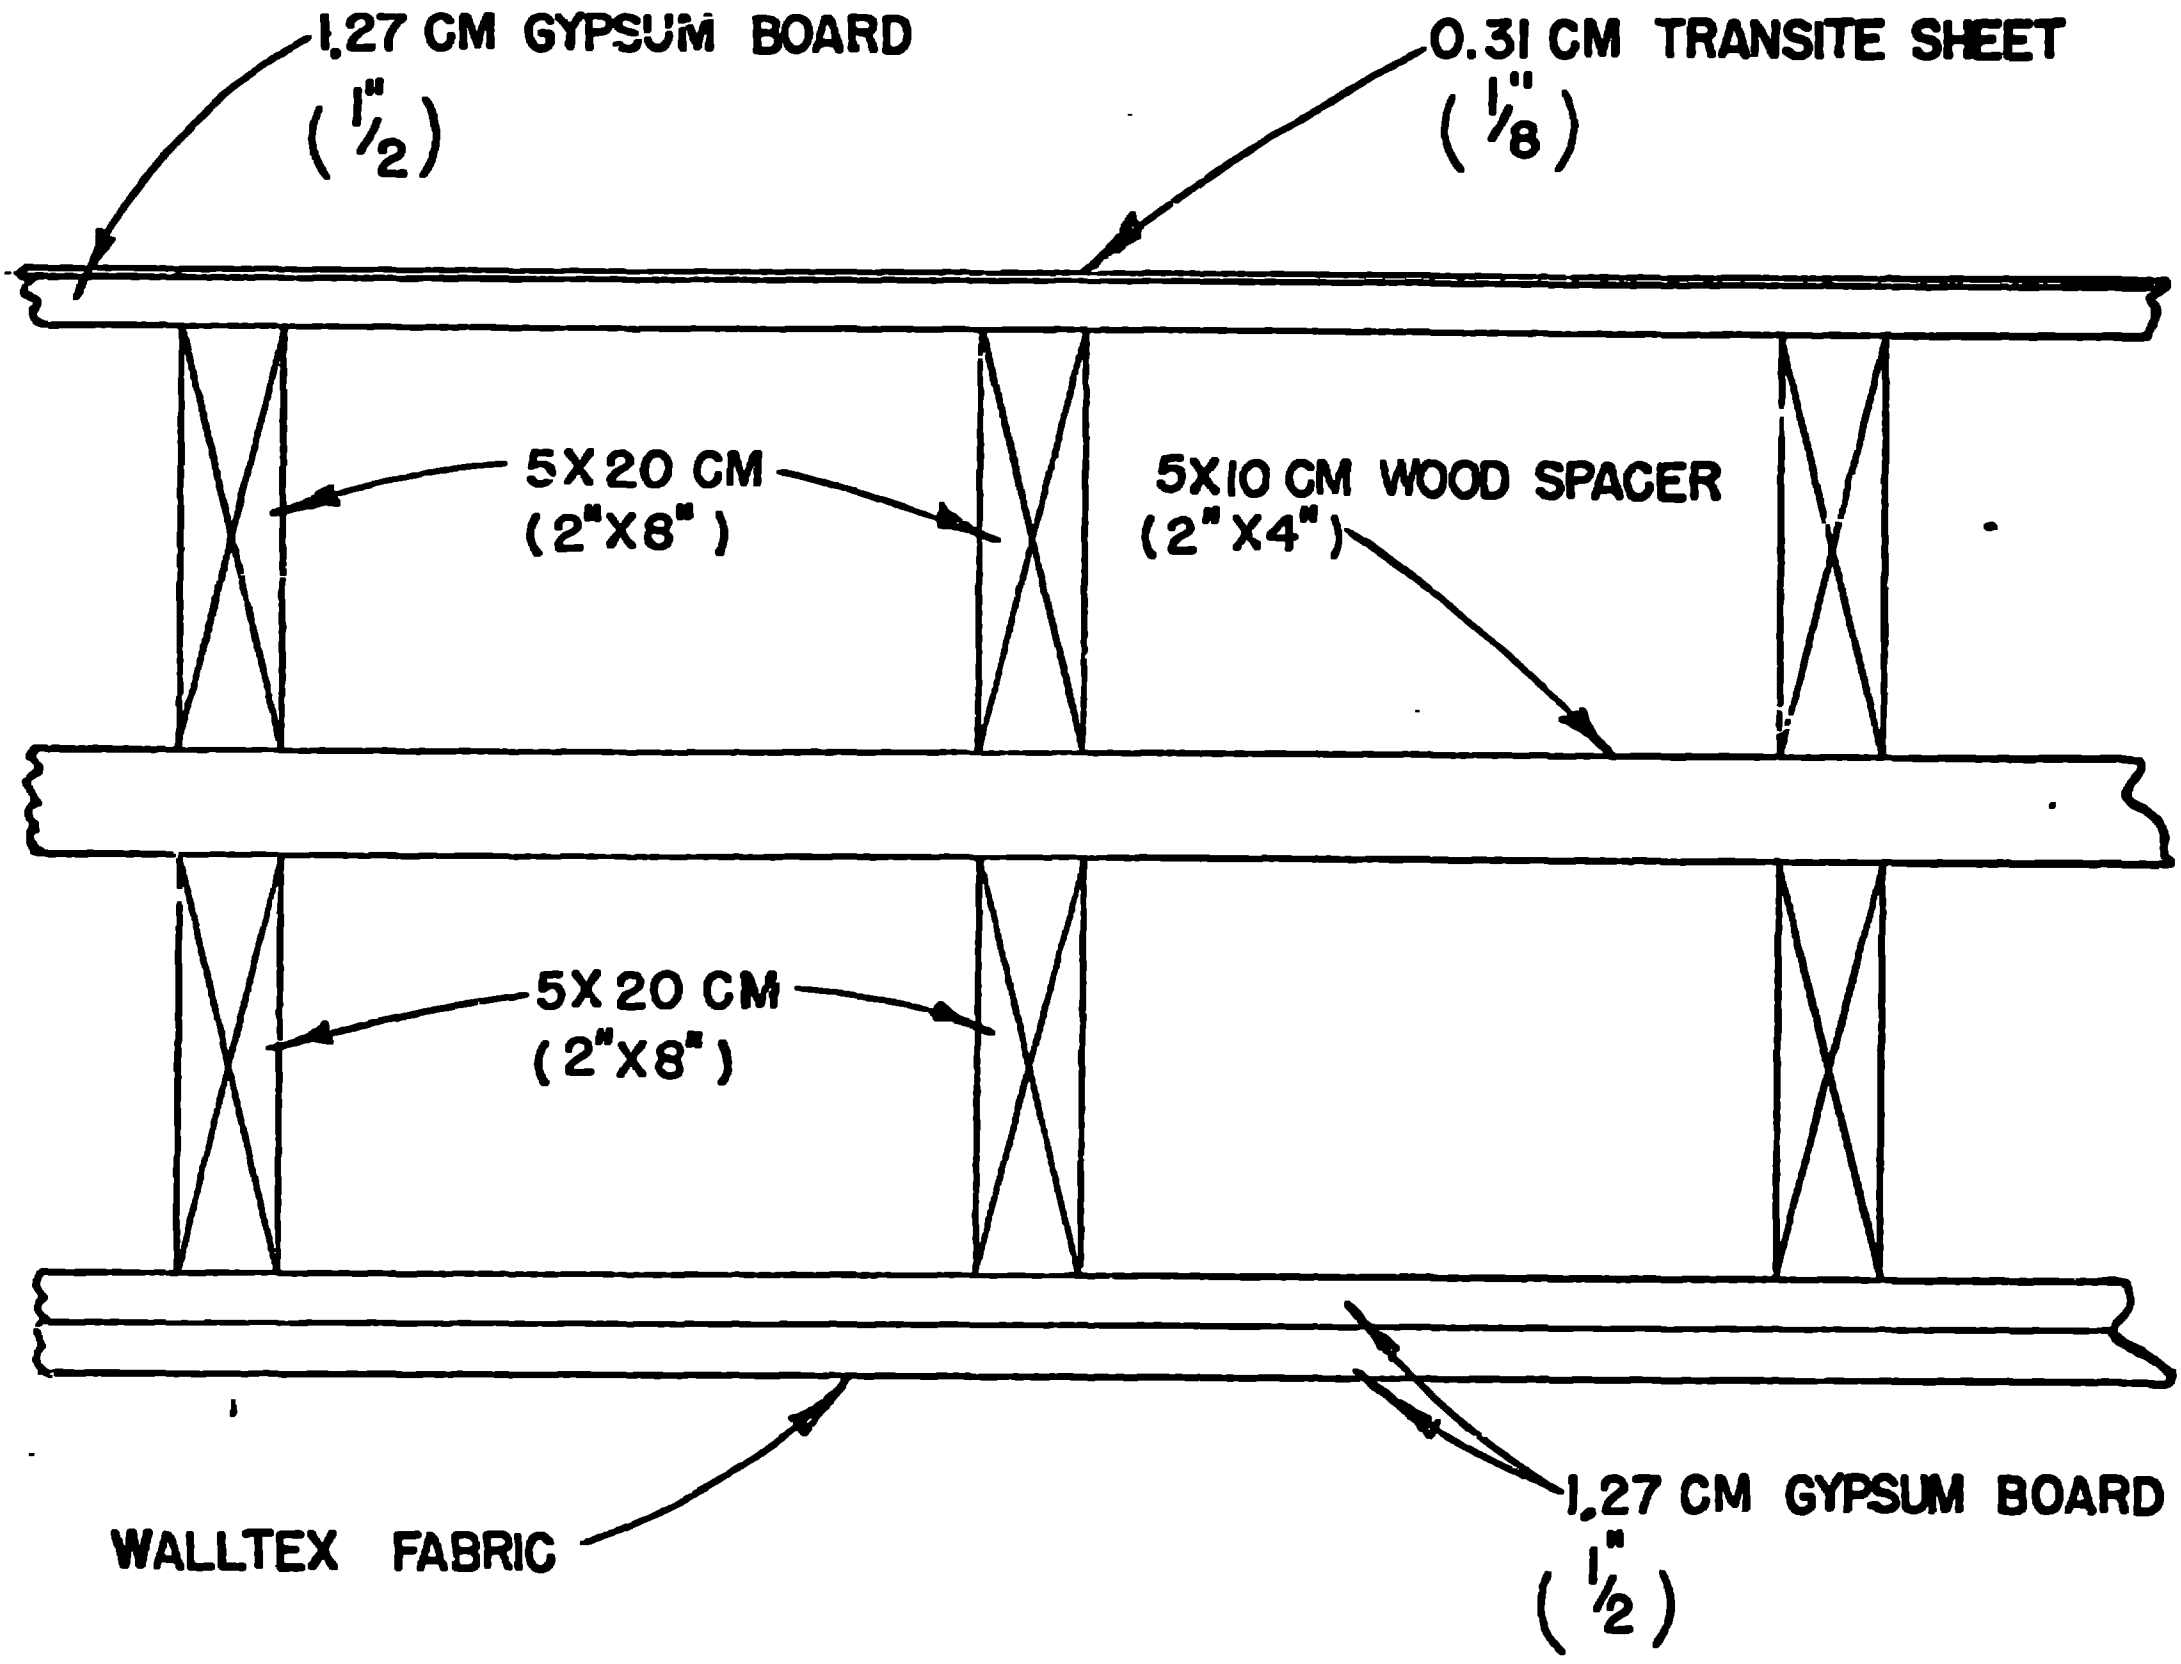
FIG 13 DETAILS OF ROOF CONSTRUCTION

The details of construction indicated that the contamination of walls and ceiling might be restricted to the first layer of material. As can be seen in Fig. 13 the roof was made of two layers of wood beams, 5 cm x 20 cm (2 inches by 8 inches), supported by metal I beams. The ceiling was constructed of 2 layers of gypsum board covered by a fabric material called "Walltex". A 1.6 mm thick metal strip was used as a nailing strip to prevent

the nails from pulling through the gypsum board when the plenum was at its lower air pressure during operation.

The roof was built of 2 layers of gypsum board on top of the beams and covered by a 0.3 cm layer of transite. The final layer was a hot tar and 114 kg of roofing paper application.

After the metal strips had been pulled from the ceiling the surface layer, which was fabric covered with several coats of paint, could be easily pulled off leaving a nearly contamination free surface.

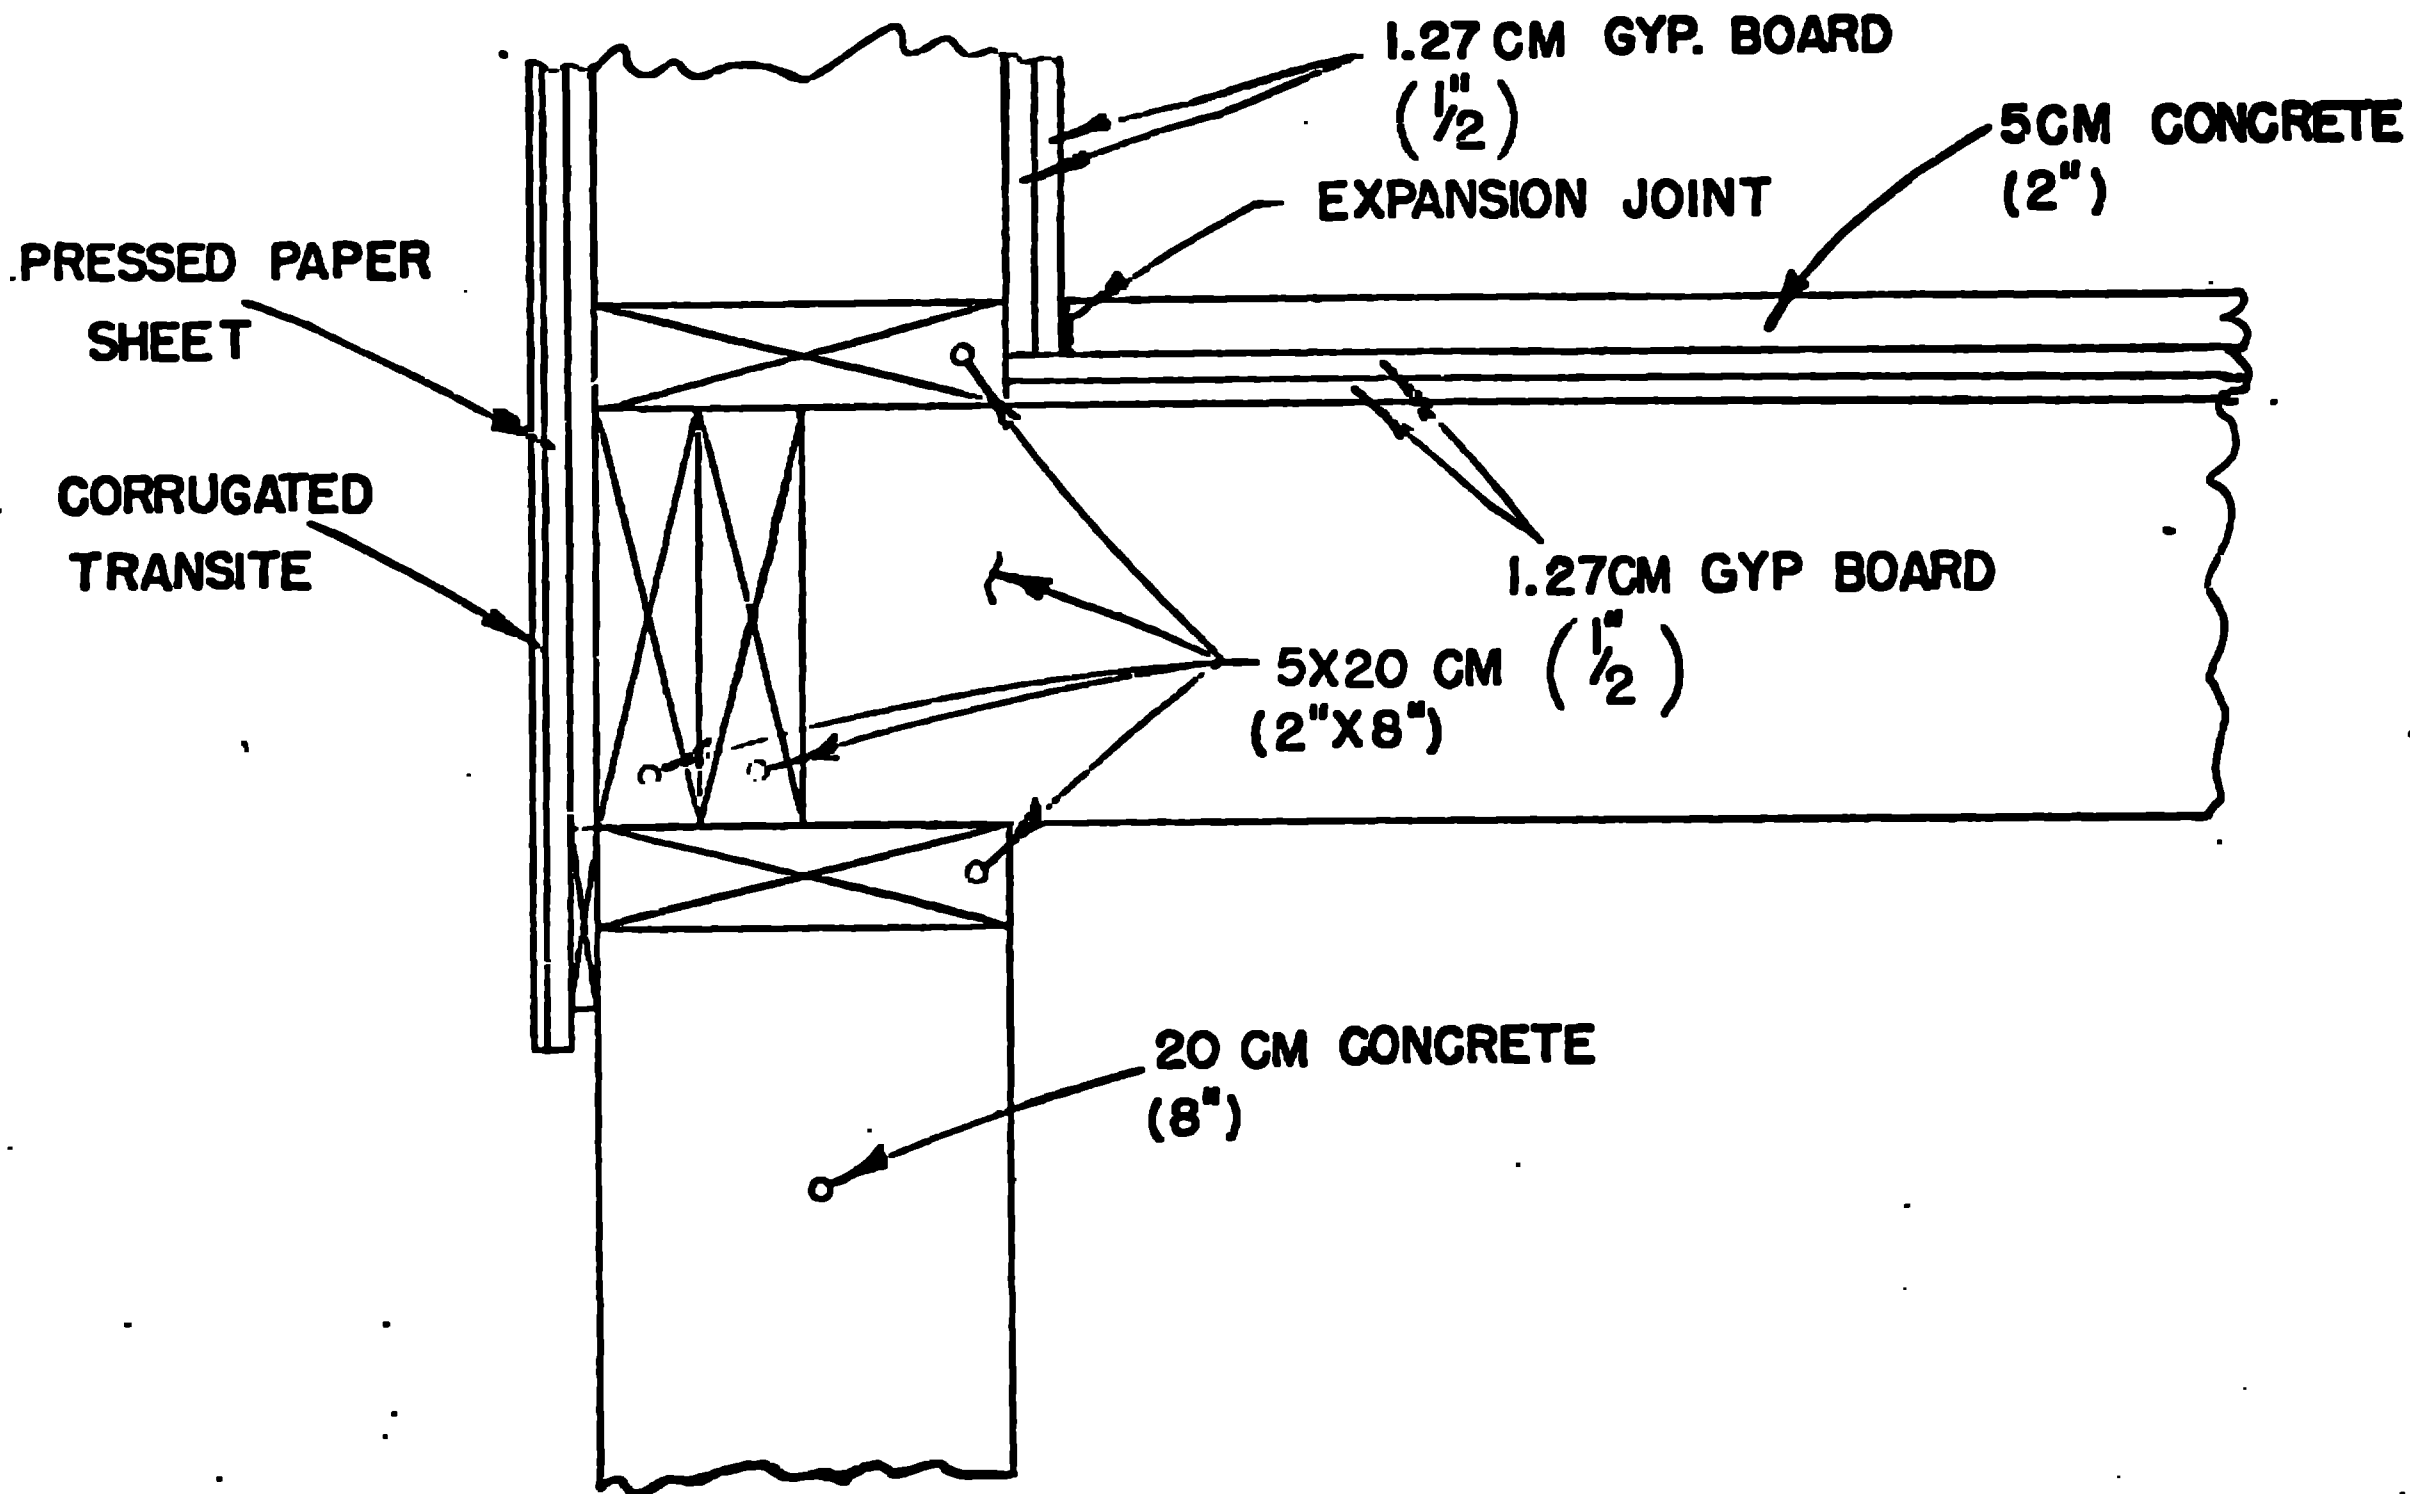
FIG 14 DETAILS OF FLOOR AND WALL CONSTRUCTION

The construction of the walls and the floor are shown in Fig. 14. The walls were built with 2 layers of gypsum board nailed to the inside of the 5 cm x 20 cm studs. Here, too, the gypsum board could be pulled off without spreading contamination to the studs. All exposed surfaces were immediately covered with a coat of paint to seal porous surfaces.

The construction at the wall and floor junction consisted of overlapping layers of gypsum board, expansion joint material and gunnite. This construction had kept the sill from becoming contaminated, and by removing the expansion joint material along with a strip of the gunnite, the sill was exposed free of contamination. The rest of the gunnite was given several coats of paint, until all of the contamination was covered, and allowed to remain on the floor for removal along with the foundation.

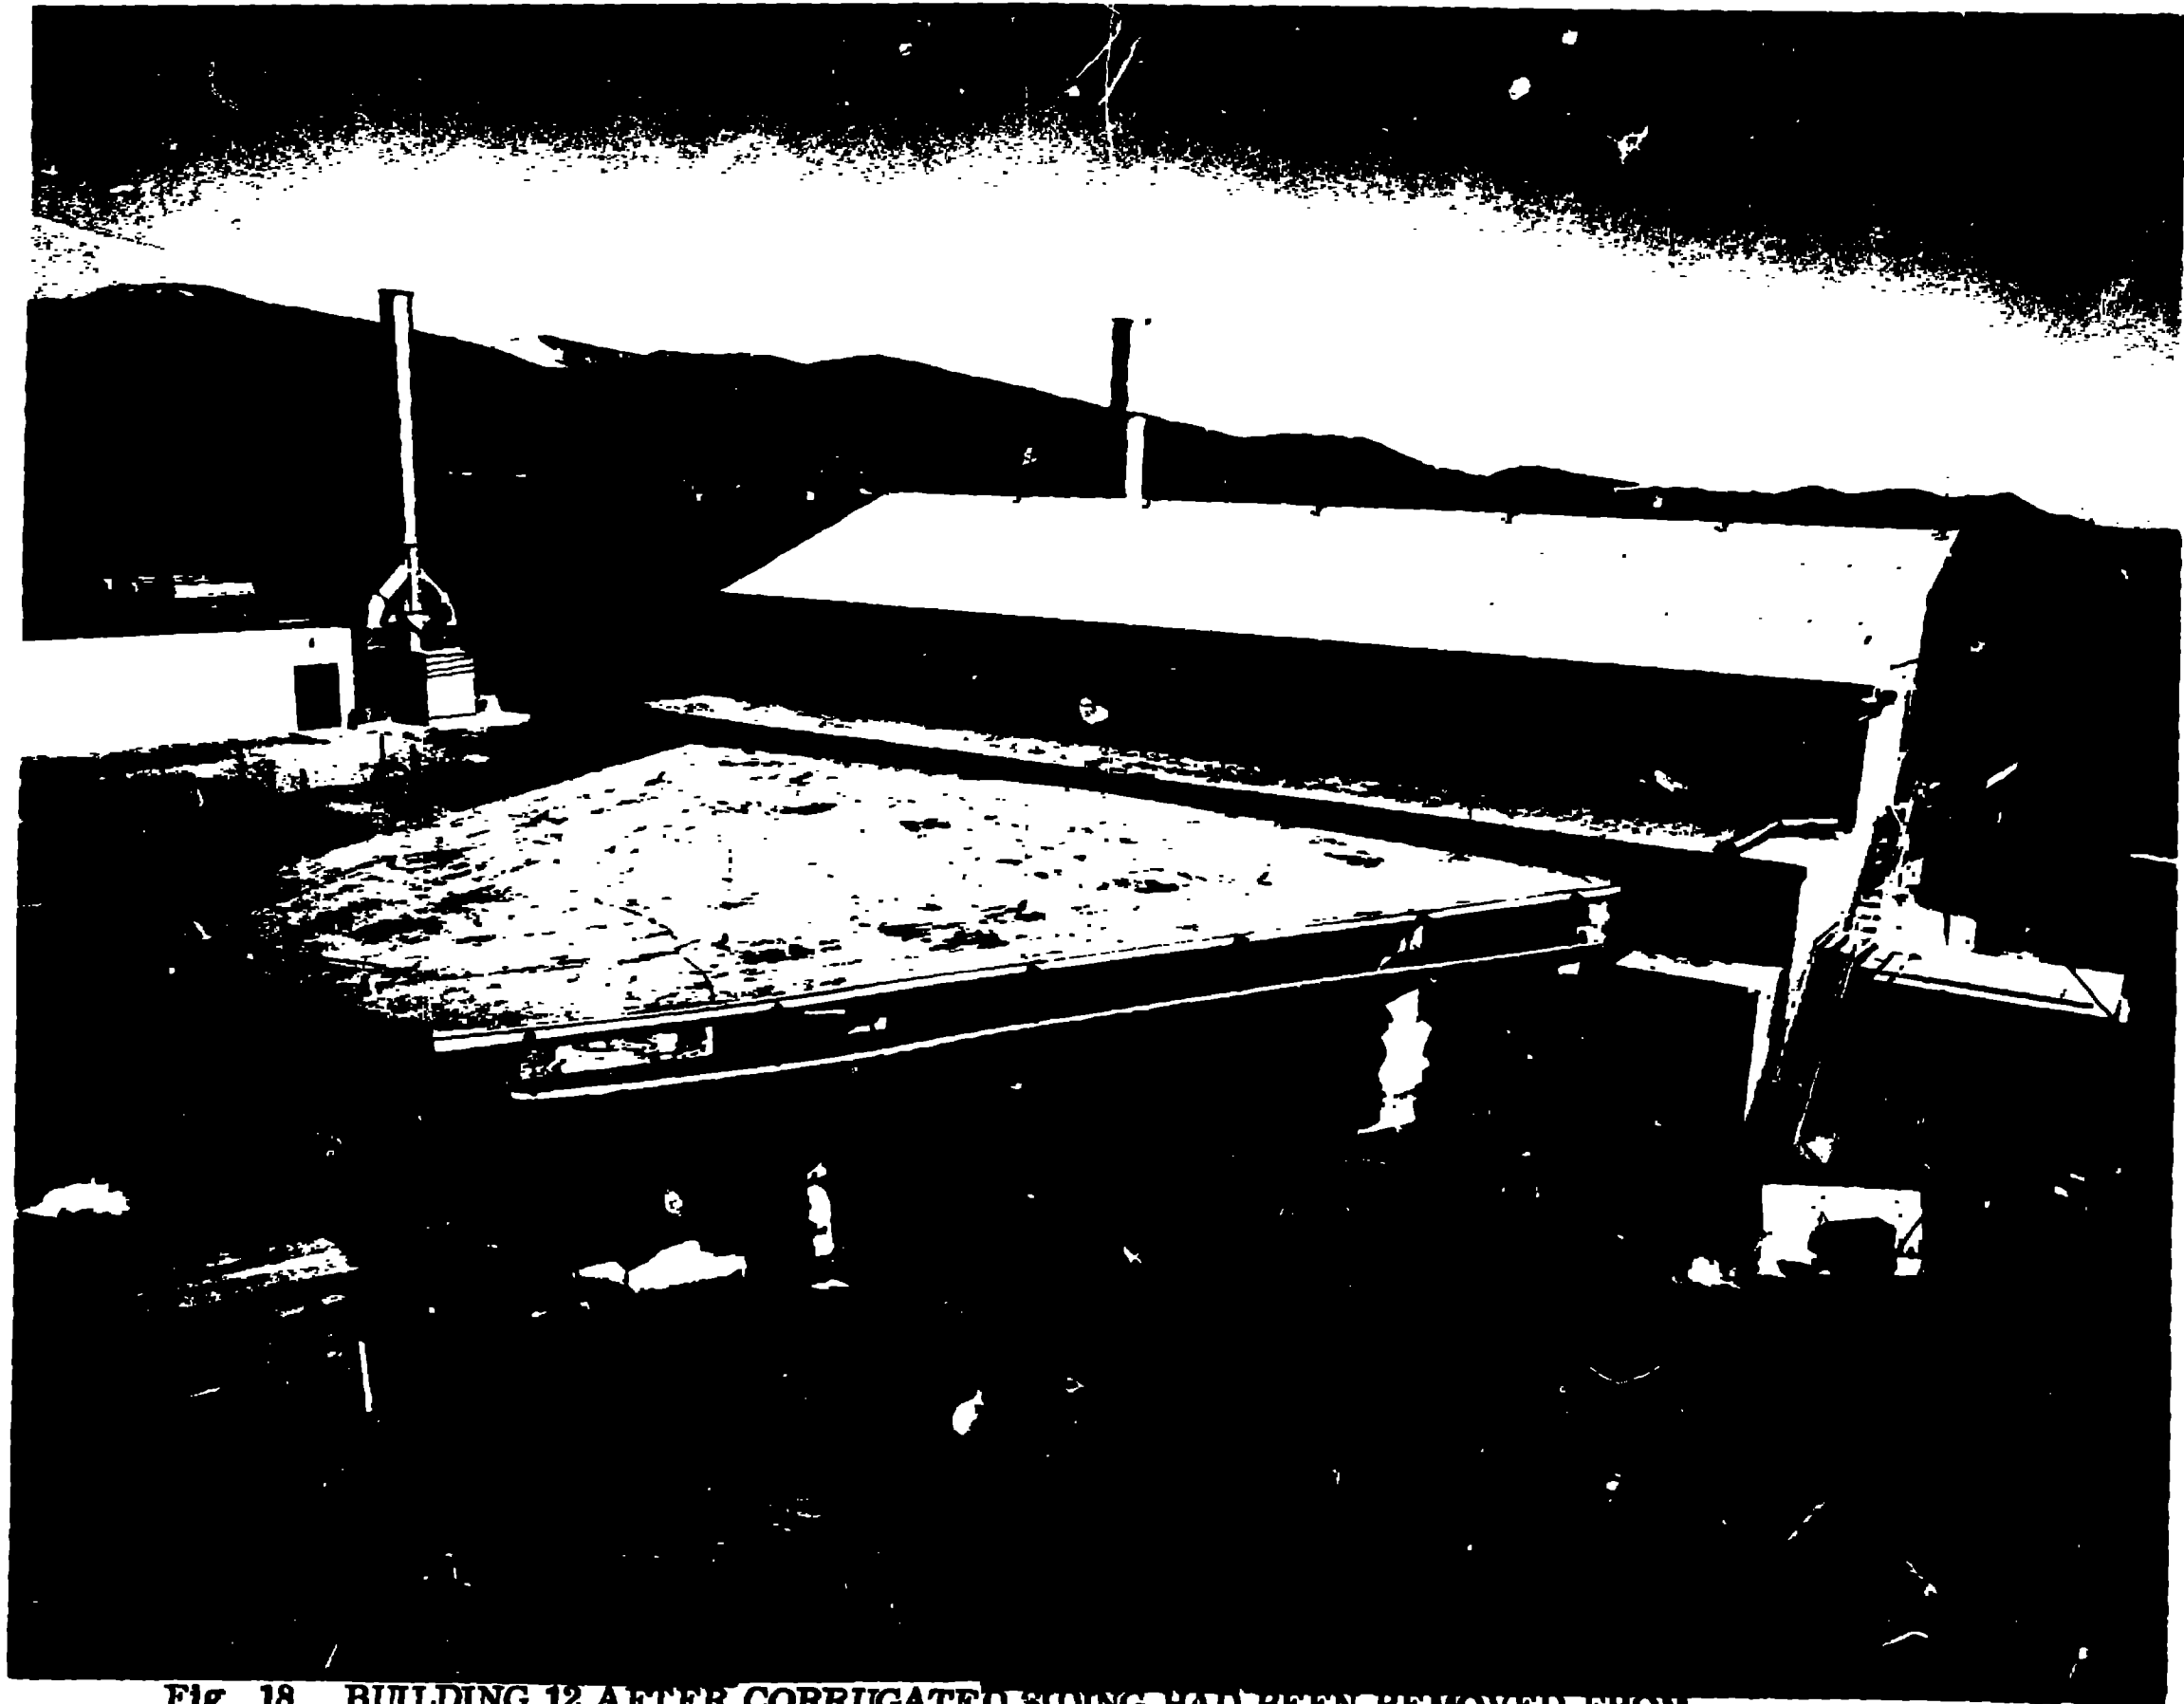
**Fig. 18. BUILDING 12 AFTER CORRUGATED SIDING HAD BEEN REMOVED FROM INTAKE PLENUM WALL**

The external siding was built of paperboard nailed to the 5 cm x 20 cm studs covered with corrugated asbestos siding. The asbestos siding was removed, monitored for alpha contamination and hauled to the LASL waste disposal site leaving the building as shown in Fig. 18. Since no alpha

contamination was found on any of the siding it was hauled to the disposal site in an open dump truck.
