**TITLE: DEMOLITION OF BUILDING 12, AN OLD PLUTONIUM FILTER FACILITY**

**AUTHOR(S): E. L. Christensen, R. Garde, and A. M. Valentine**

**SUBMITTED TO: 2nd AEC ENVIRONMENTAL PROTECTION CONFERENCE,  
ALBUQUERQUE, NEW MEXICO, APRIL 16-19, 1974**

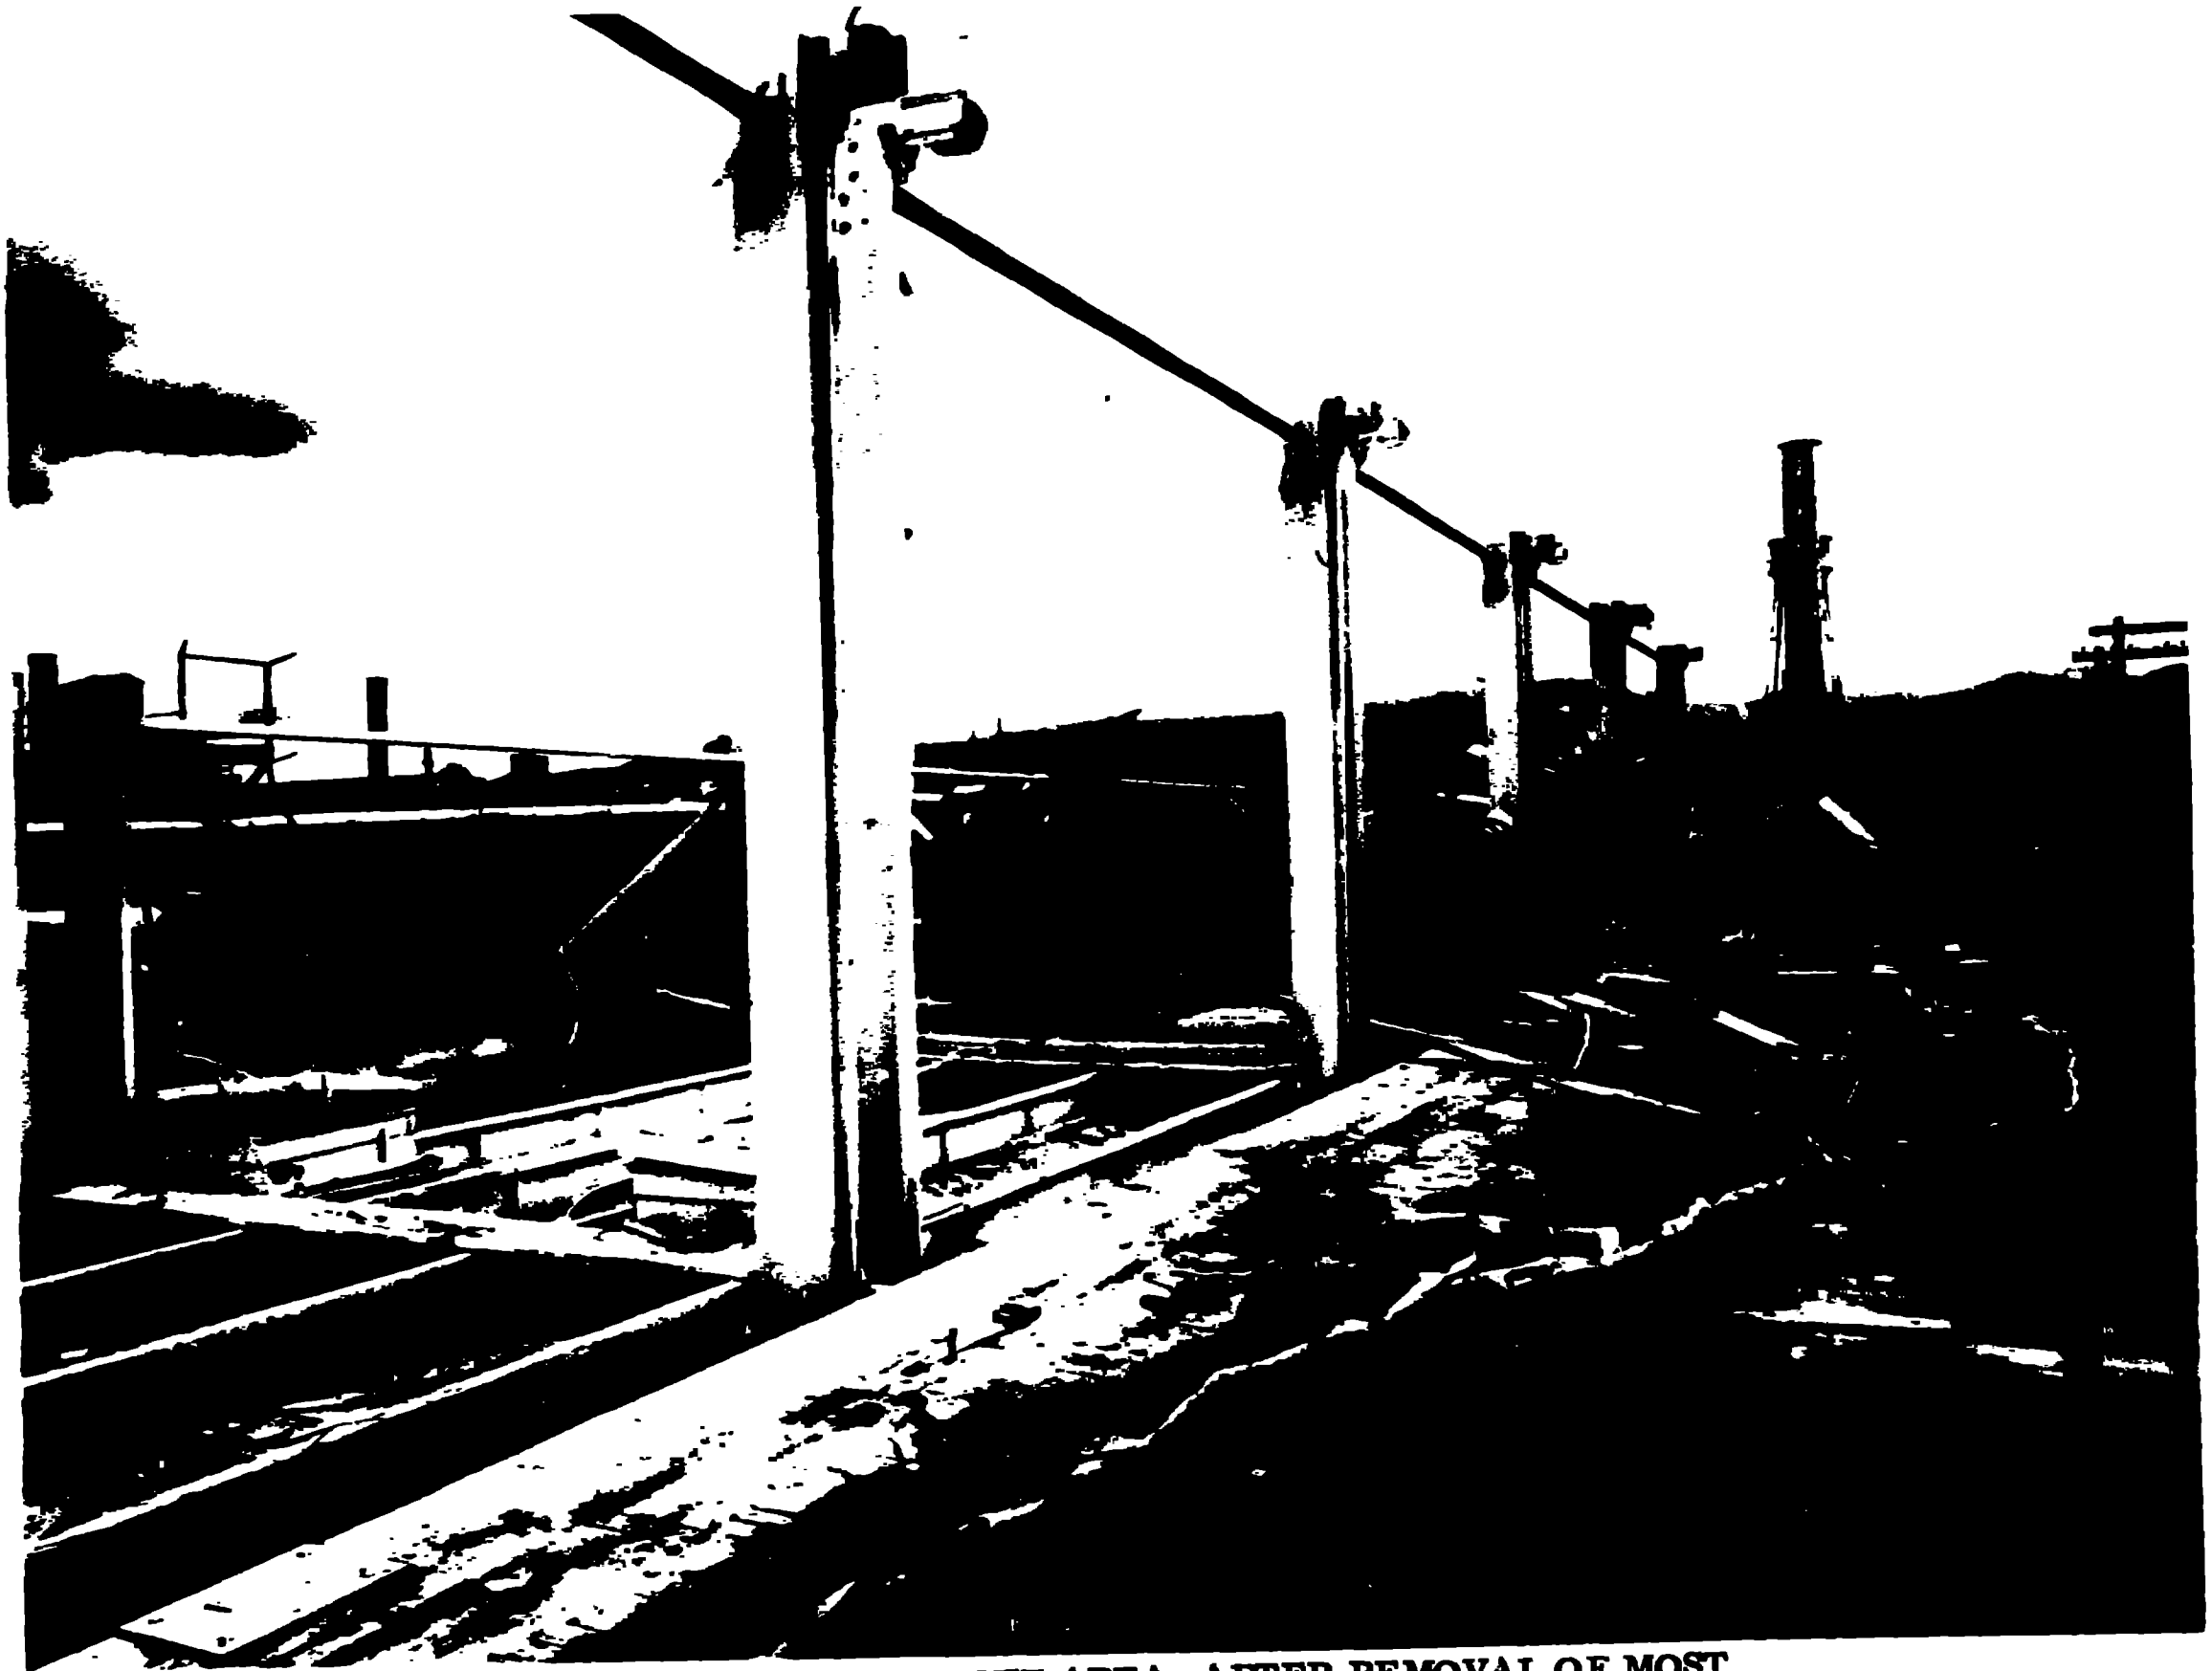
Since no contamination could be detected on the remaining portions of the walls, it was decided to pull the penthouse over with a cable as if it was a normal building being razed. This was done, exposing the steel beam door supports. Figs. 19 and 20 show the building with most of the penthouse gone. As portions were pulled down, the long boards were cut into 2.5 metre sections with chain saws. The pieces were checked for contamination and then loaded into a dump truck fitted with plywood sides, canvas top and rear flap. Only rarely was any contamination found and when it was the area was immediately painted.

**Fig. 19. GROUND LEVEL VIEW PENTHOUSE AREA AFTER REMOVAL OF MOST OF THE WALLS AND ROOF**

**Fig. 20. ROOF LEVEL VIEW OF PENTHOUSE AREA, AFTER REMOVAL OF MOST OF THE WALLS AND ROOF**

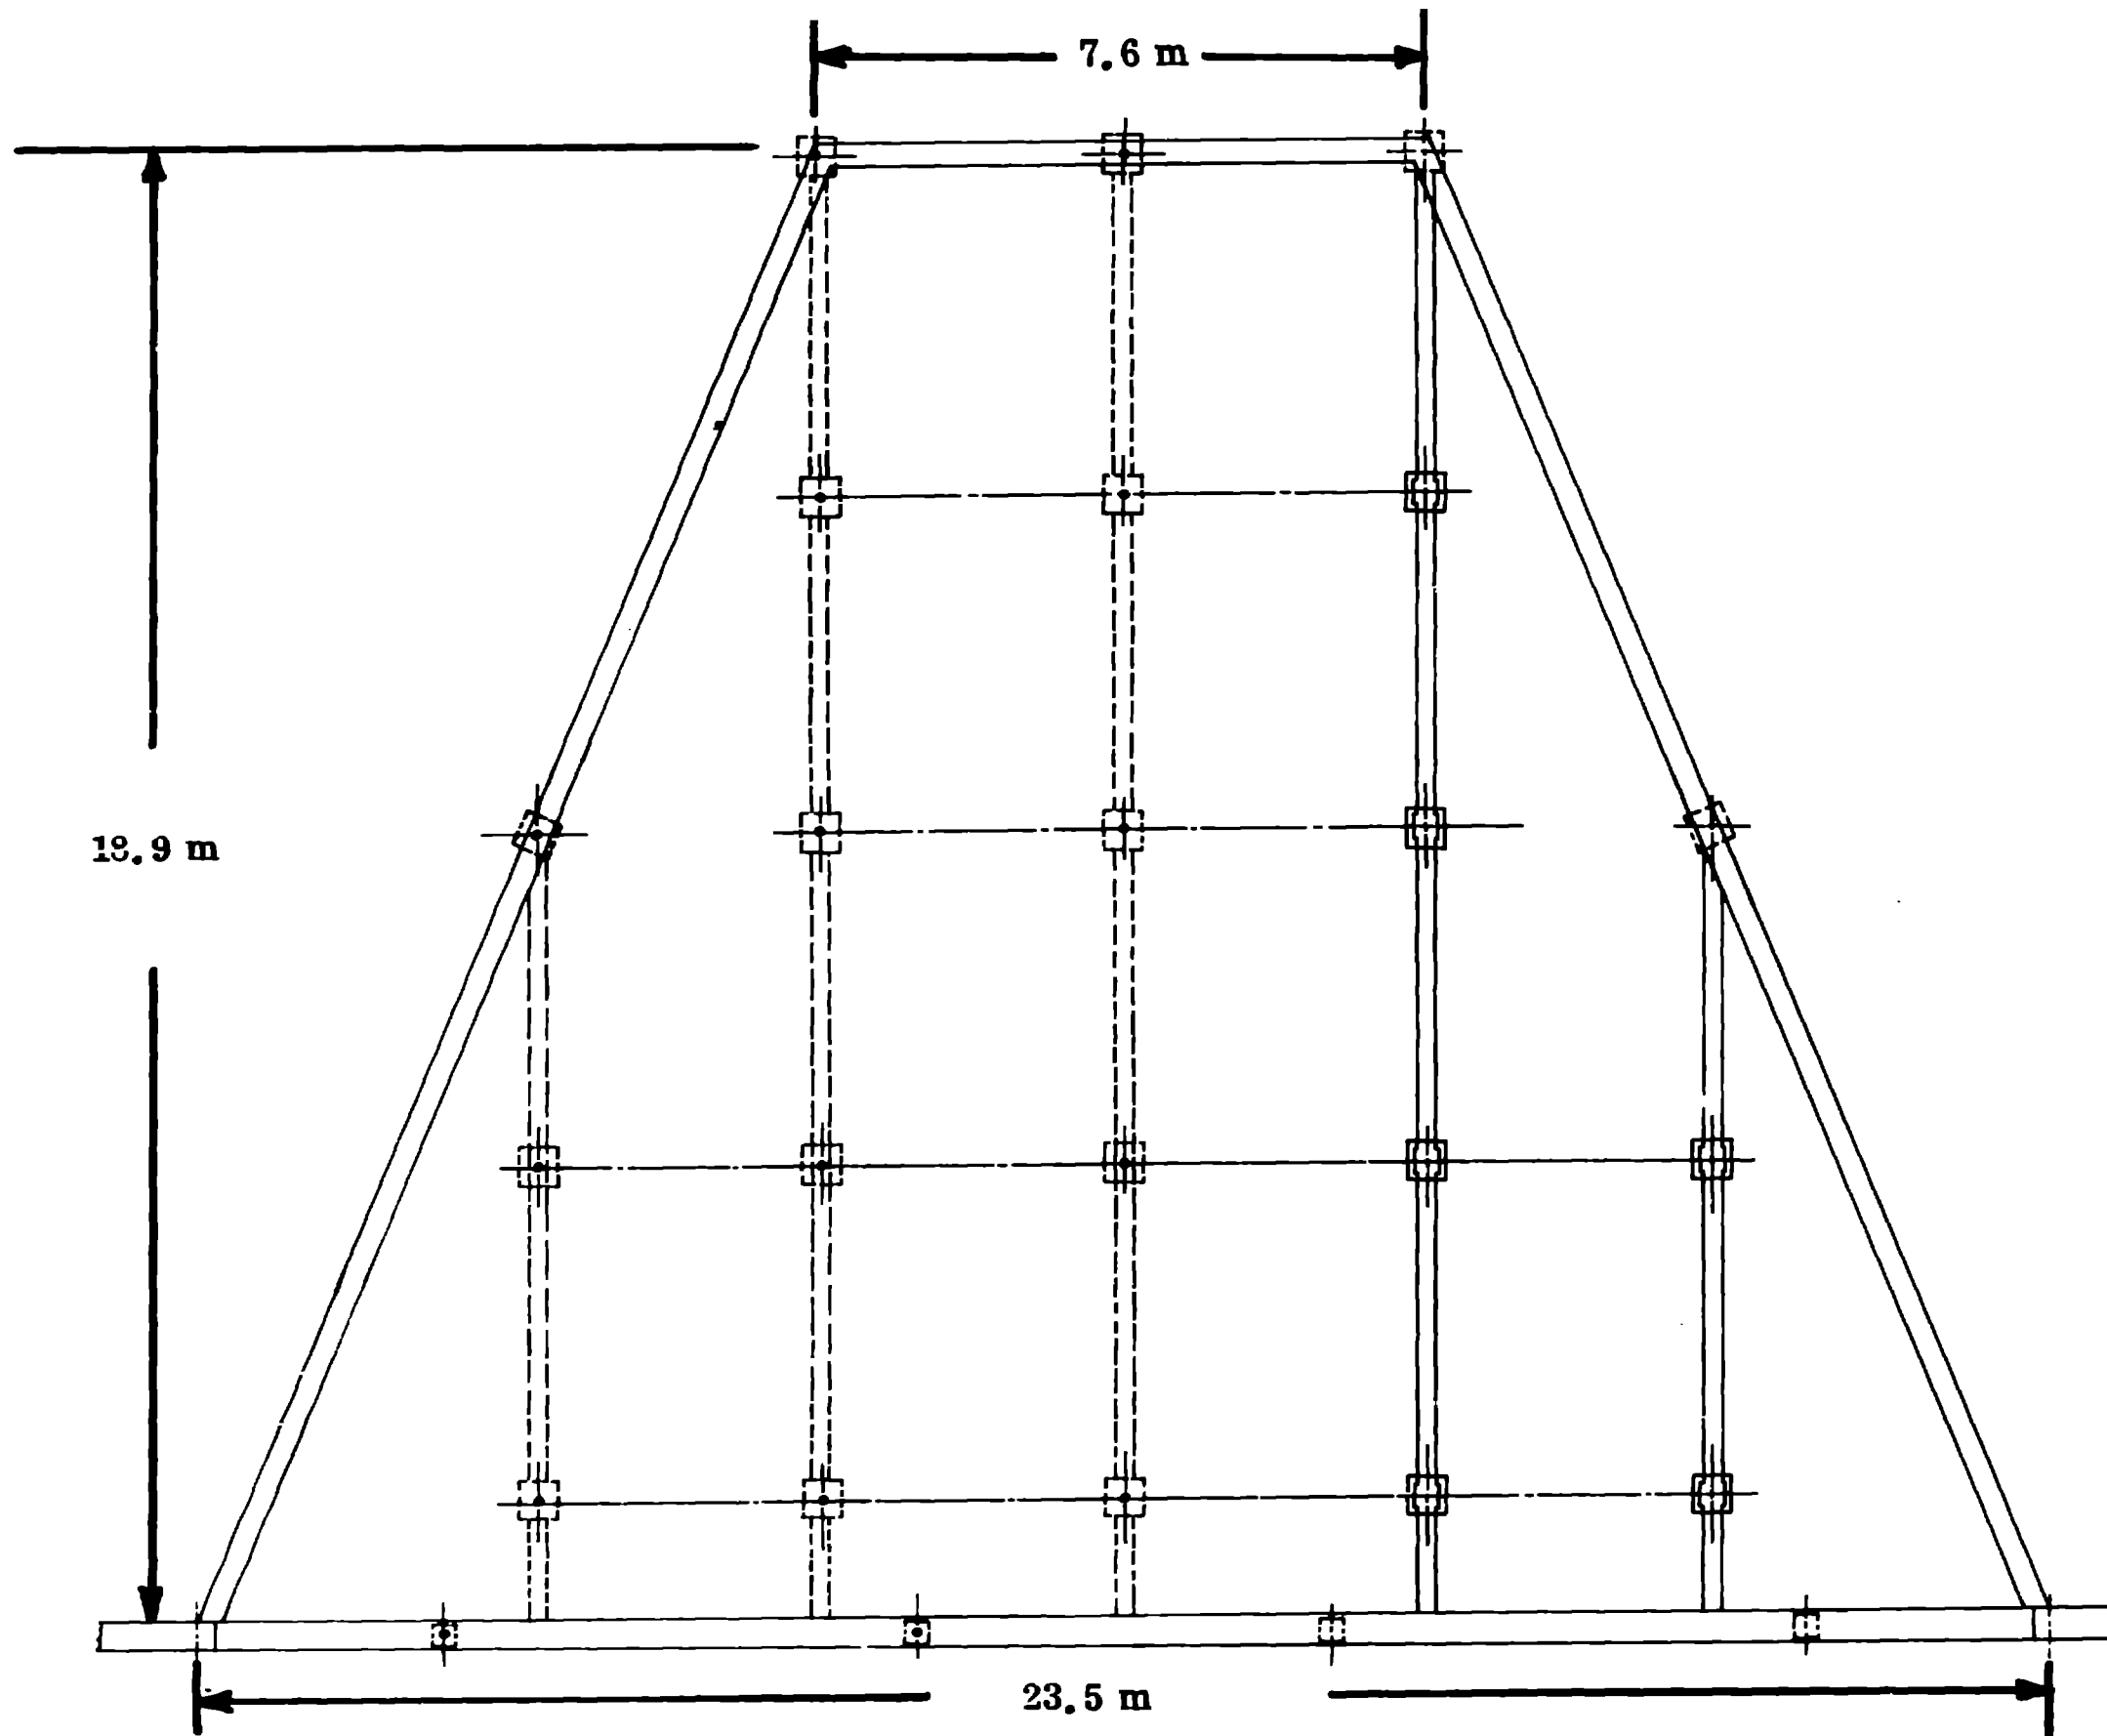
Fig. 22. FOUNDATION FOR INTAKE PLENUM

The next stage was to tear out the intake plenum floor with a payload loader. The foundation was quite extensive as can be seen in Fig. 22. Note that the concrete at the point where the external foundation intersects with the internal foundations was often 46 cm thick. The foundation was 1.52 metres deep and since it was known that some of the soil inside was contaminated, the decision was made to have the equipment dig deep enough to go beneath the foundation and load foundation, soil and floor at the same time. Fig. 23 shows the equipment in the process of removing the plenum floor area.

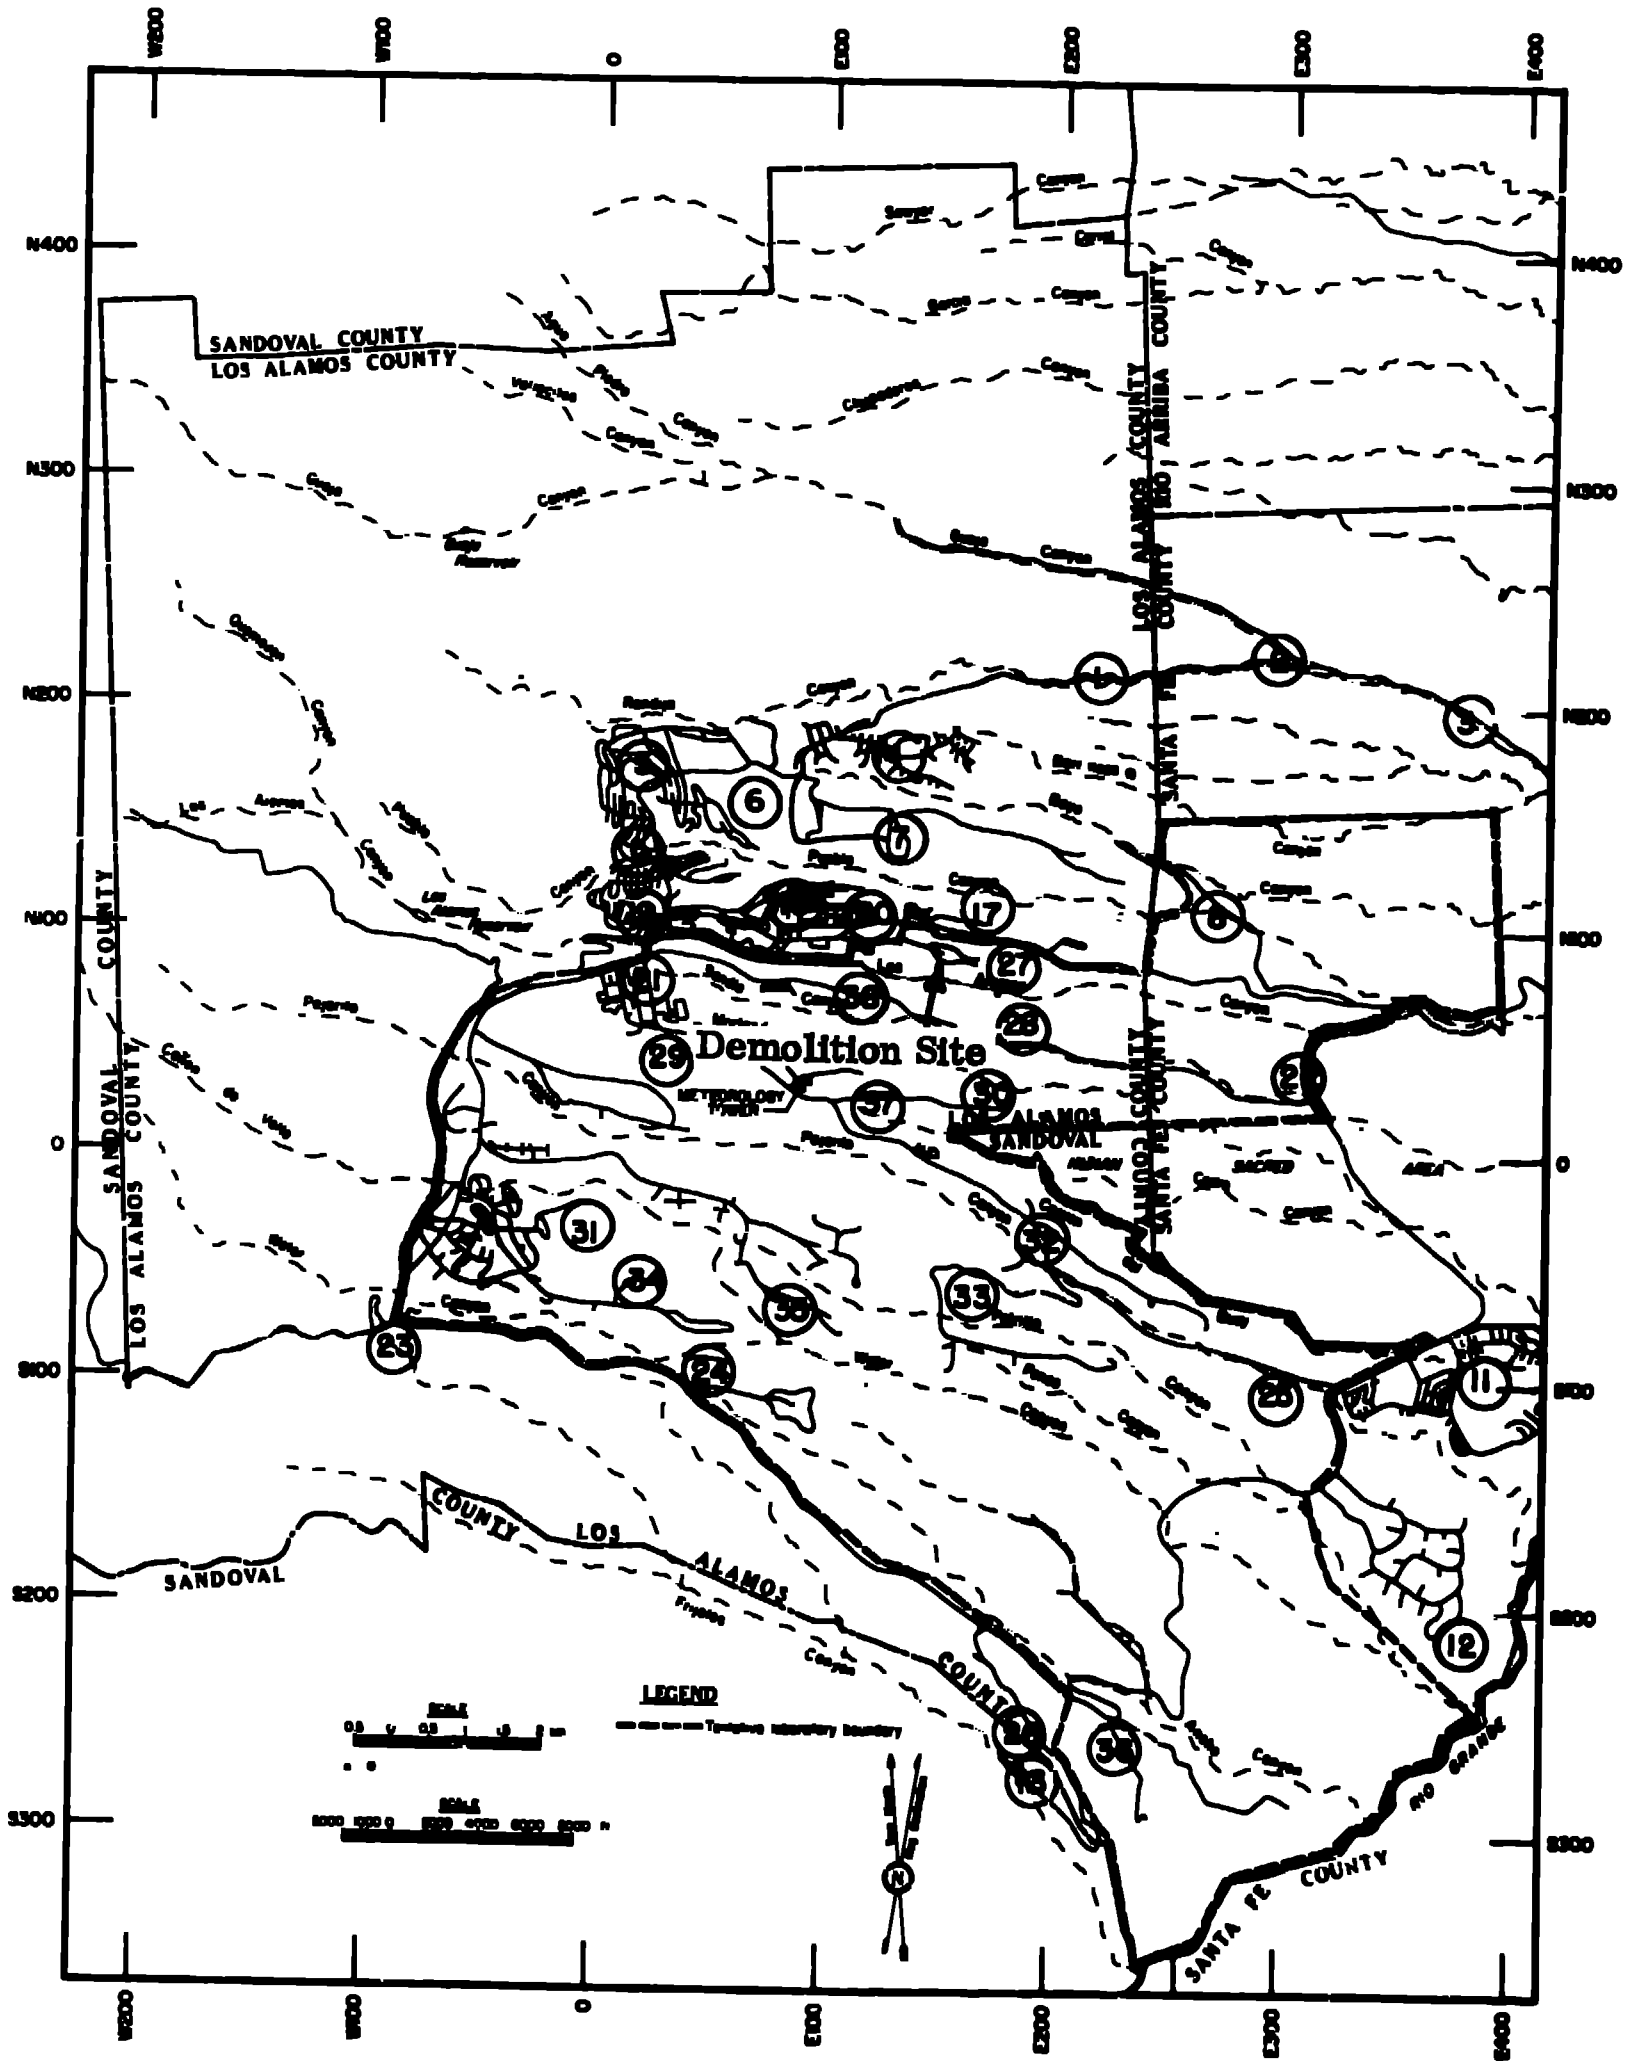
FIG. 35

The routine air sampling network consisting of 36 sampling stations was supplemented with two additional stations to more adequately encircle the demolition site with samplers. The positioning of the supplemental samplers was limited somewhat by the availability of electrical power and access to the equipment. The location of these sampling stations (with the exception of the Santa Fe, Espanola, and Pojoaque stations) and of the demolition site are shown in Fig. 35.

LOCATION OF DEMOLITION SITE AND AIR SAMPLING STATIONS

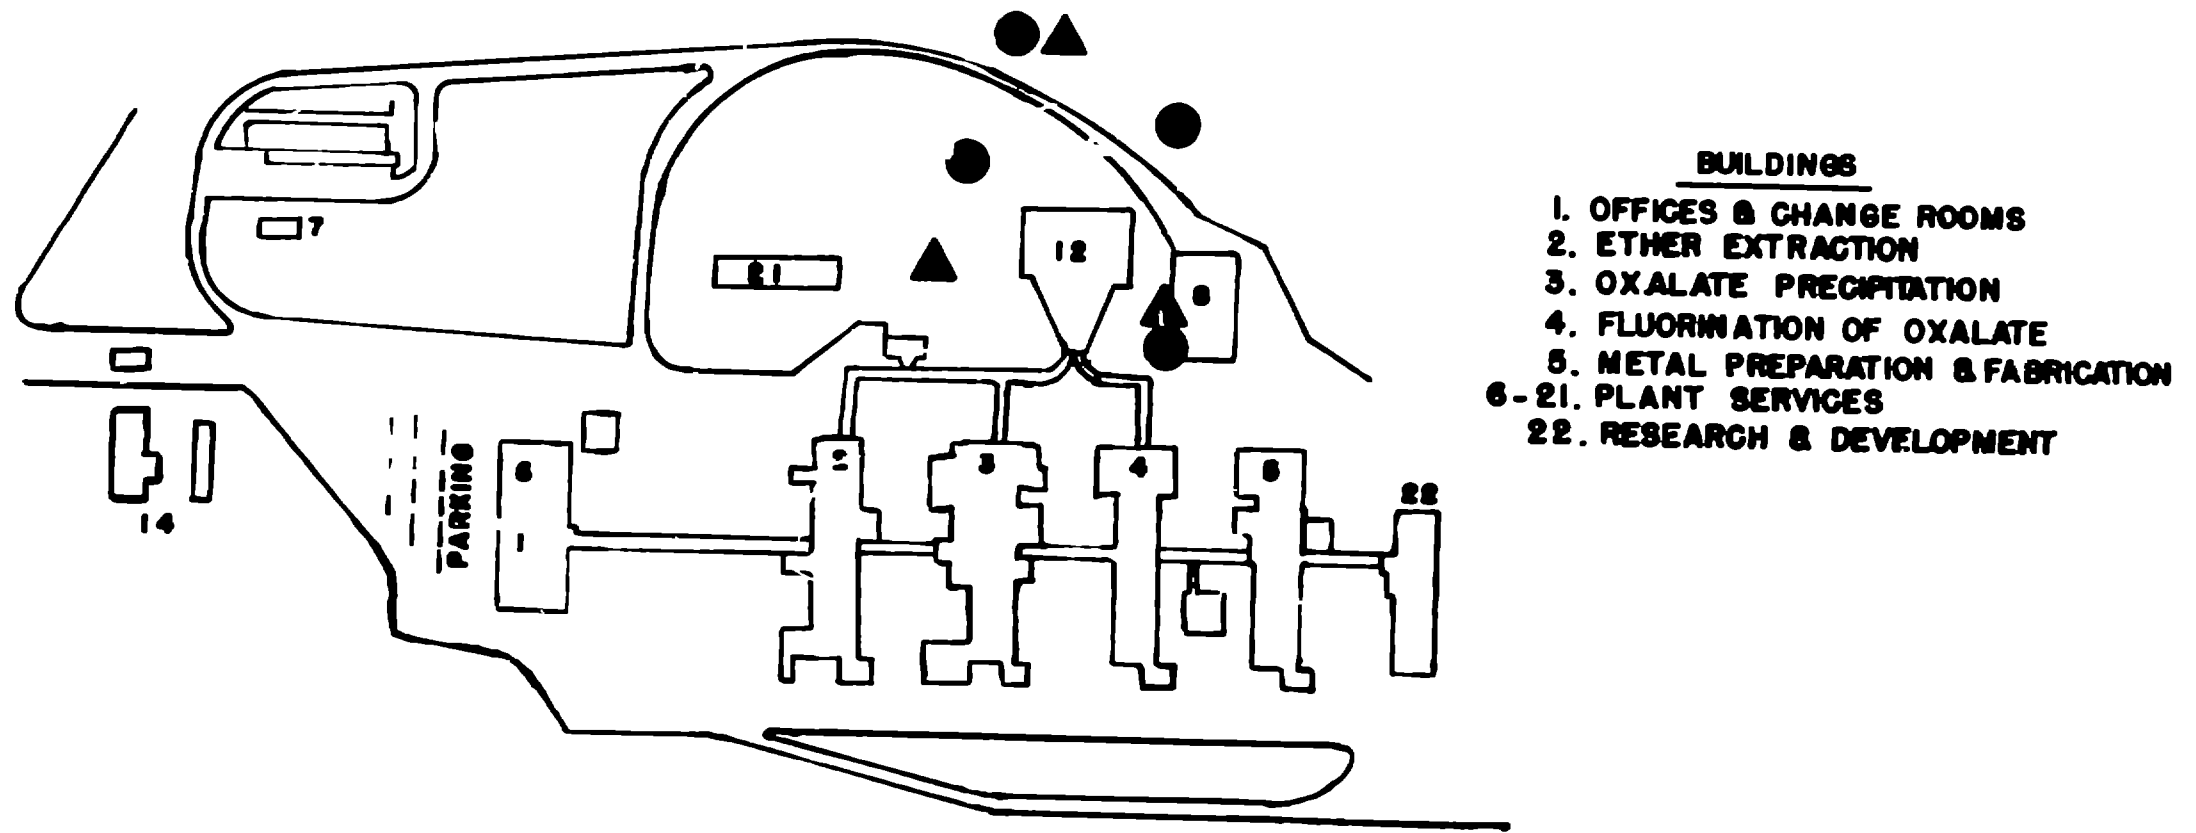
FIG 36. ON SITE (TA-21)  
AIR SAMPLER LOCATIONS

These samples (location of samplers shown in Fig. 36) were collected daily. Due to mechanical failures a variety of sampling devices and rates were used. On April 4, 1973, at the start of the sampling operation the sampling network consisted of four Staplex "Hi-Volume" samplers. They sampled through 76 mm diameter Microsorban paper (similar to the filter media for the weekly samples) at a rate of approximately  $0.37 \text{ m}^3/\text{min}$ . Two of the samplers were located near buildings and used line power; the other two were driven by gasoline powered generators.

- APPROXIMATE LOCATION OF INITIAL SAMPLING NETWORK
- ▲ APPROXIMATE LOCATION OF FINAL SAMPLING NETWORK

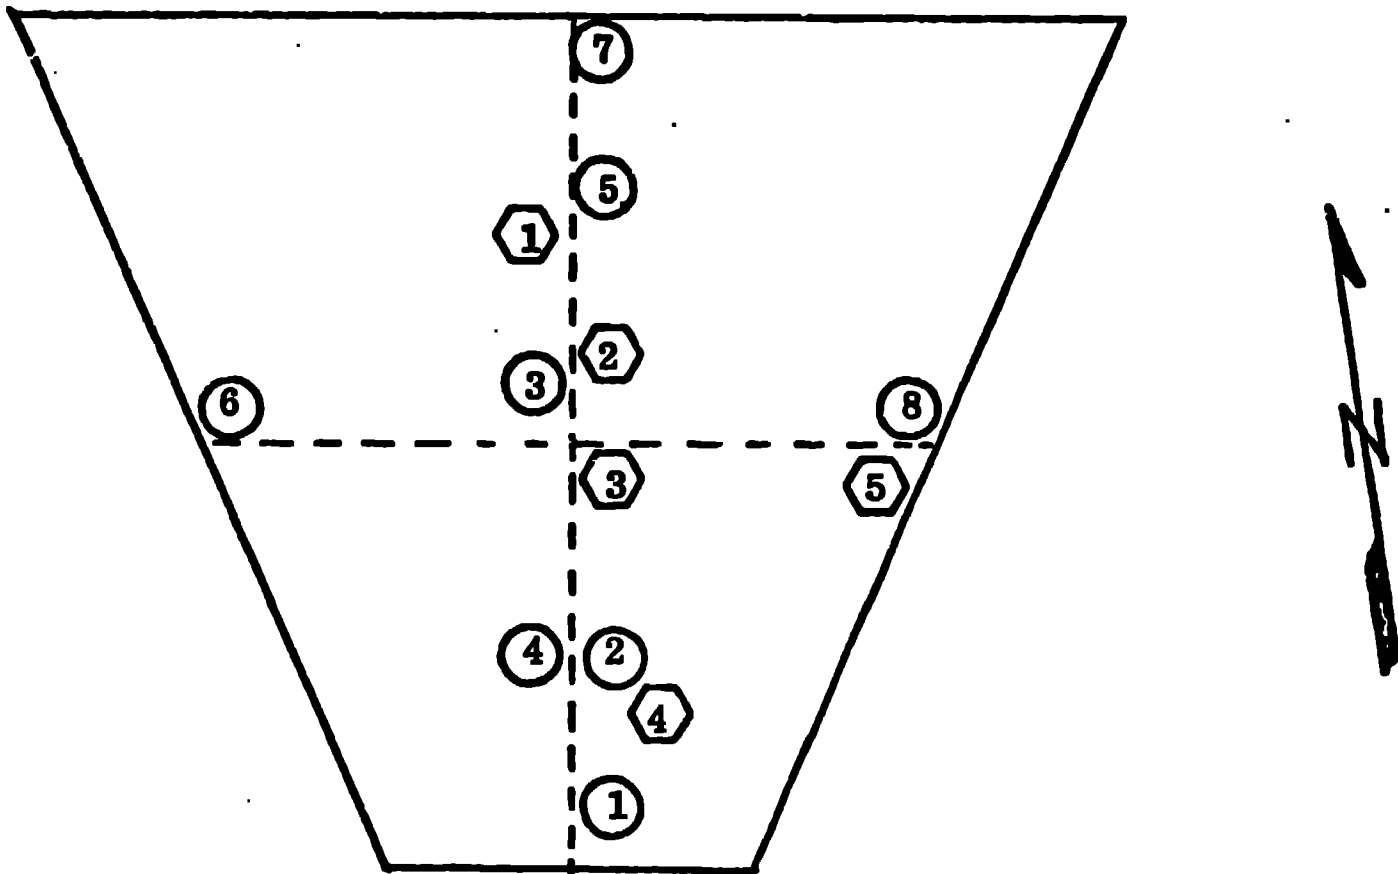
**Fig. 37. LOCATIONS OF SOIL SAMPLES TAKEN FROM UNDER INTAKE PLENUM.**

As was mentioned in the Demolition Section of this report, water had escaped the building through expansion joints in the concrete floor during past clean-up operations. Therefore, the concrete was broken and surface and core samples of dirt were collected at suspect locations to determine the magnitude and depth of contamination. The surface

Surface Samples		Core Samples		
Sample Location <sup>a</sup>	Gross alpha Concentration pCi/gm	Sample Location <sup>a</sup>	Depth from Surface	Gross alpha Concentration pCi/gm
①	67	①	0 - 2.5 cm	36
②	21	"	6.4 - 8.9 cm	9
③	17	"	12.7 - 15.2 cm	6
④	563	②	0 - 2.5 cm	10
⑤	207	"	6.4 - 8.9 cm	1
⑥	124	③	0 - 2.5 cm	108 000
⑦	4	"	6.4 - 8.9 cm	4 653
⑧	311	"	12.7 - 15.2 cm	3 722
		"	25.4 - 27.9 cm	446
		④	0 - 2.5 cm	30
		"	6.4 - 8.9 cm	4
		⑤	0 - 2.5 cm	33
		"	6.4 - 8.9 cm	10
		"	12.7 - 15.2 cm	21
		"	20.3 - 22.9 cm	20

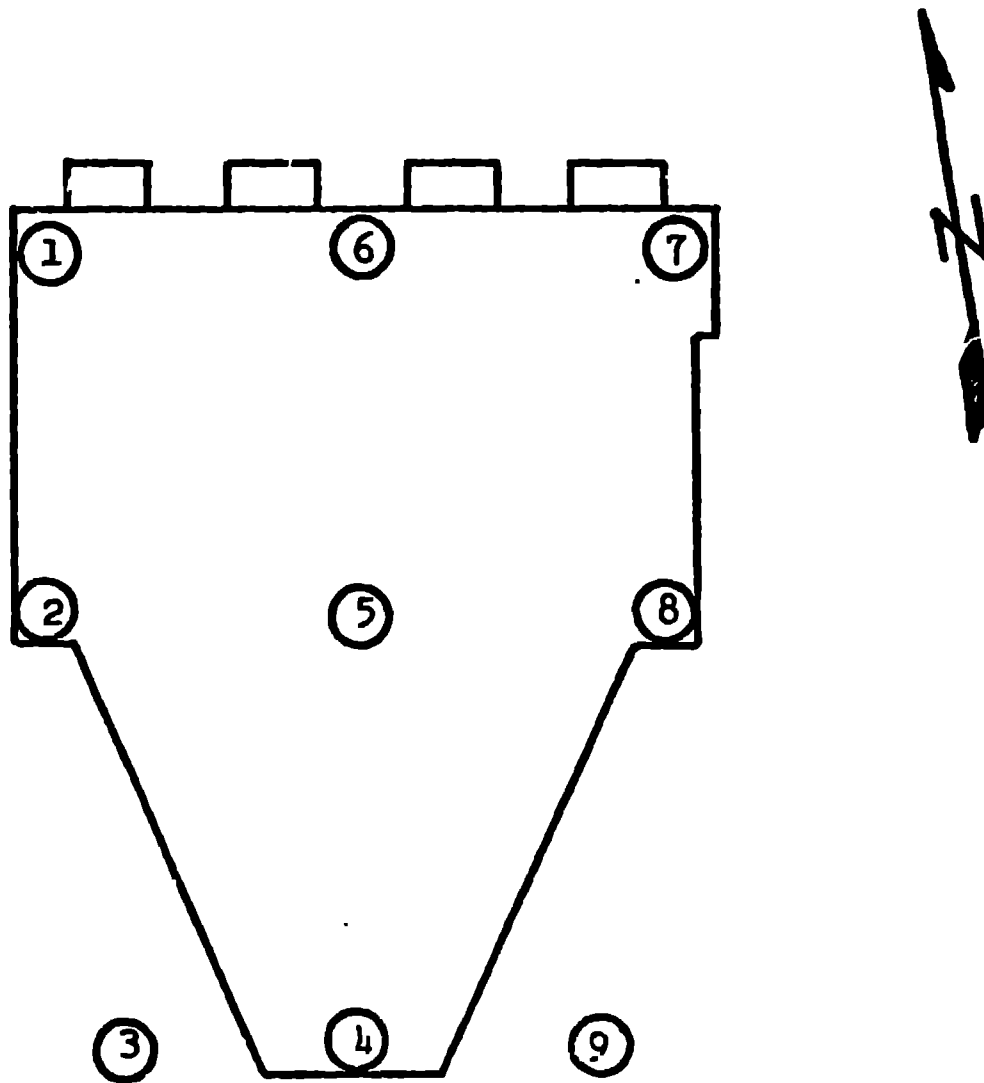
**Fig. 38 LOCATIONS OF SOIL SAMPLES TAKEN FROM CLEARED SITE**

were made on all the samples by leaching the samples with acid and analyzing the leachate. The gross alpha concentrations were used to select samples for plutonium analyses which would include the maximum and minimum gross alpha concentrations and several concentrations within the range. The plutonium data are shown in Table 6.
