LA-6529

Mechanical Properties of $^{238}\text{PuO}_2$

J. J. Petrovic
S. S. Hecker
C. C. Land
D. L. Rohr

los alamos
scientific laboratory
of the University of California
LOS ALAMOS, NEW MEXICO 87545

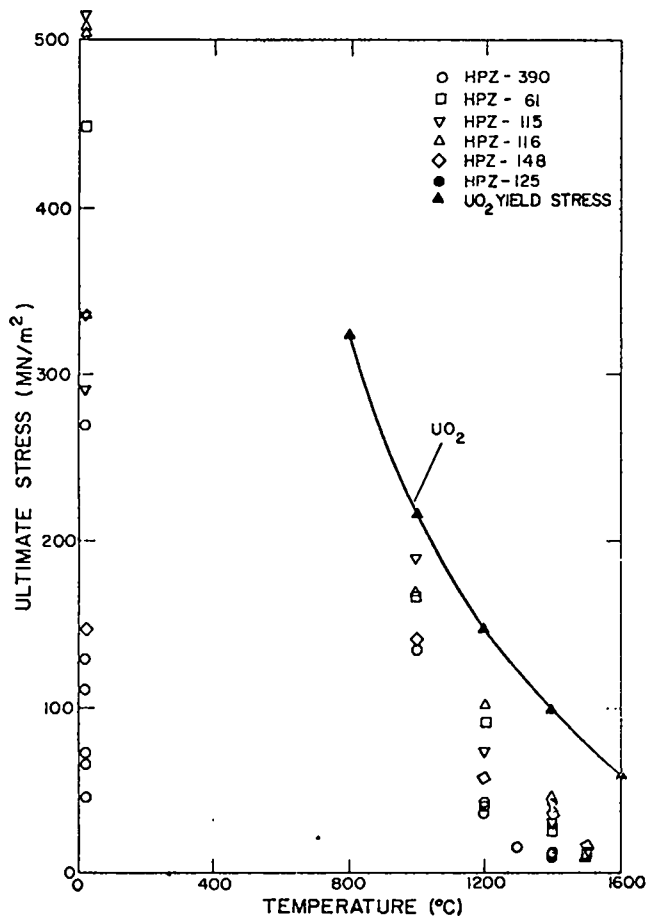
$^{238}\text{PuO}_2$ compressive ultimate stress vs test temperature, for various material conditions. The 0.2% yield stress of UO_2 is shown for comparison. The ultimate stress is very temperature sensitive.

The test results are listed in Tables III and IV. The ultimate stress (derived from the maximum load) as a function of test temperature is plotted in Fig. 7. Shown for comparison is the 0.2% compressive yield stress of UO_2 that Radford and Terwilliger² recently determined using comparable density, grain size, and strain rate conditions. Ultimate

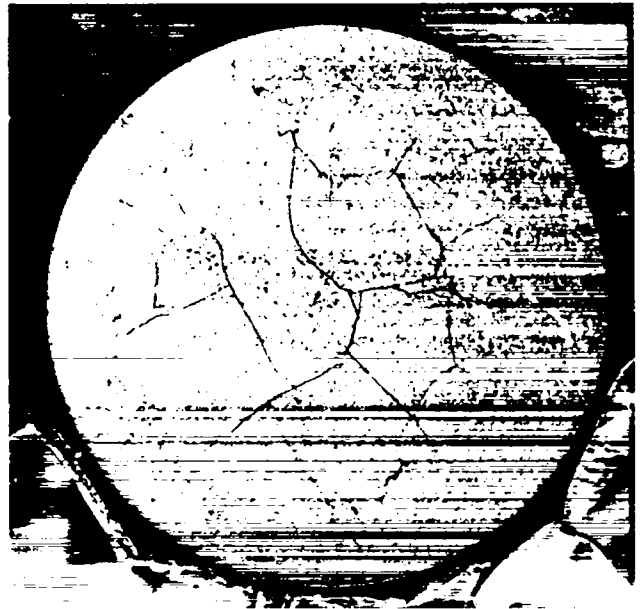
Fig. 12.

As-fabricated test pellet of Lot HPZ-116, sectioned approximately 3.2 mm into its interior and showing a network of large internal cracks. (10X).

The above explanation suggests that general plastic deformation would be observed in ²³⁸PuO₂ below 1500°C, if the specimens tested were free of internal cracks. Because all the specimens we tested apparently contained cracks before testing, general

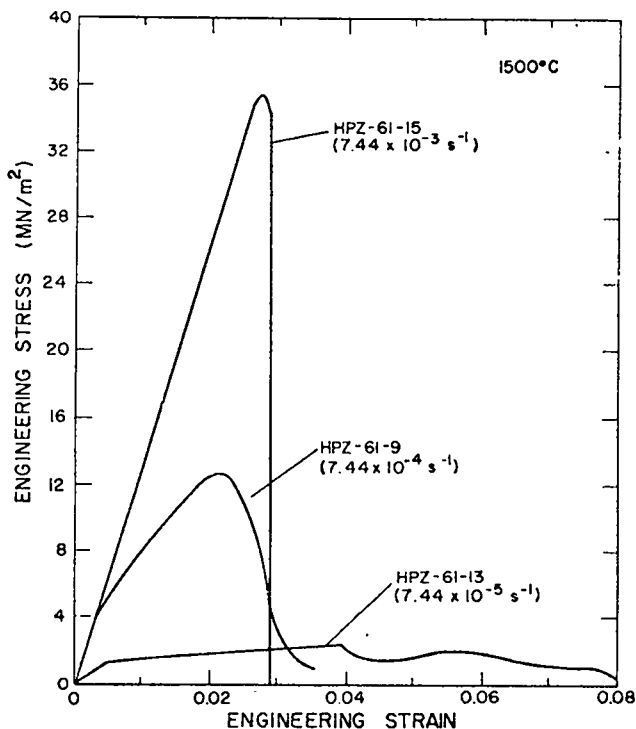
Table IV lists the results of the various tests at 1500°C. Figure 13 shows engineering stress-strain curves for specimens of Lot HPZ-61 tested at 1500°C at various strain rates. At the highest strain rate, the pseudobrittle behavior was observed. The stress-strain curve is linear, with slight rounding at the ultimate stress, followed by the sample's catastrophic fracture into shards. A 0.2% yield stress cannot be defined. However, at the lower strain rates, generalized plastic deformation was observed and the 0.2% yield stresses can be defined. The yield stresses and ultimate stresses decreased with decreasing strain rate. At the lowest strain rate, there was an apparent decrease in the modulus. Fracture was no longer catastrophic at the lower strain rates. The stress dropped off gradually beyond the point of maximum load. The total amount of plastic strain increased with decreasing strain rate. At the lowest strain rate, we observed 8% plastic strain, quite large for a ceramic material.

The detail in the stress-strain curve at the lowest strain rate is probably due to the slow displacement of cracks. All the characteristics of these 1500°C tests are representative of large-scale plastic deformation in the ²³⁸PuO₂.

rate at 1500°C, the stress-strain curve for which is shown in Fig. 13. This specimen exhibited about 8% plastic strain, as determined from measurements of its length before and after testing. Note that, even after this amount of strain, the specimen was sound enough to endure the mounting and polishing procedures required to obtain the longitudinal section. Some of the cracks were probably present before testing.

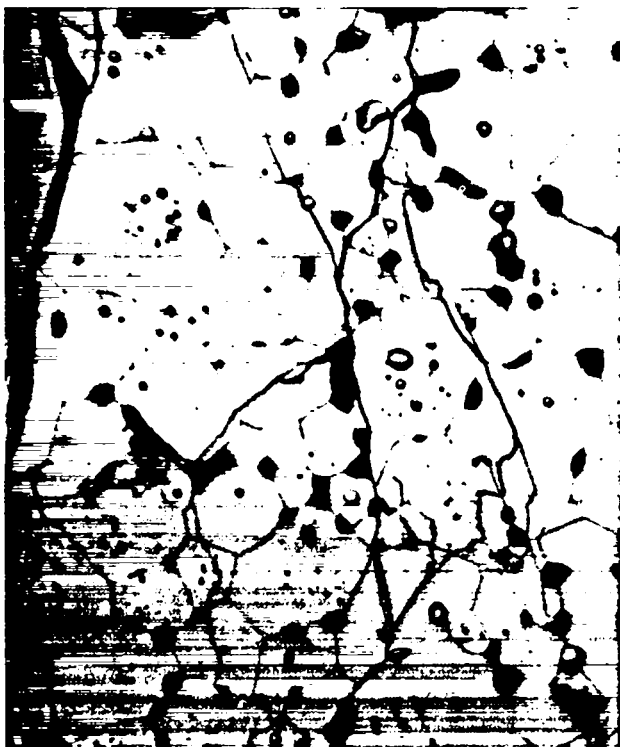
Fig. 15.
Specimen HPZ-115-3, tested at ambient temperature. The transgranular fracture mode is operative, and cracks traverse grains and grain boundaries. (1000X).

Figure 15 is a metallographic section of a ²³⁸PuO₂ specimen fractured at room temperature. The microstructures of as-fabricated ²³⁸PuO₂ typically showed internal grain porosity, triple-point pores, and some pores along the grain boundaries. The room temperature fracture was totally transgranular with cracks traversing the grains. Figure 16 is a replica electron micrograph of the room-temperature transgranular fracture. Fracturing has exposed the internal grain porosity, and cleavage markings are evident.

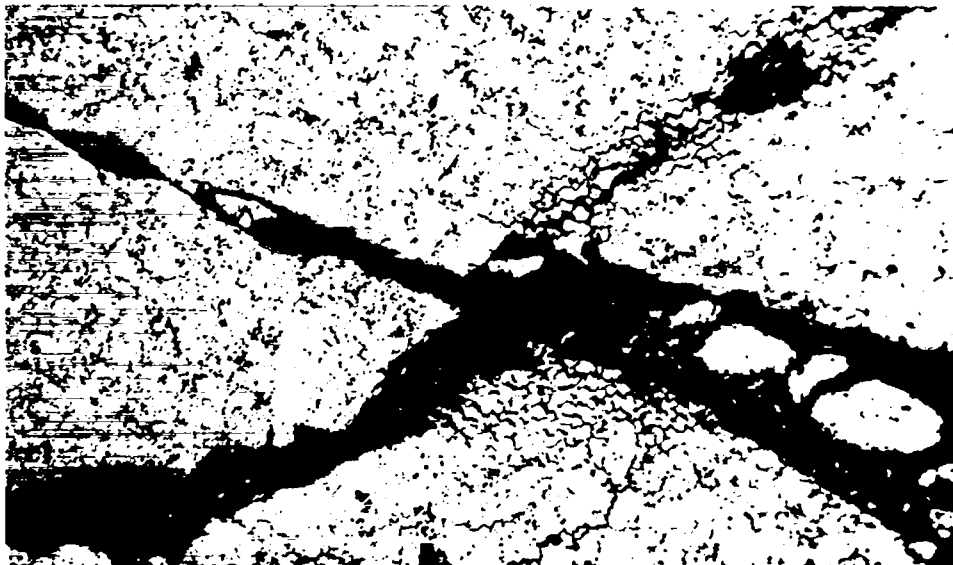
Fig. 21.

Specimen HPZ-116-7, tested at 1400°C. Intense intergranular fracture occurs adjacent to large cracks. Note the decreased intensity of the intergranular separations away from the immediate vicinity of the large cracks. (100X).

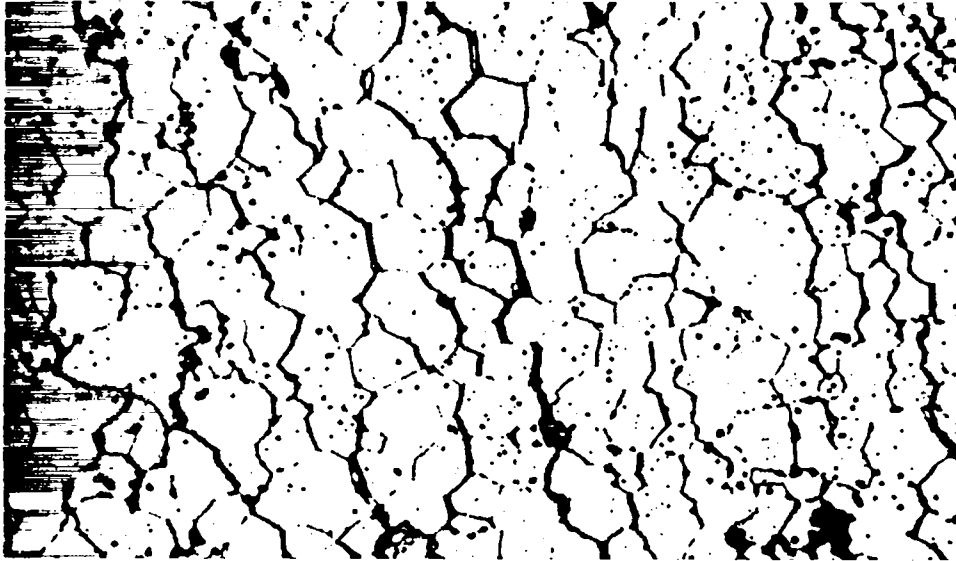
Fig. 22.

Specimen HPZ-61-5, tested at 1400°C. The grain boundaries are almost totally separated in this region of the specimen. (500X).

These questions cannot be answered precisely for $^{238}\text{PuO}_2$ at present. For the cracks shown in Fig. 22, the strains represented by the cracked regions in relation to the grain size are about 10%. This might suggest extensive prior continuous deformation. Note that both UO_2 and ThO_2 , materials similar to $^{238}\text{PuO}_2$, exhibit grain boundary separations as a result of elevated temperature deformation.⁶⁻¹⁰ In both of these materials, continuous deformation seems to precede formation of intergranular separations. Such intergranular separations in ceramic

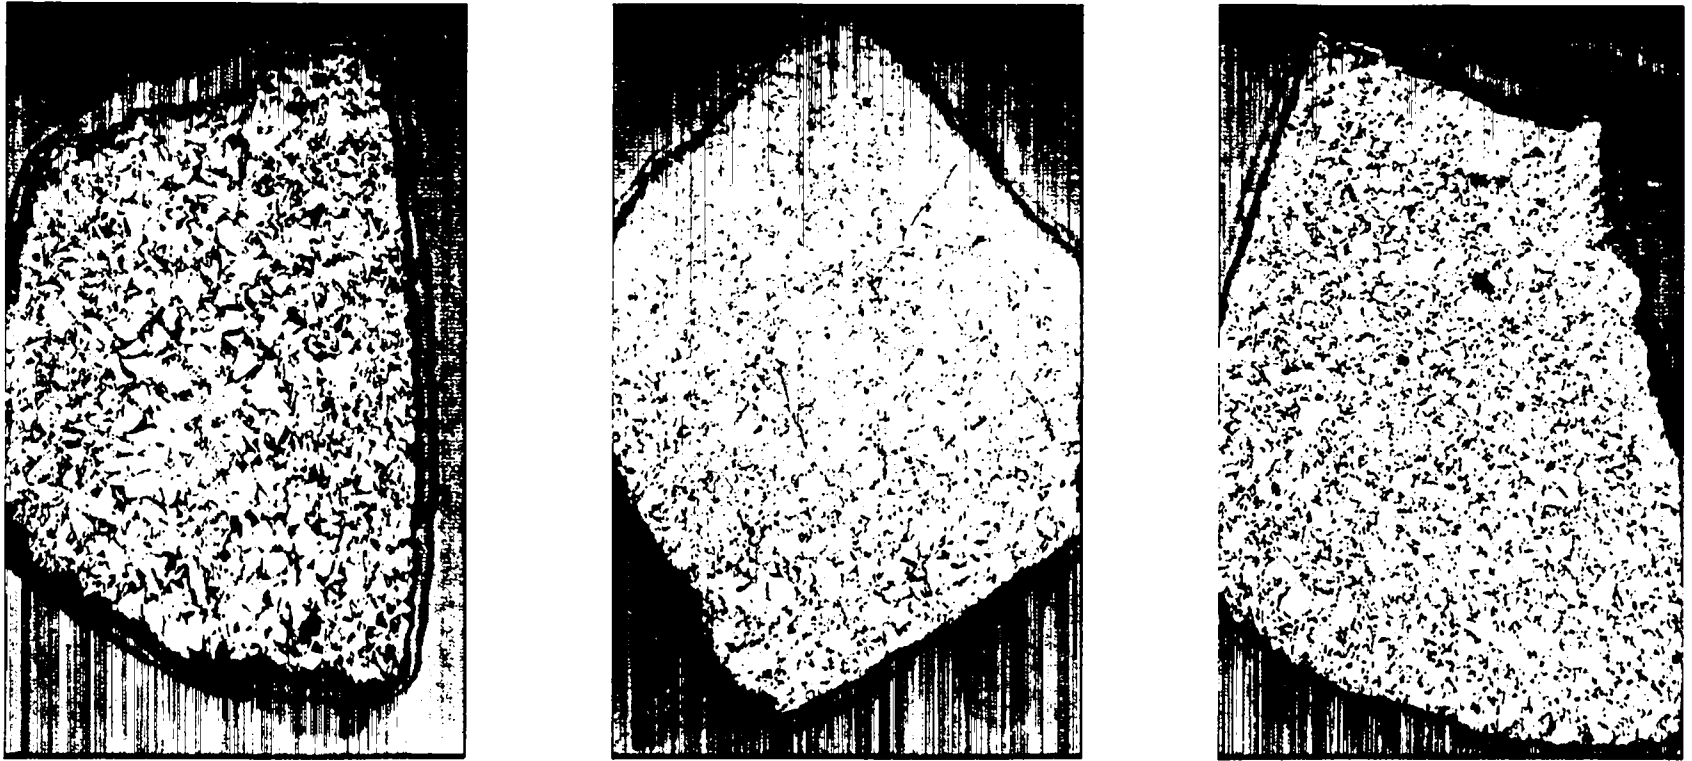
Fig. 37.
Plutonia microstructure in the polar, equatorial, and middle regions of the fuel in FSA 25.
Typically, the density of the equatorial region is greatest. (15X).

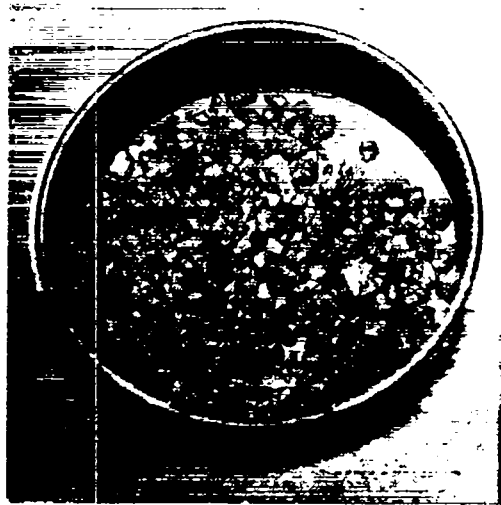
Fig. 40.

$^{238}\text{PuO}_2$ fuel sphere after impact of FSA-33 at 86 m/s and $\sim 370^\circ\text{C}$. Note the ductile behavior shown by the extensive shape change and imprints of the vent and iridium shell near the equator.

fracture and crushing with extensive fines generation (Fig. 39), and pronounced plastic flow with little cracking and fines generation (Fig. 40). We do not yet understand the reasons for these differences.

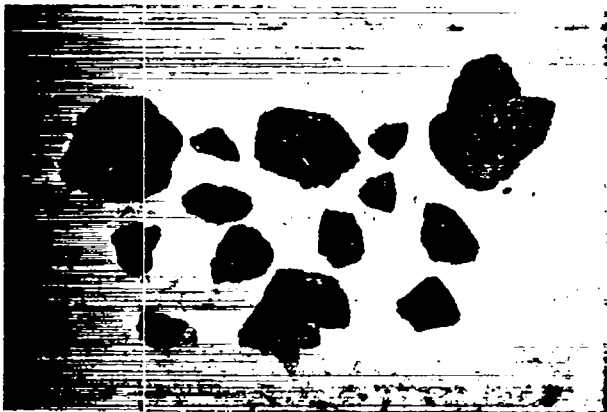
Fig. 39.

$^{238}\text{PuO}_2$ fuel sphere after impact of FSA 29 at 76.2 m/s and 1093°C . Note the brittle fracture behavior shown by the extensive fragmentation.

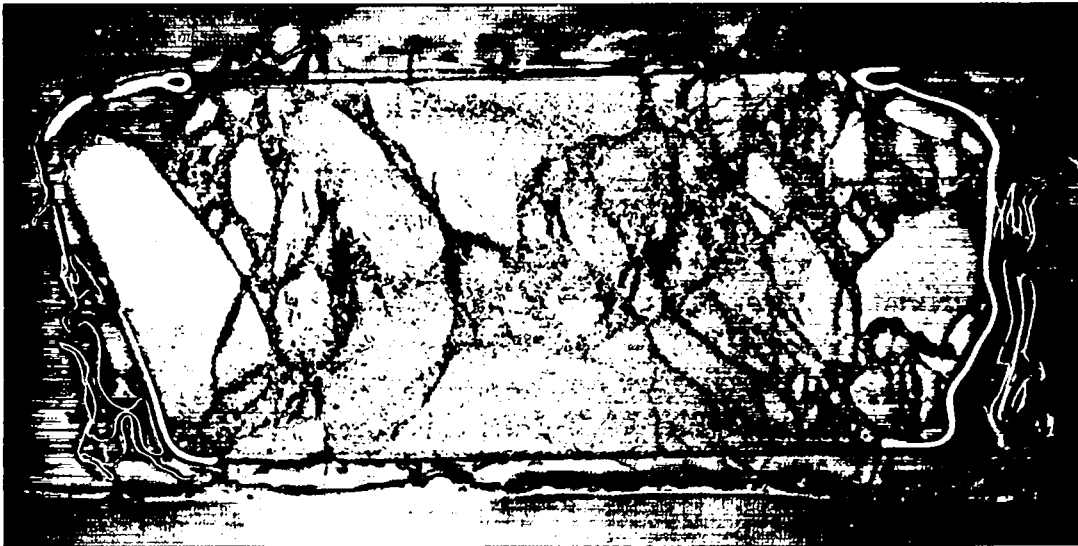
Compression test specimen HPZ-390-12 tested at 1200°C in a niobium container. After initial fracture, specimen was reloaded and crushed as shown. The specimen assumes the shape of the container, although no large-scale plastic flow occurred. (5X).

ted as a function of test temperature in Fig. 7. During the compression test of one $^{238}\text{PuO}_2$ pellet at 1200°C, we continued to deform the specimen after initial fracture. Because the pellet was surrounded by a thin niobium container, deformation proceeded by crushing of the pseudobrittle $^{238}\text{PuO}_2$ as shown in Fig. 41. During the crushing phase of deformation, the $^{238}\text{PuO}_2$ absorbed considerable energy, as shown in the load-displacement record in Fig. 42.

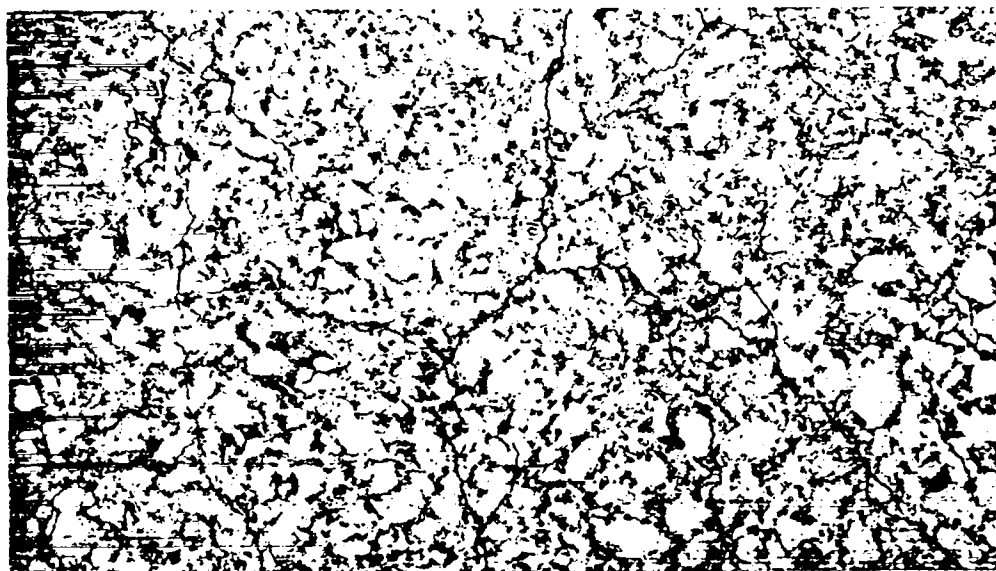
Fig. B-1.

As-fabricated HPZ-61 (90.7% theoretical density, 12- μm grains). Note extensive internal crack network and inhomogeneous microstructure. (50X).

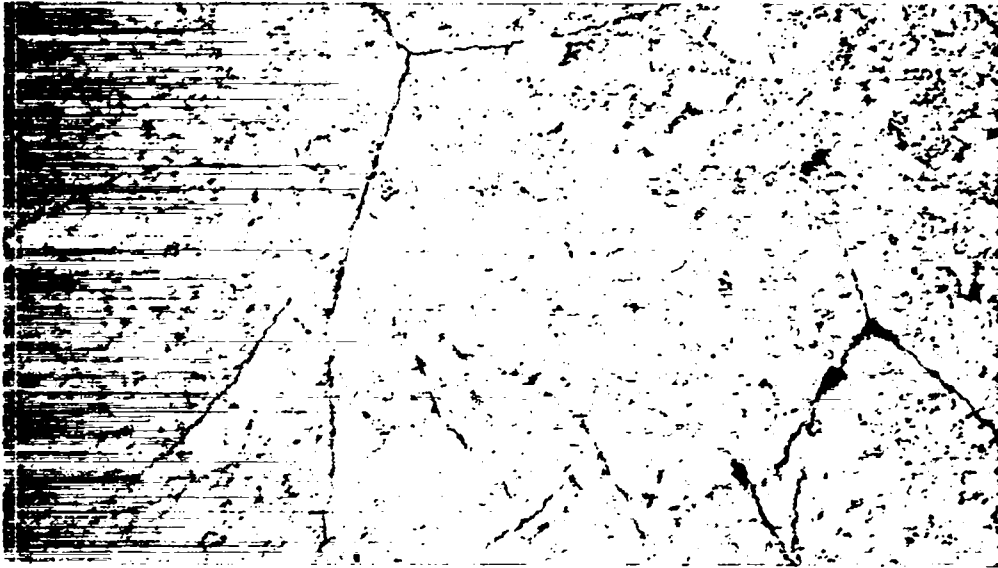
Fig. B-2.

As-fabricated HPZ-115 (92.3% theoretical density, 16- μ m grains). Note extensive internal crack network and inhomogeneous microstructure. (50X).

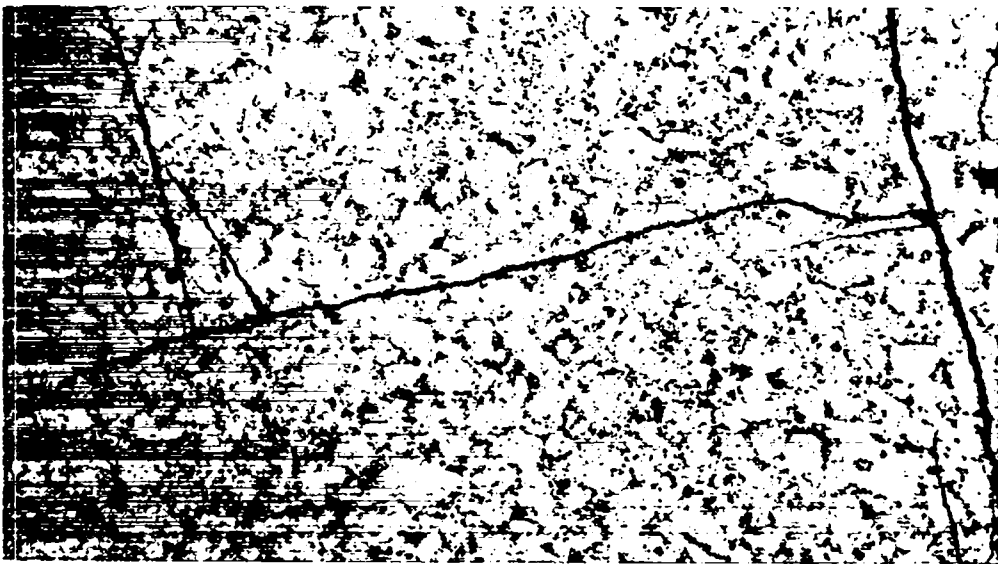
Fig. B-3.

As-fabricated HPZ-116 (92.1% theoretical density, 12- μ m grains). Note extensive internal crack network and inhomogeneous microstructure. (60X).

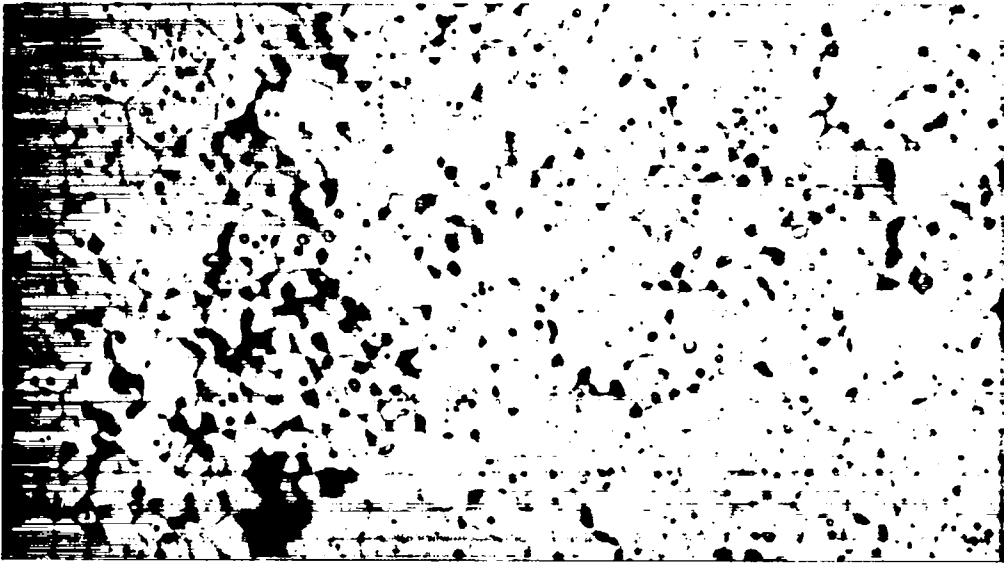
Fig. B-5.

Specimen HPZ-61-1, tested at ambient temperature after 505-day ambient temperature storage. Note internal grain porosity and grain boundary porosity. (1000X).

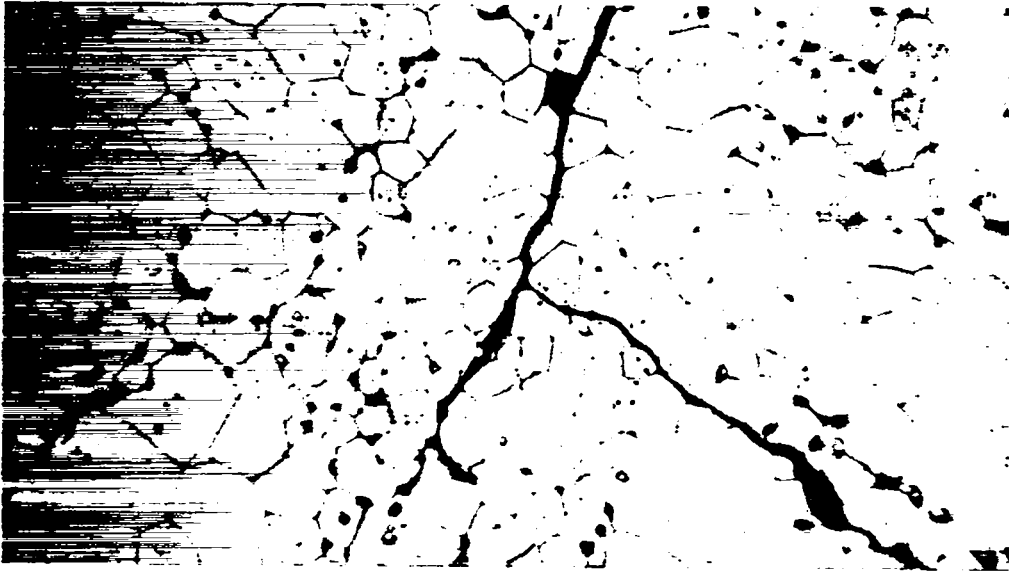
Fig. B-6.

Microstructure of as-fabricated HPZ-115 specimen. Note internal grain porosity and grain boundary porosity. (500X).

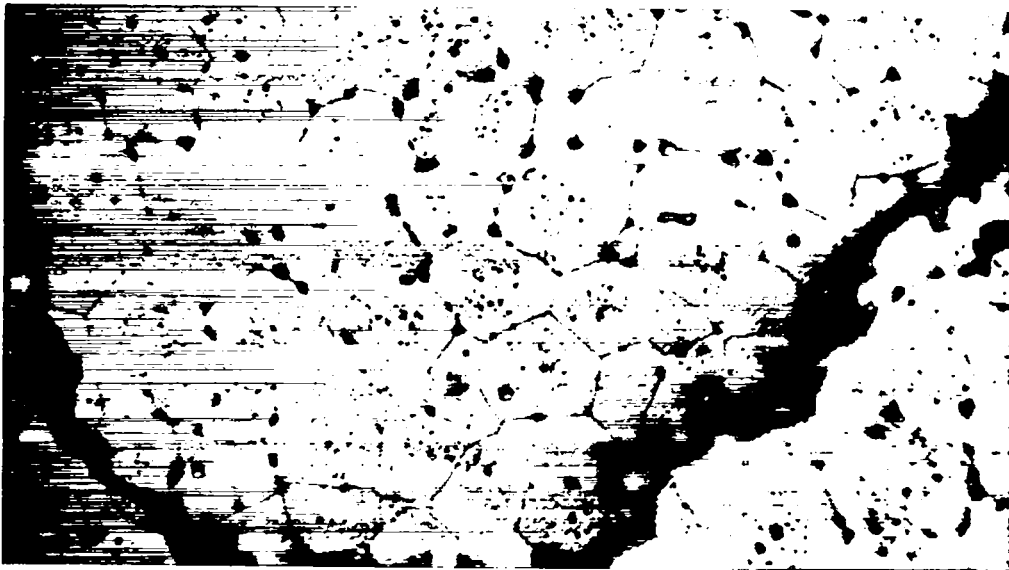
Fig. B-7.

Microstructure of as-fabricated HPZ-116 specimen. Note internal grain porosity and grain boundary porosity. (1000X).

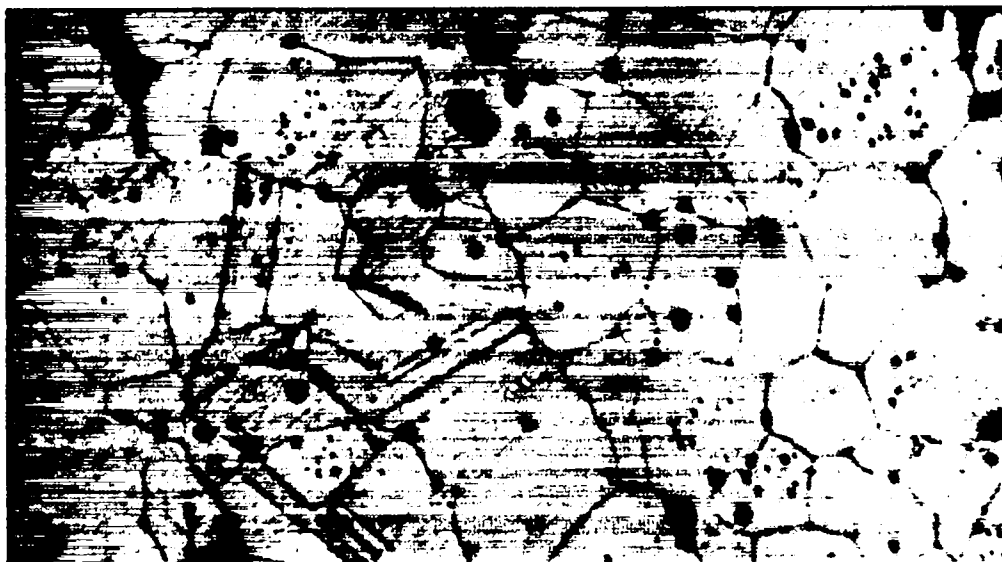
Fig. B-8.

Microstructure of as-fabricated HPZ-125 (91% theoretical density, 10- μ m grains). Note internal grain porosity, grain boundary porosity, and presence of twins. (1500X).

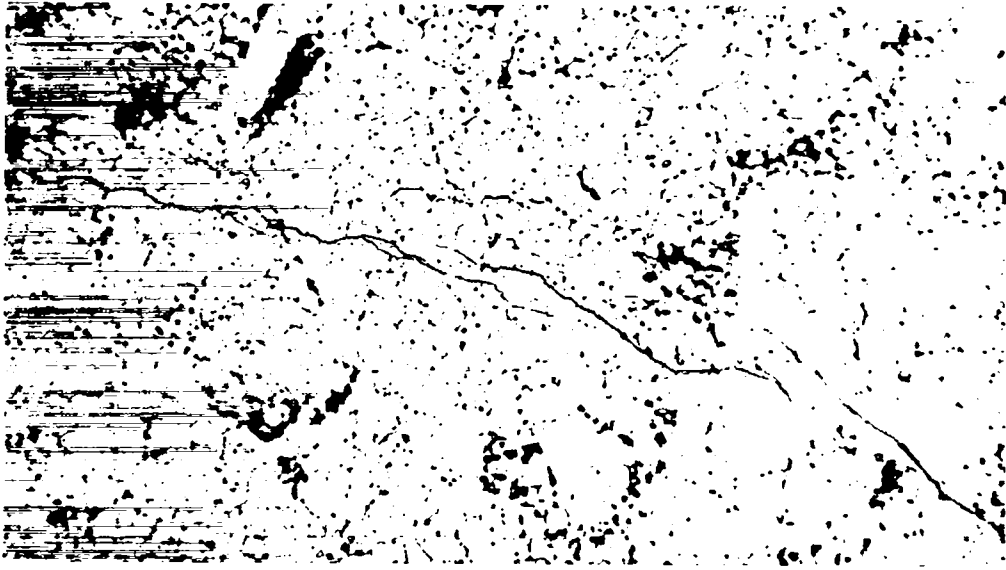
Fig. B-10.
Specimen HPZ-61-1, tested at ambient temperature after 505-day ambient temperature storage. Note transgranular fracture mode. (500X).

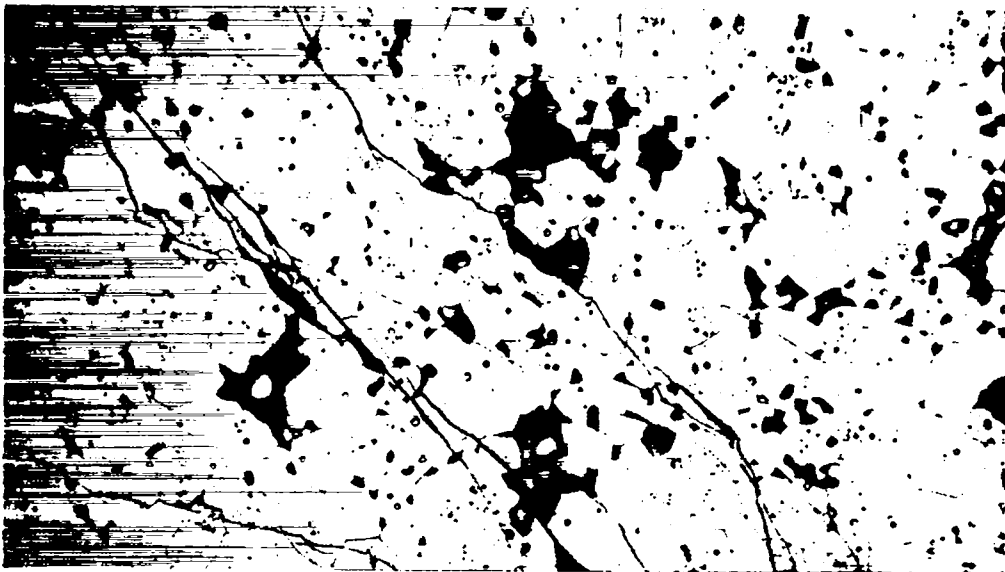
Fig. B-11.
Specimen HPZ-115-3, tested at ambient temperature after 176-day ambient temperature storage. Note transgranular fracturing. (500X).

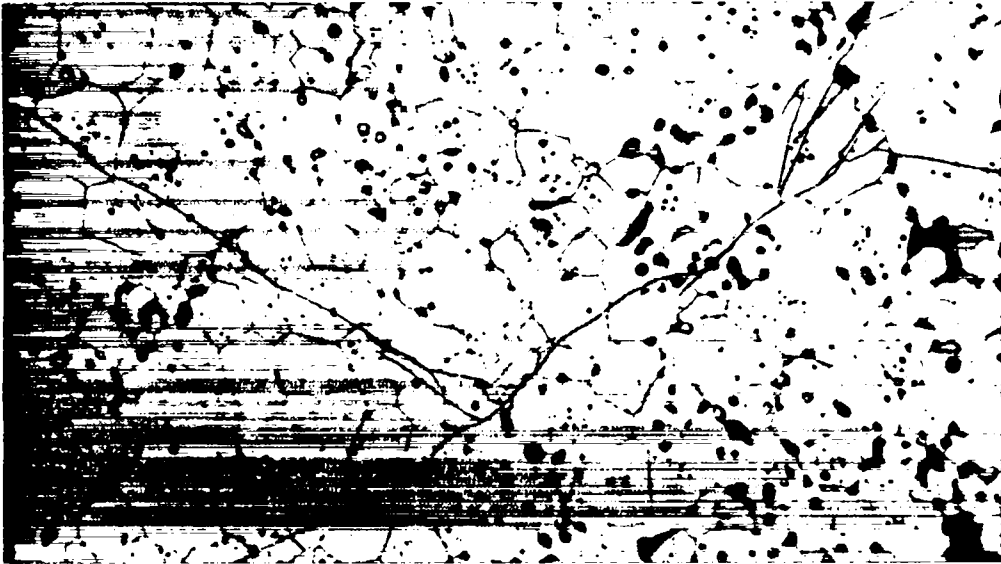
Fig. B-12.

Specimen HPZ-116-9, tested at ambient temperature after 181-day ambient temperature storage. Fracturing is transgranular. (500X).

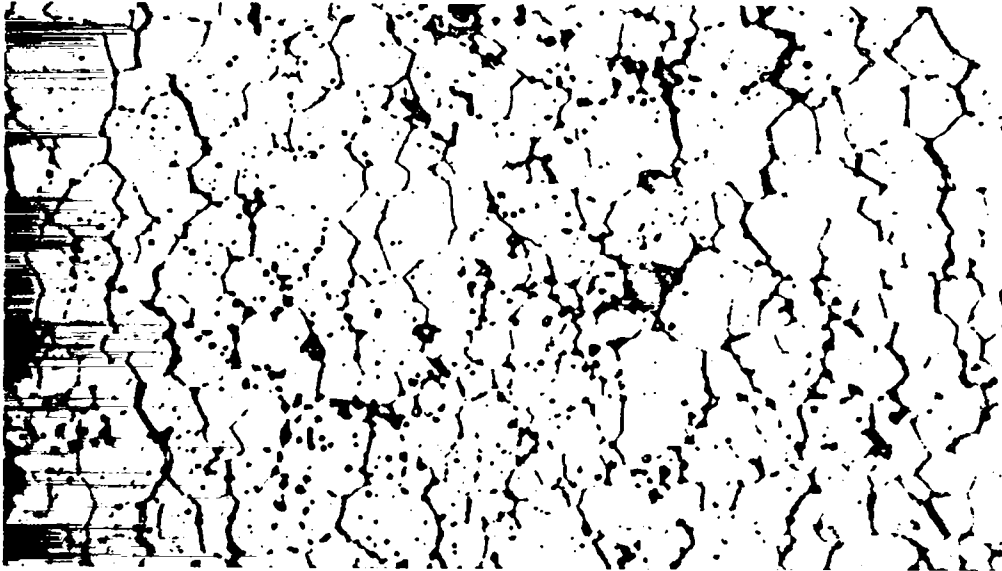
Fig. B-14.

Specimen HPZ-61-5, tested at 1400°C after 366-day ambient temperature storage. Fracture is intergranular. (500X).

1400°C was totally intergranular in all material conditions, as shown in Figs. B-14 through B-18. Intense areas of intergranular separations adjacent to large cracks suggested that such separations played a role

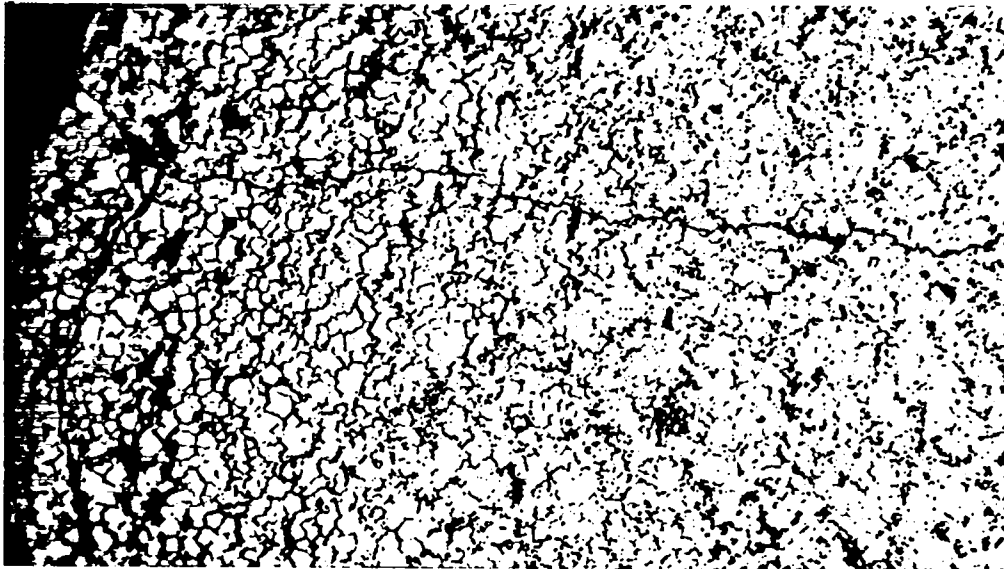
Fig. B-15.

Specimen HPZ-115-1, tested at 1400°C after 113-day ambient temperature storage. Note intense intergranular fracturing near the large crack at right. (100X).

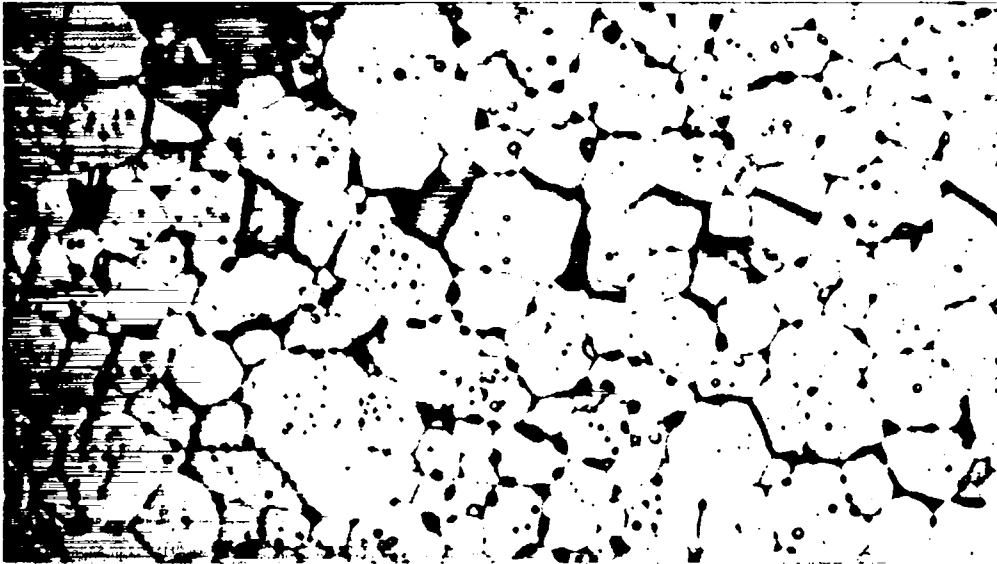
Fig. B-16.
Specimen HPZ-116-7, tested at 1400°C after 57-day ambient temperature storage. Note intergranular separations. (1000X).

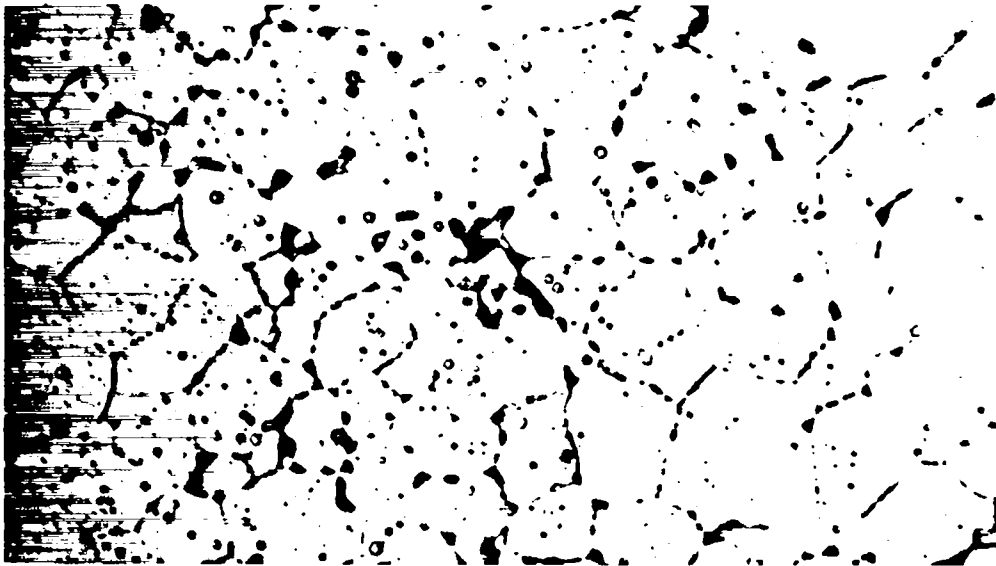
Fig. B-19.
Specimen HPZ-61-5, tested at 1400°C after 366-day ambient temperature storage. Extensive helium bubbles have formed at the grain boundaries. (1000X).

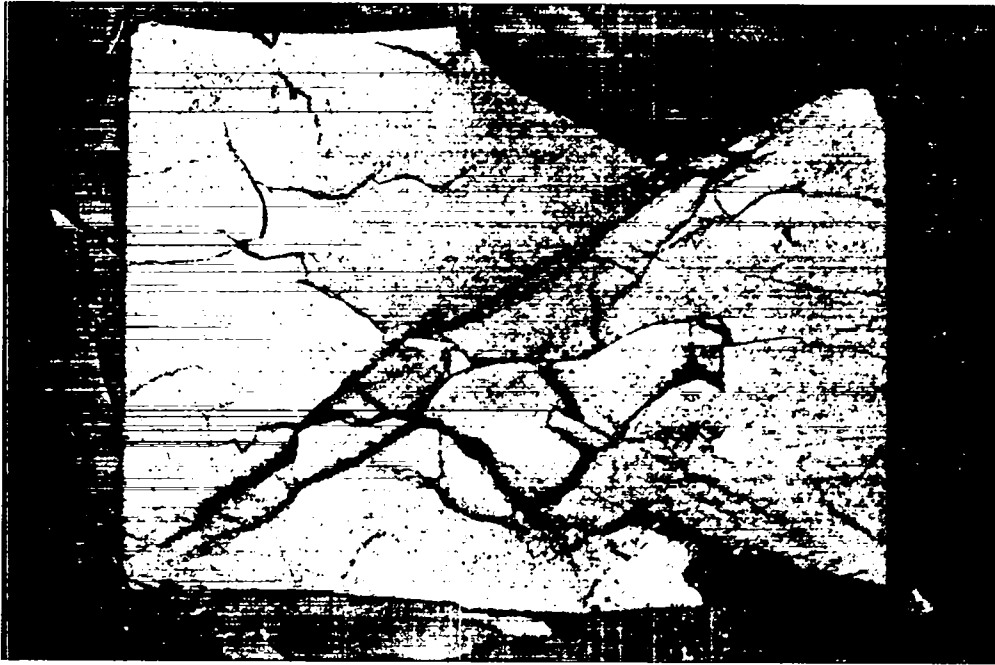
Fig. B-27.

Specimen HPZ-116-5, tested at 1500°C after 263-day ambient temperature storage. The polished longitudinal cross section shows extensive cracking along 45° directions and many as-fabricated internal cracks. (~10X).

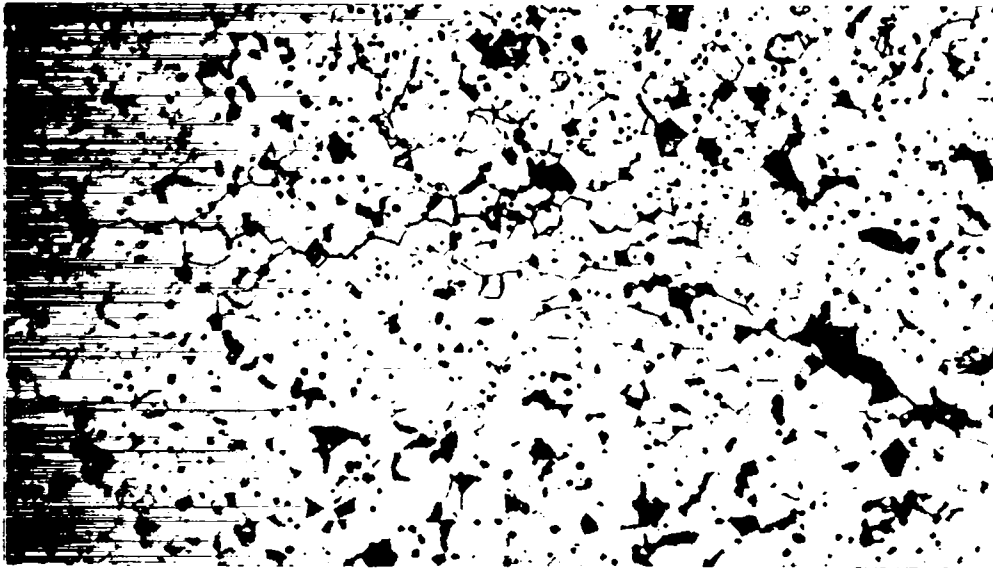
Fig. B-28.

Specimen HPZ-61-11, tested at 1500°C after 604-day ambient temperature storage. Note intergranular fracturing. (200X).

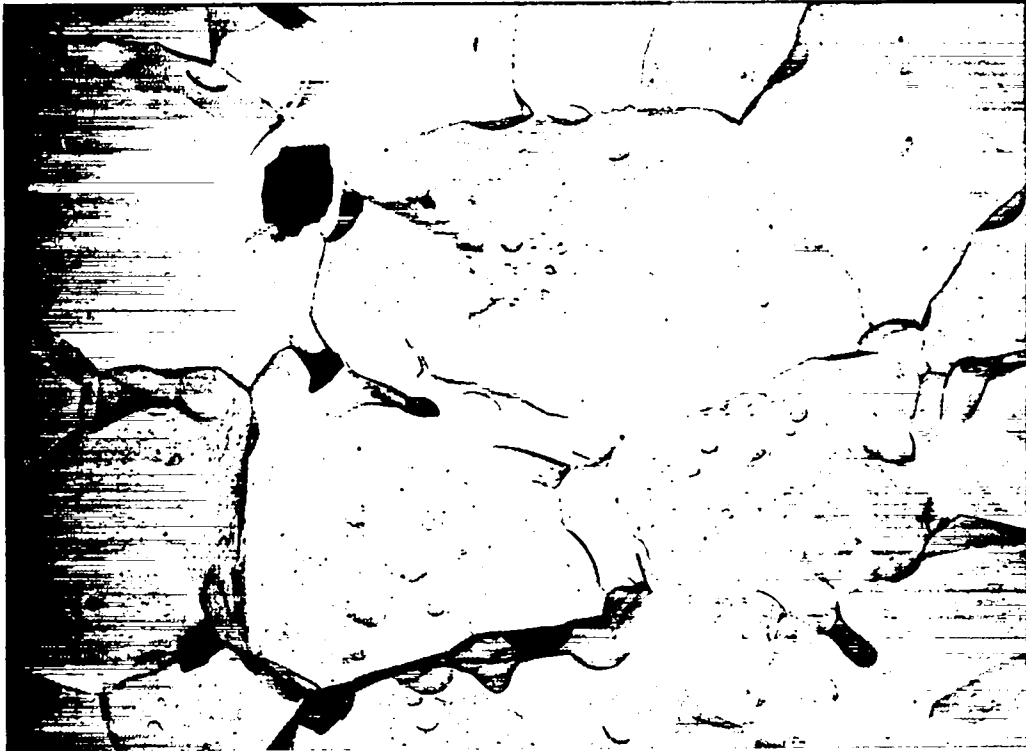
Fig. C-9.

REM of fracture surface of HPZ-116-8, tested at 1000°C after 58-day ambient temperature storage. Fracturing is intergranular, with grain and grain boundary definition. Note grain boundary helium bubbles. (3600X).

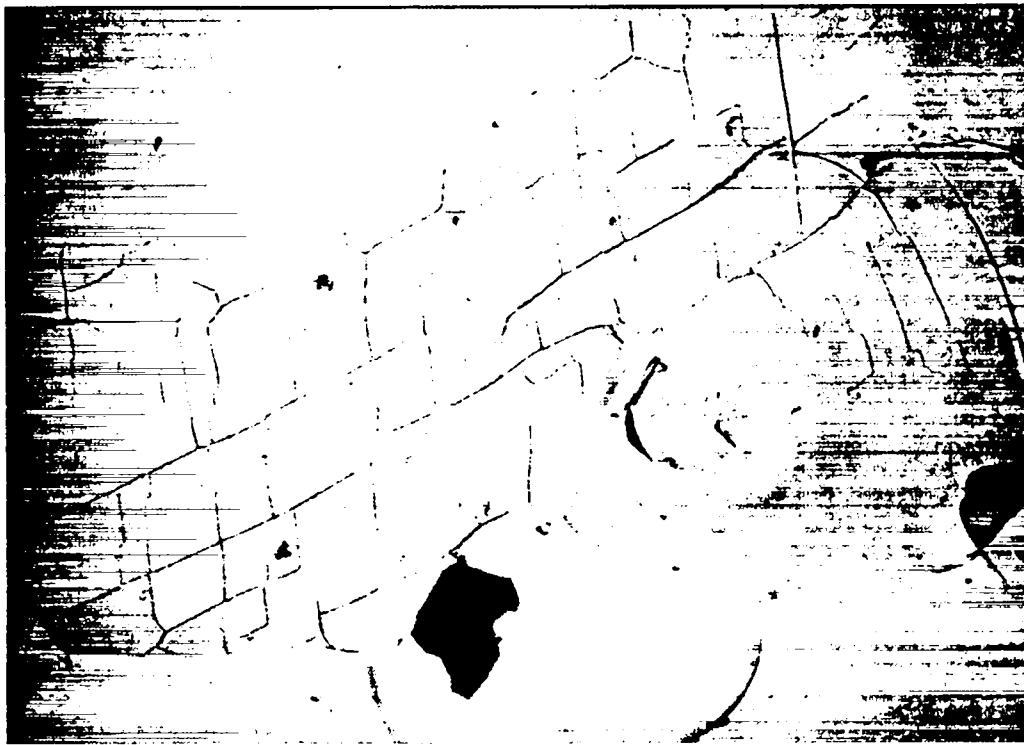
Fig. C-14.
REM of fracture surface of HPZ-61-15, tested at 1500°C after 619-day ambient temperature storage. Geometric lines may be related to dislocation activity in the $^{238}\text{PuO}_2$ at 1500°C. (4000X).

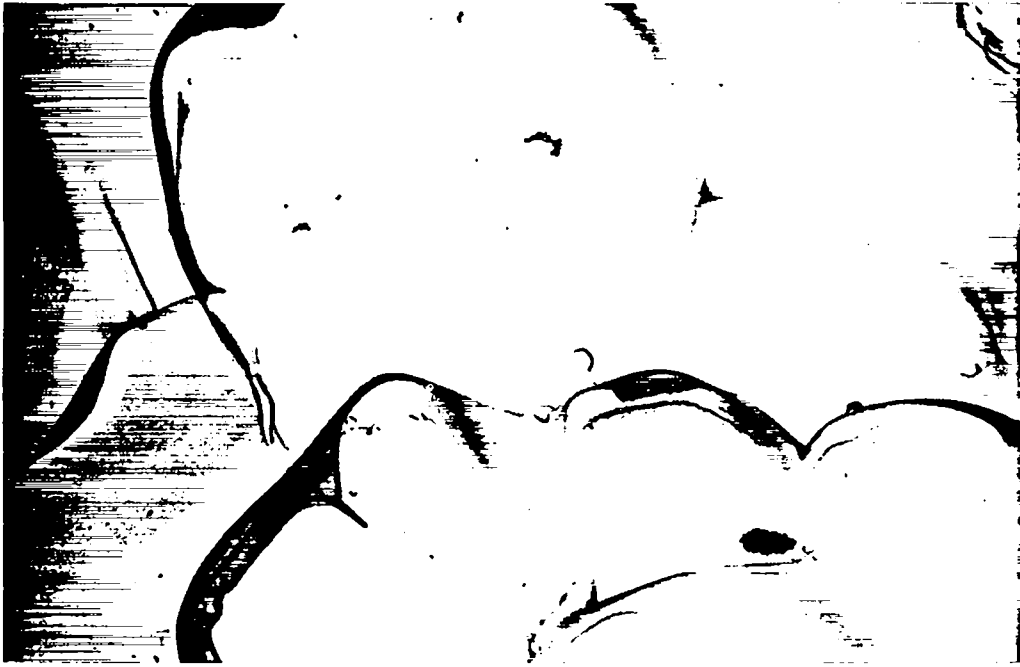
Fig. C-17.

REM of fracture surface of HPZ-115-1, tested at 1400°C after 113-day ambient temperature storage. Note the smooth, featureless rounded grains. (4400X).

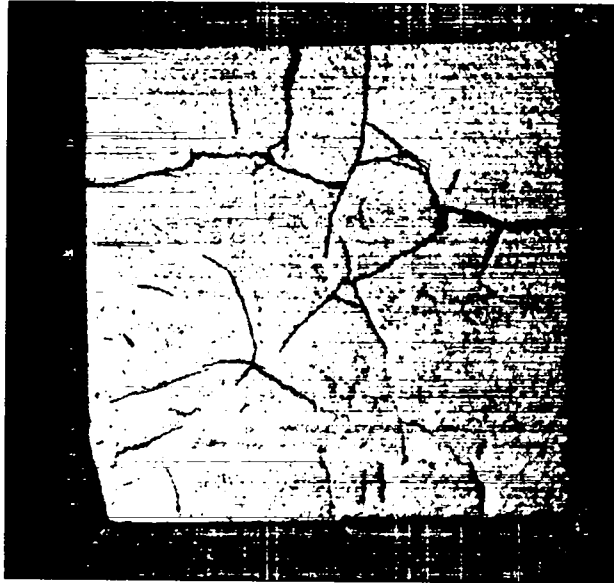
Fig. D-1.
Polished cross section of specimen HPZ-115-12
after annealing. (8X).

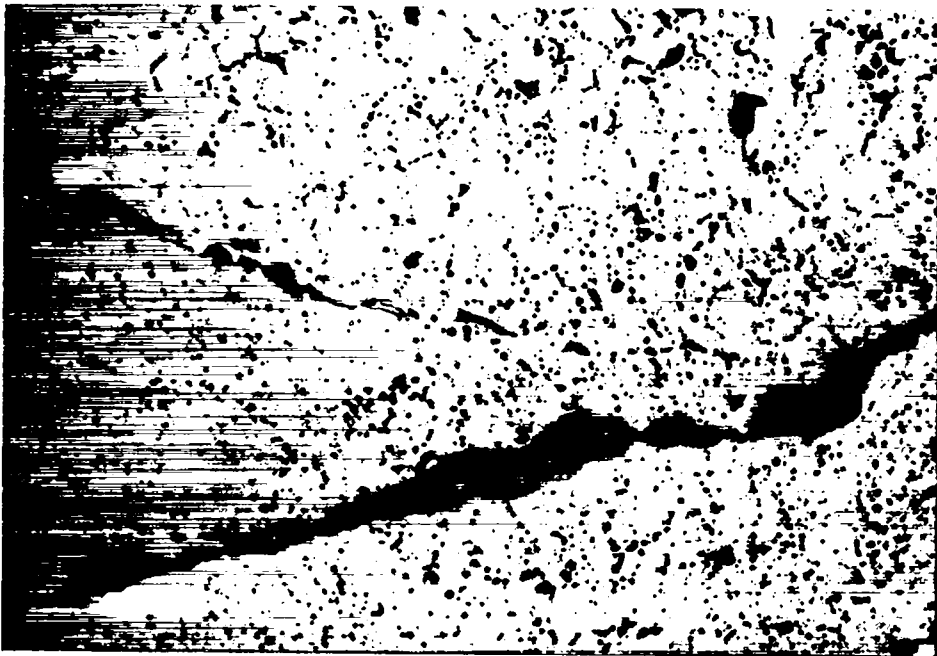
Fig. D-2.
Crack healing in HPZ-115-12. Note the string of porosity
resulting from crack healing. (200X).

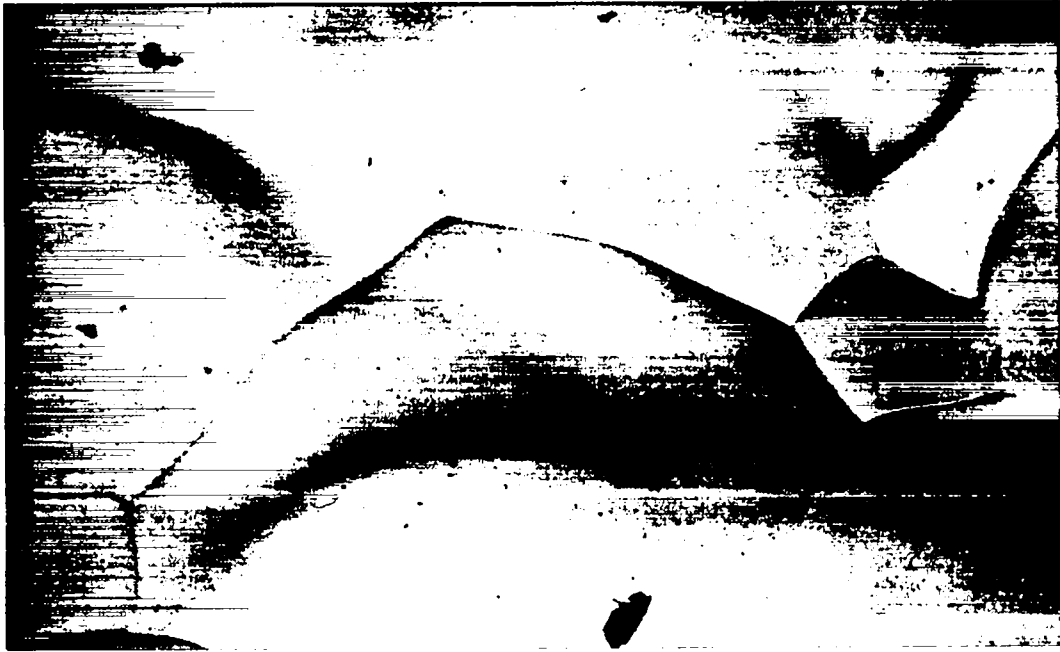
Fig. E-1.
Room temperature rounded grain fracture surface. (5000X).

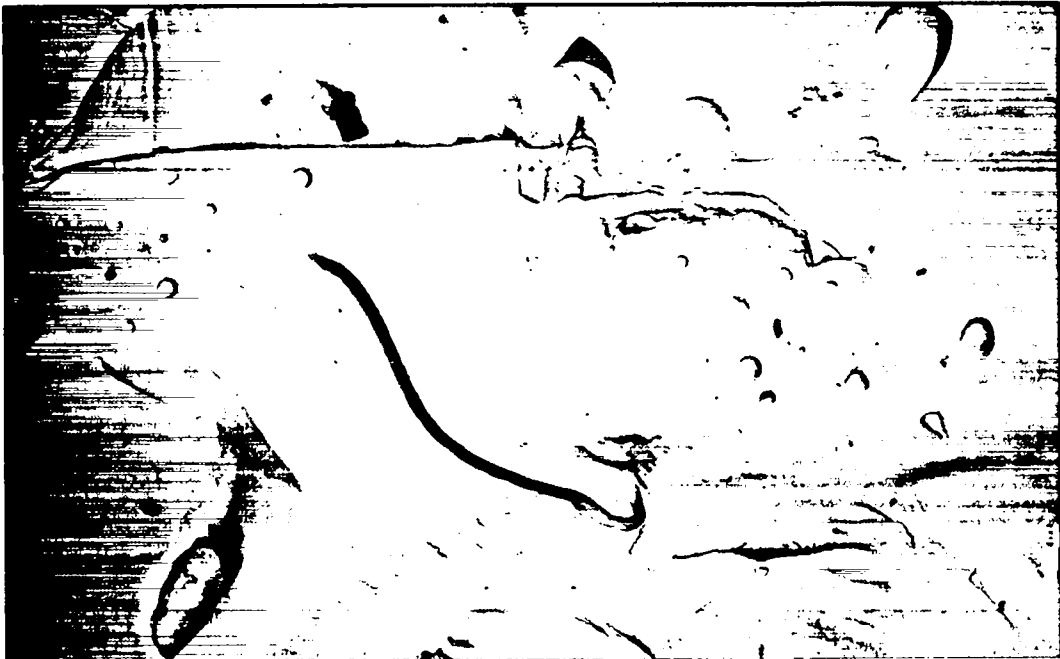
Fig. E-2.
Room temperature transgranular cleavage fracture surface. (4000X)
