*High Explosive Spot Test Analyses of  
Samples from Operable Unit (OU) 1111*

# HIGH EXPLOSIVE SPOT TEST ANALYSES OF SAMPLES FROM OPERABLE UNIT (OU) 1111

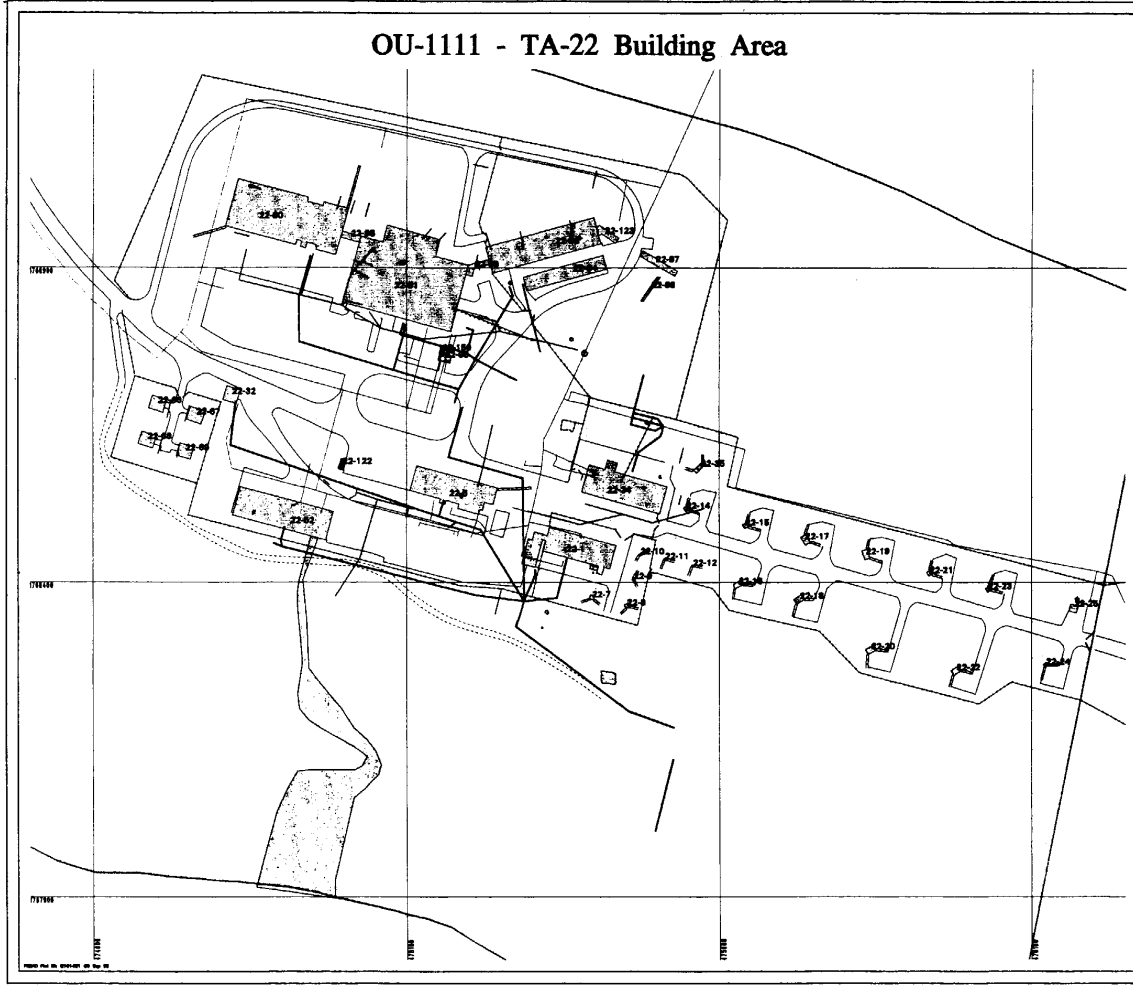
We used the field spot-test kits to screen for TNT, RDX, HMX, PETN, HNS, and PYX (Figure 1). We analyzed samples for lead, uranium, mercury, and nickel using EDXRF.
